# Inspection Photos

Operator: LOCIN OIL CORPORATION - 51130

Location Number: 322447

Garfield County, CO

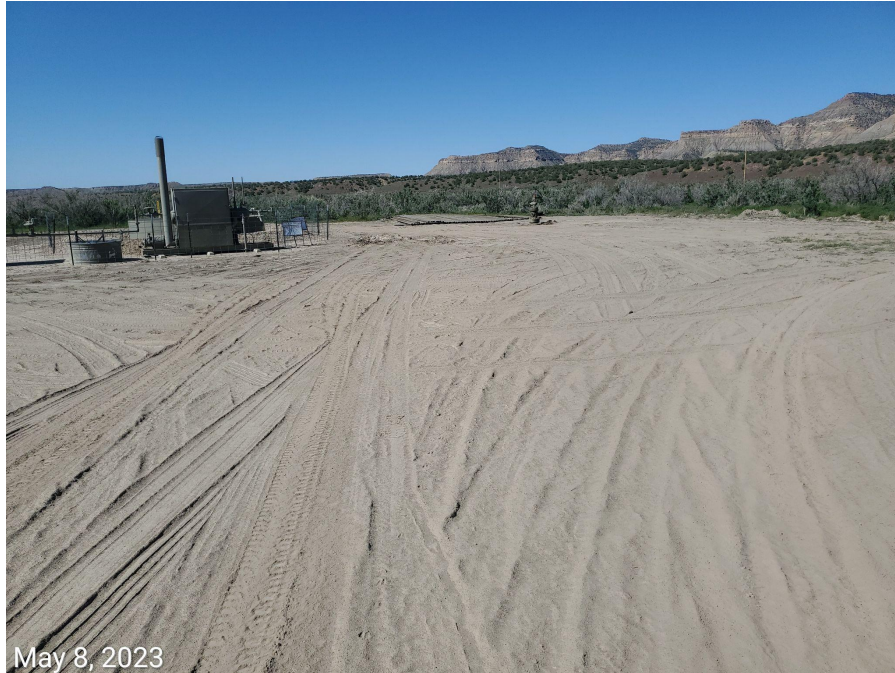
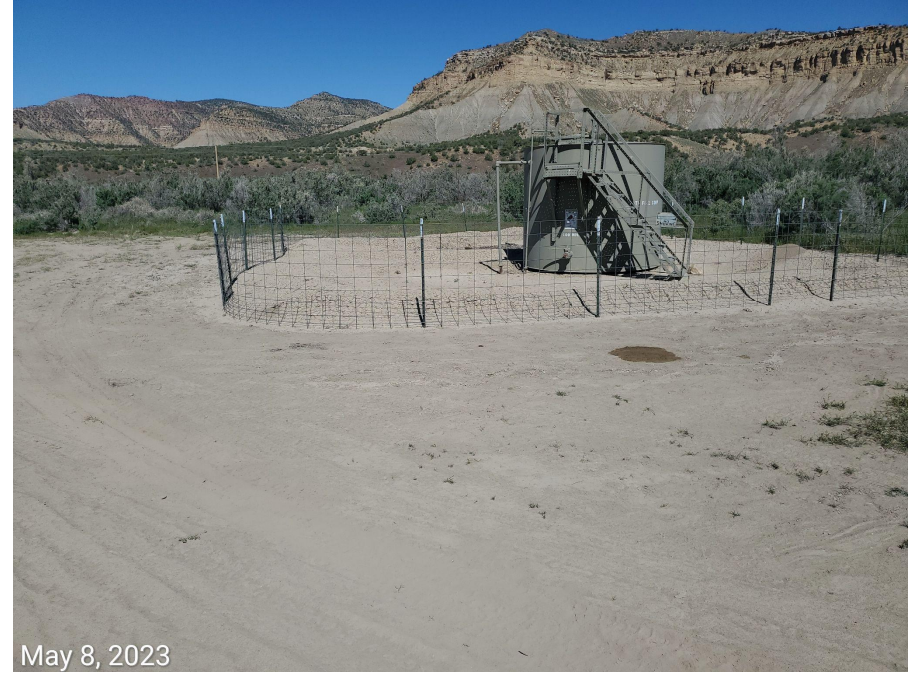
**Photo 1:** Photos taken from the north end of the Location, and provide an overview of the Location southwest to west.

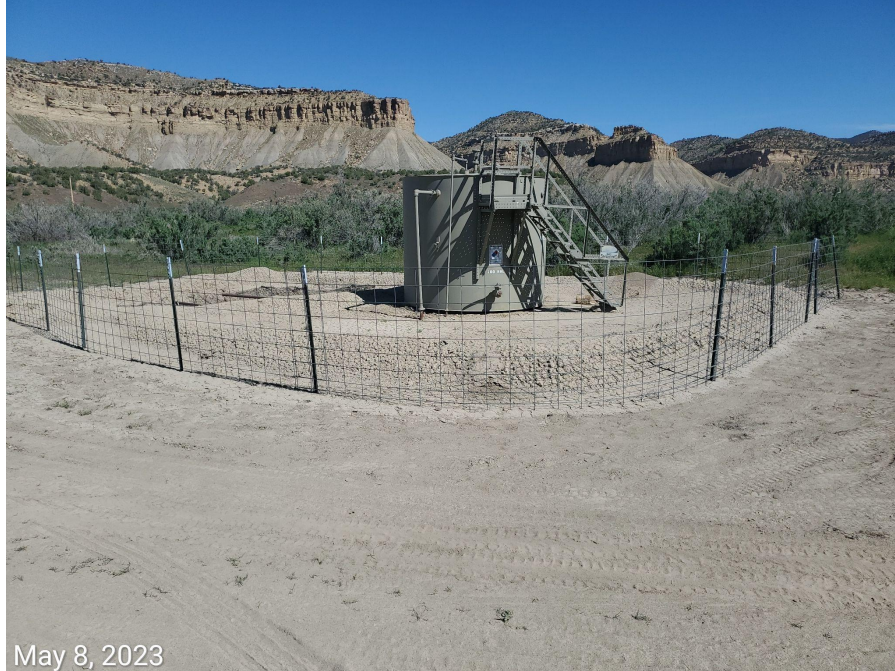
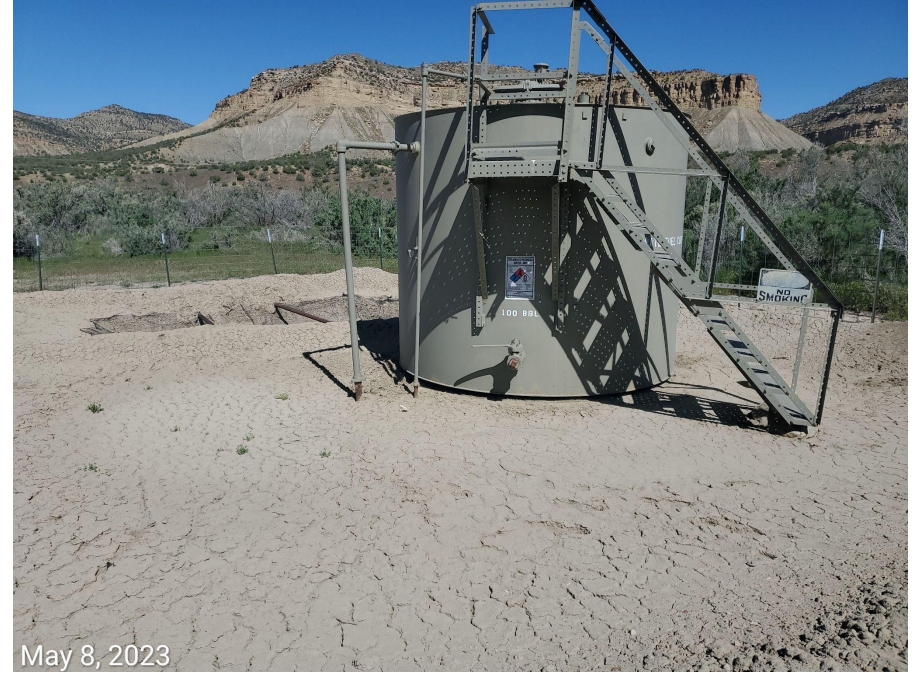
**Photo 2:** Tank battery on north end of the Location. Signage at facility, and signage on tanks do not comport with 605 Rules.

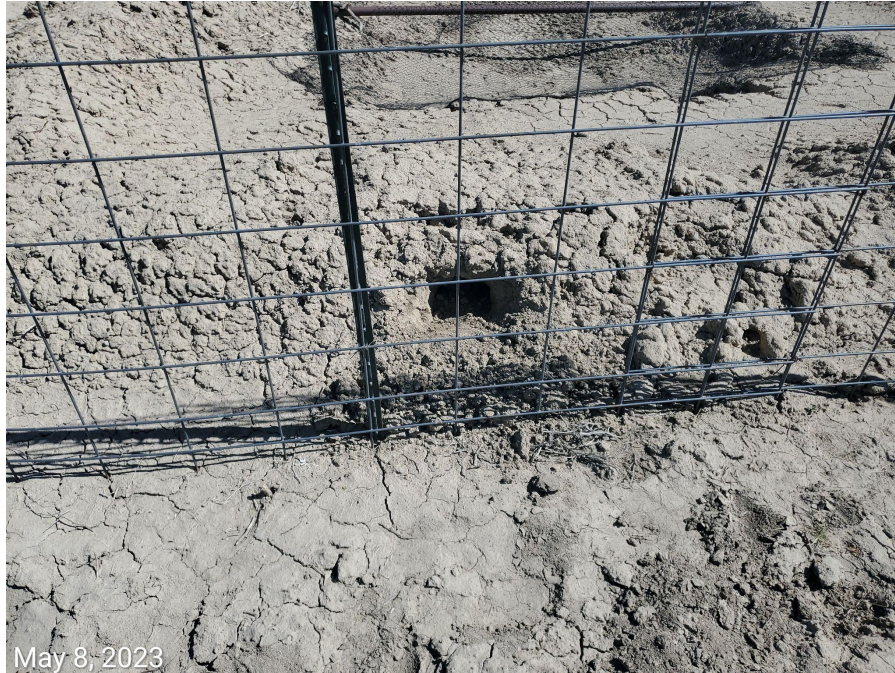
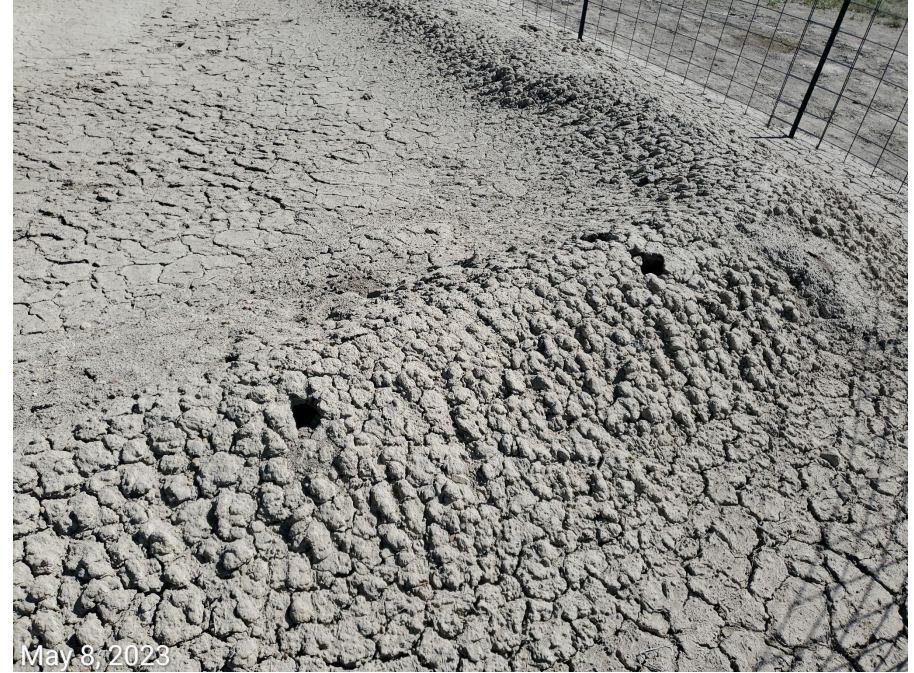
**Photo 3:** Secondary containment BMP lacks proper consolidation, and is no longer impervious to contain a spill.

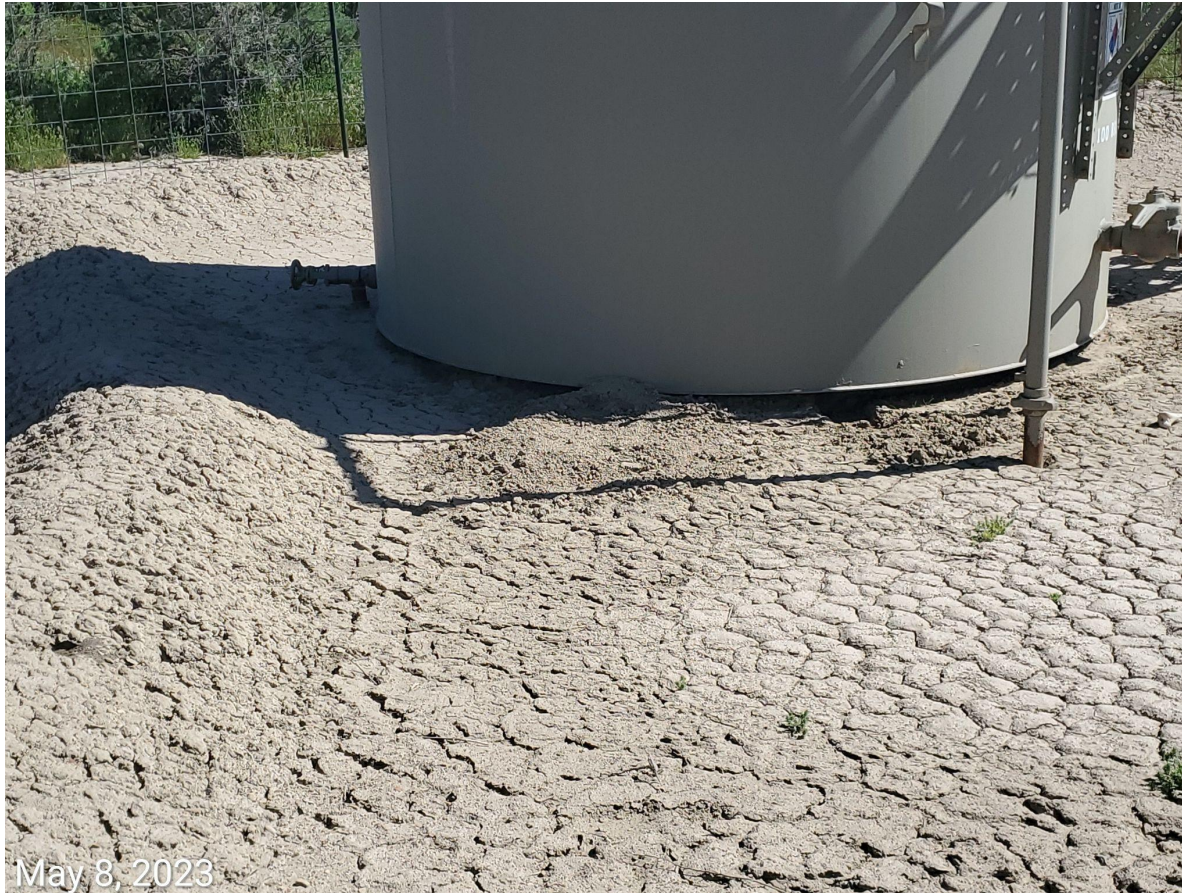
**Photo 4:** Wildlife appear to be burrowing into the base of the containment BMP; BMP is no longer impervious to contain a spill.

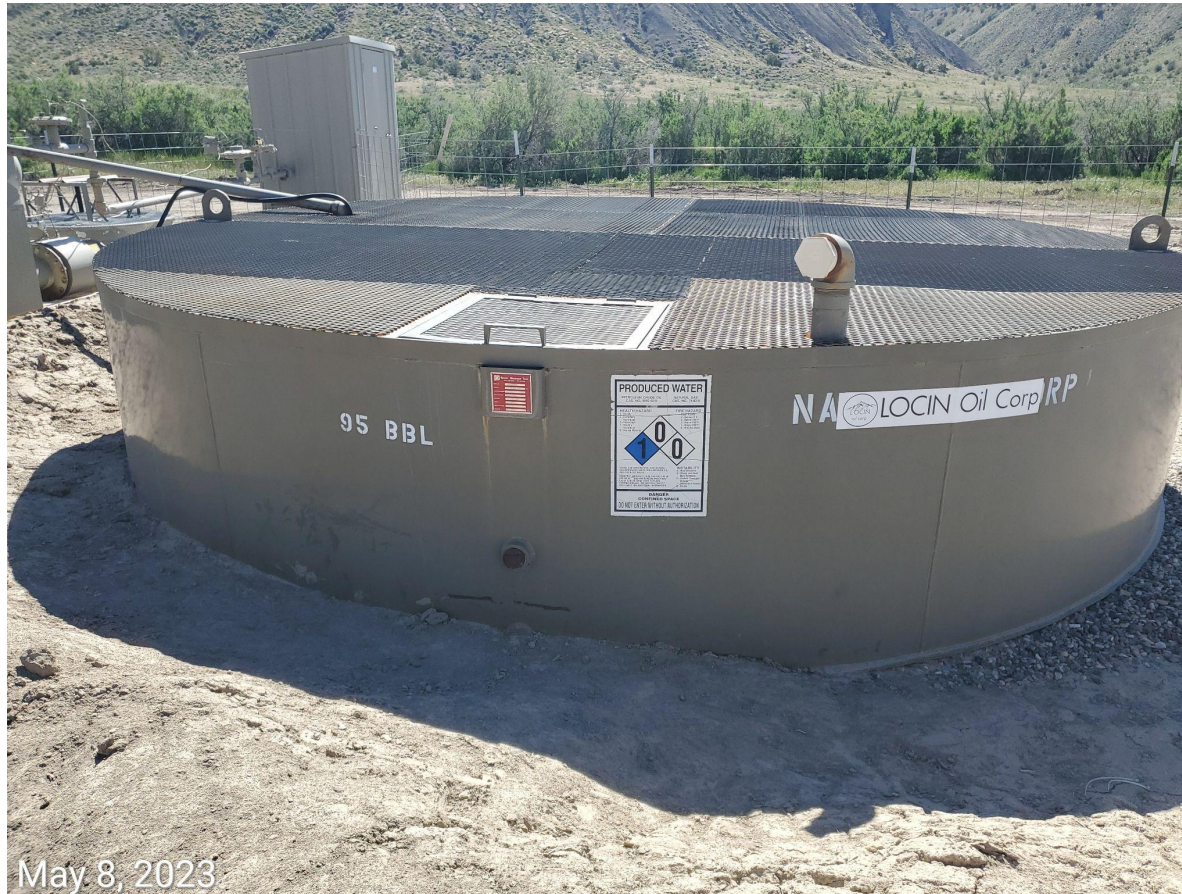
**Photo 5:** Tank battery on south end of the Location. Signage on tank does not comport with 605 Rules.

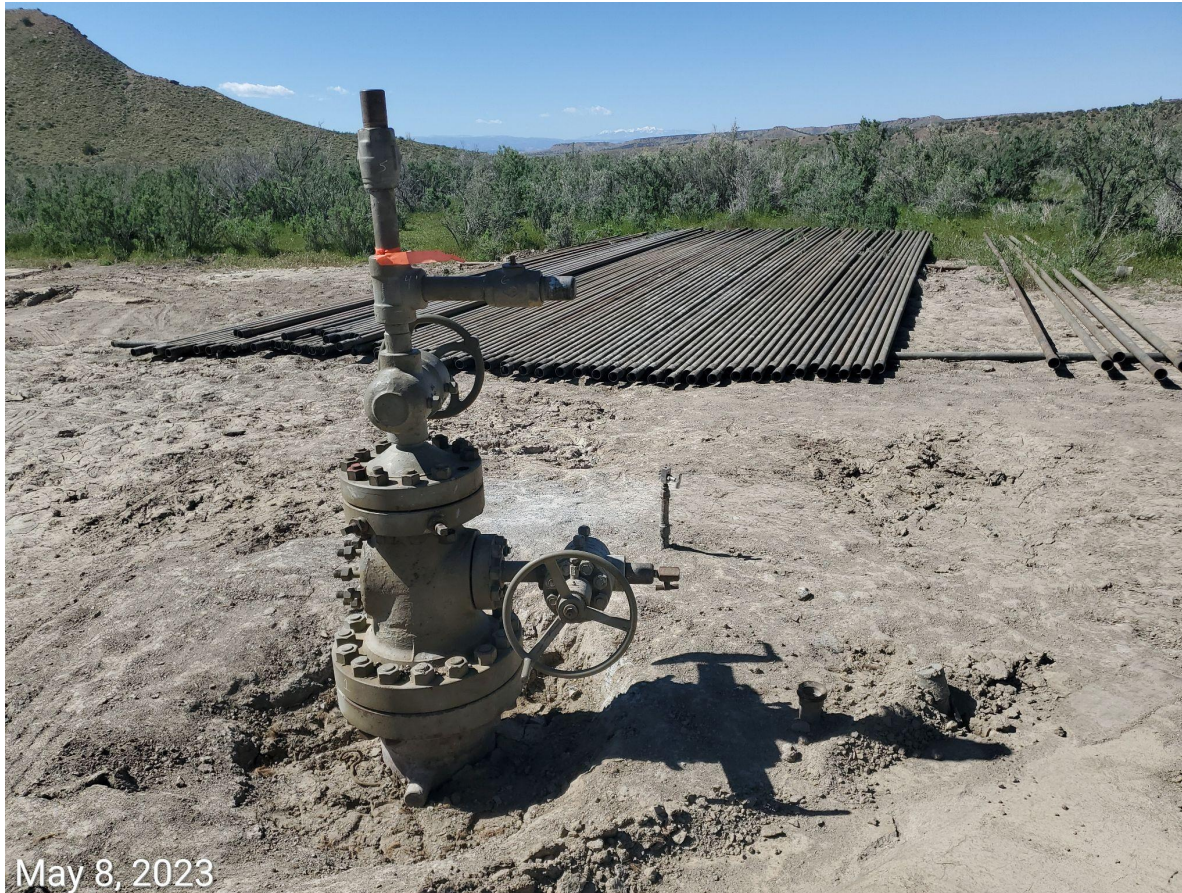
**Photo 6:** Wellhead. Signage not posted. Riser adjacent to well has not been properly capped, and remains exposed.

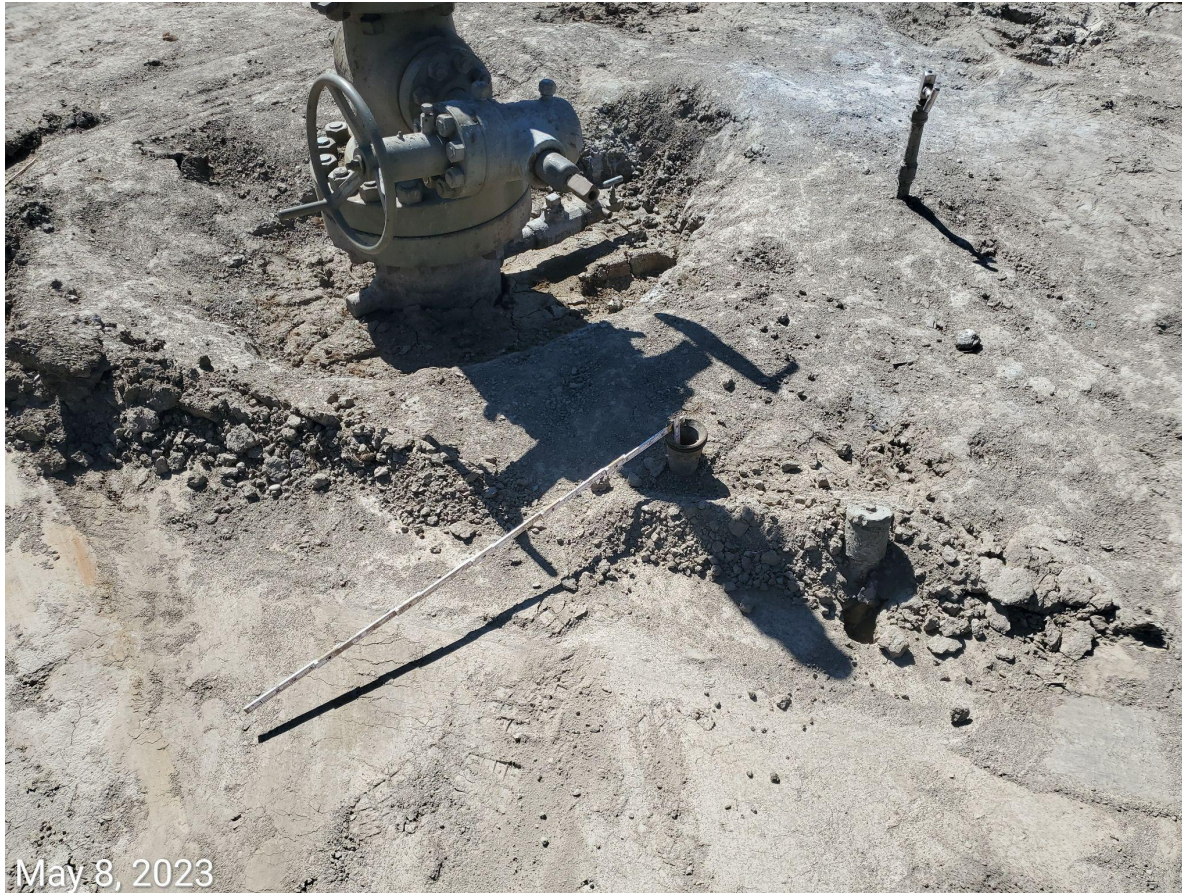
**Photo 7:** Riser adjacent to well has not been properly capped, and remains exposed.

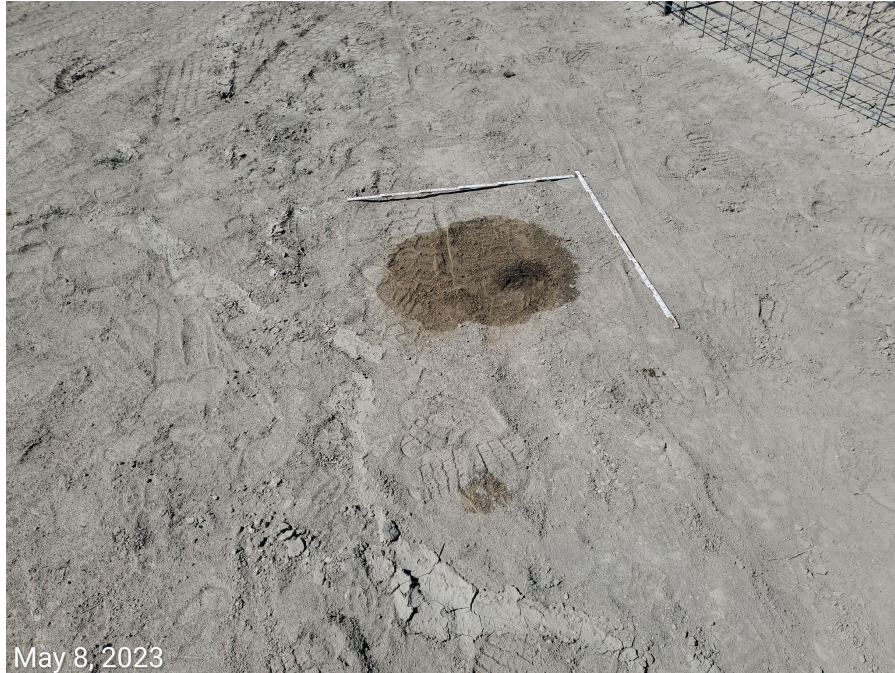
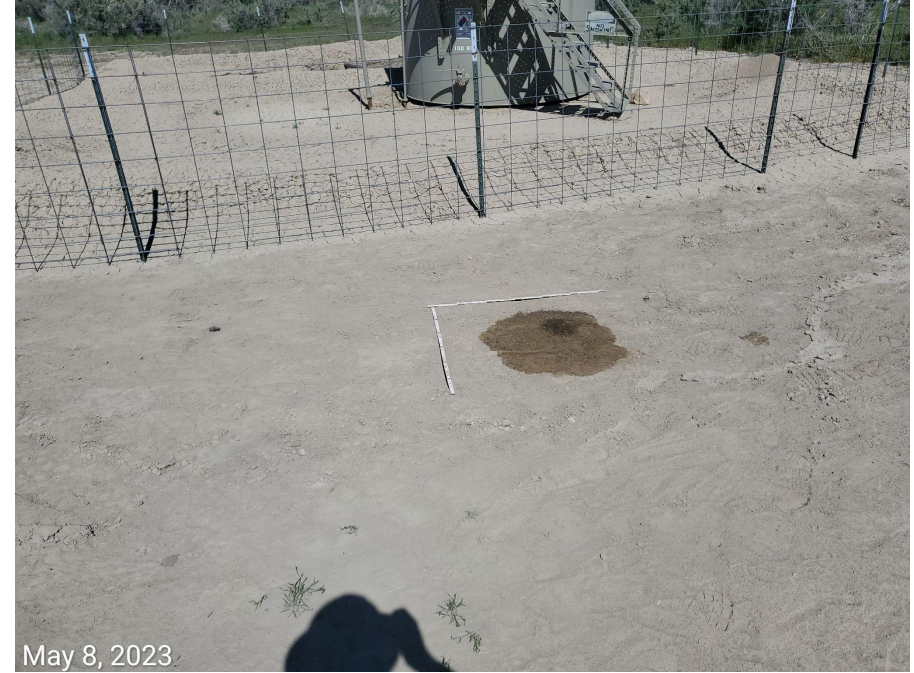
**Photo 8:** Stained soils on Location; stained soils require cleaning/remediating. 6 foot (3'x3') measuring stick used for reference.

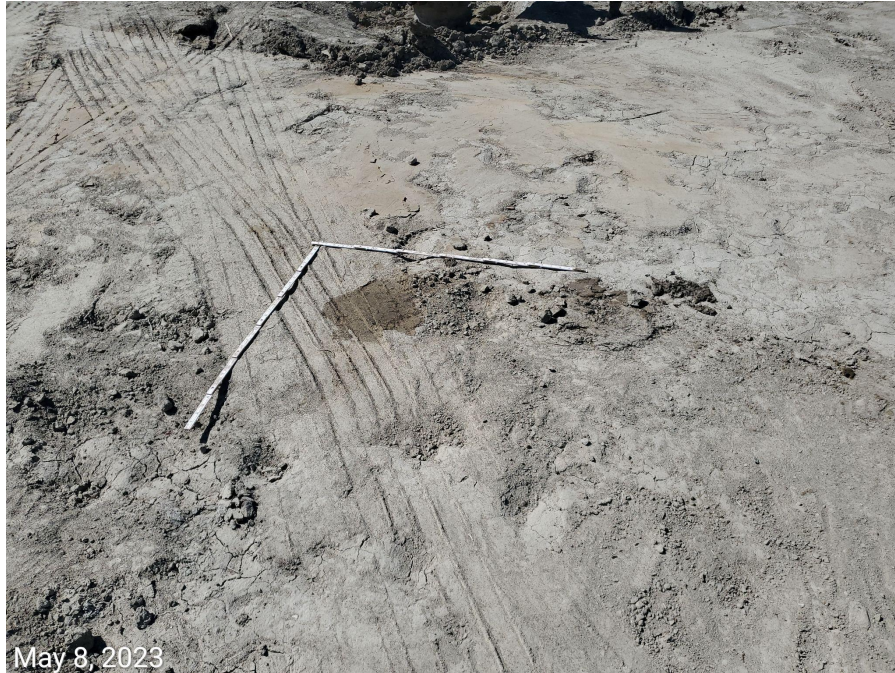
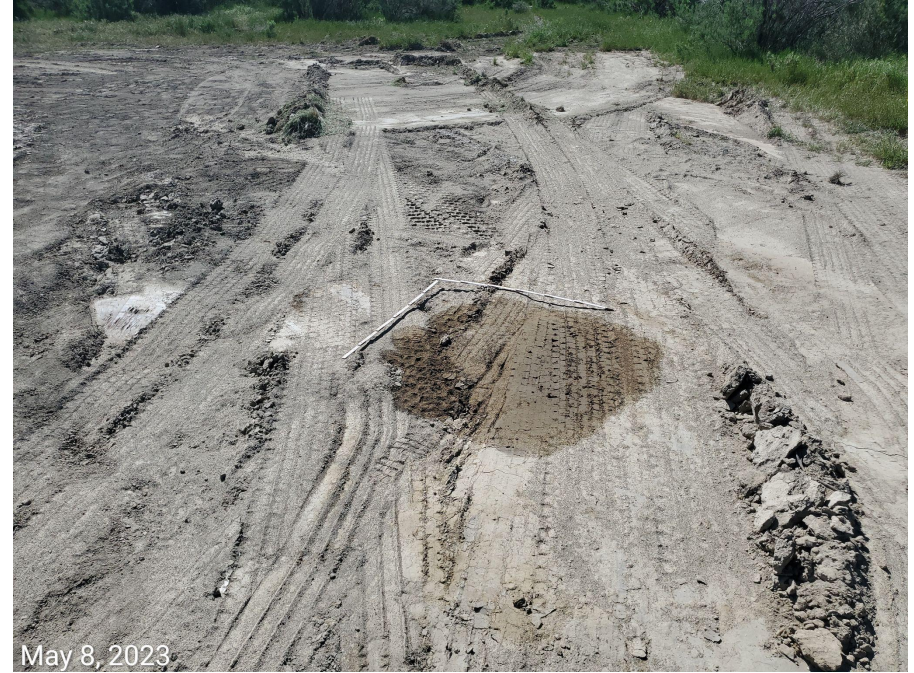
**Photo 9:** Stained soils on Location; stained soils require cleaning/remediating. 6 foot (3'x3') measuring stick used for reference.
