Interim Reclamation and Stormwater Inspection

Operator: UPLAND EXPLORATION LLC- #10701

Location ID: 462908

Inspection Photos
Location Name: Little Lady 21/North Well Pad
Location ID: 462908

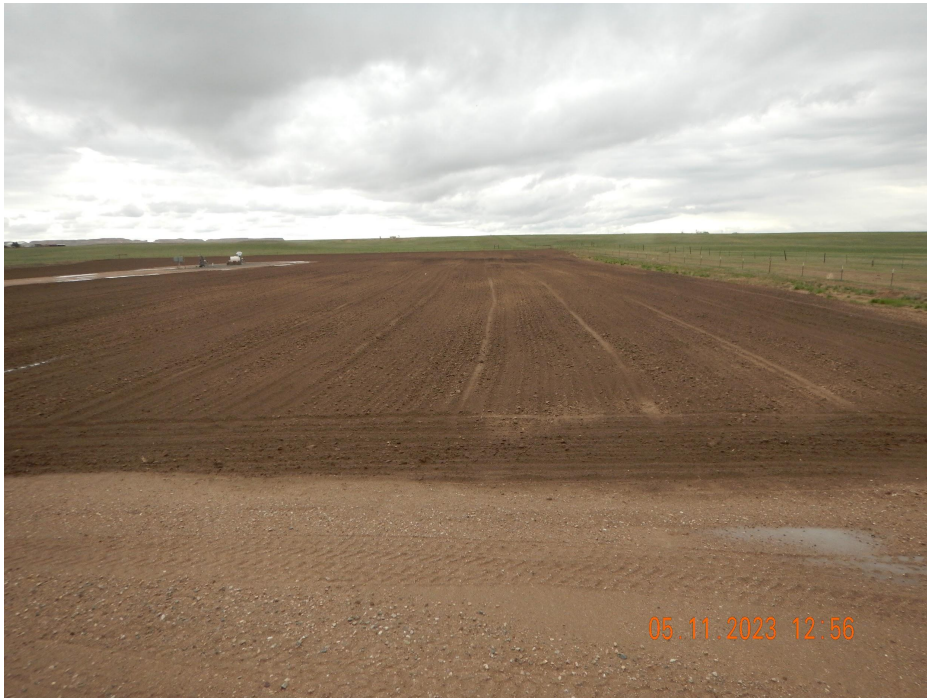
Photo 1. Photo taken from the southeastern location, facing North. Photo illustrates interim reclamation has been performed; however, interim reclamation is not complete due to the lack of soil stabilization. It appears that straw mulch was crimped but blew away in a dust storm.

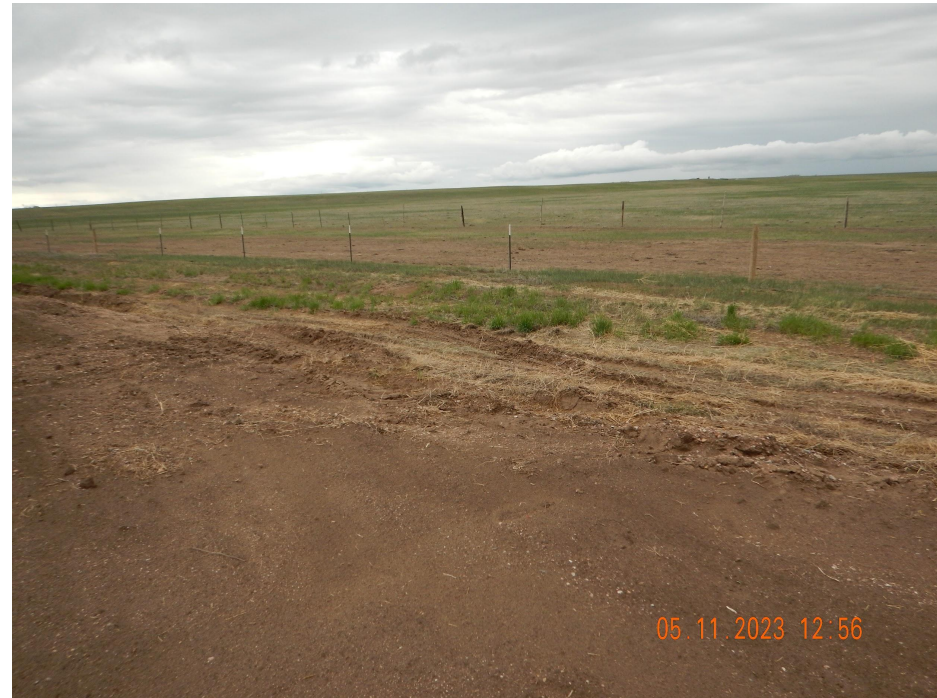
Photo 2. Photo taken from the southeastern location, facing Northeast. Photo illustrates the what appears to be the straw mulch that blew away in a dust storm.

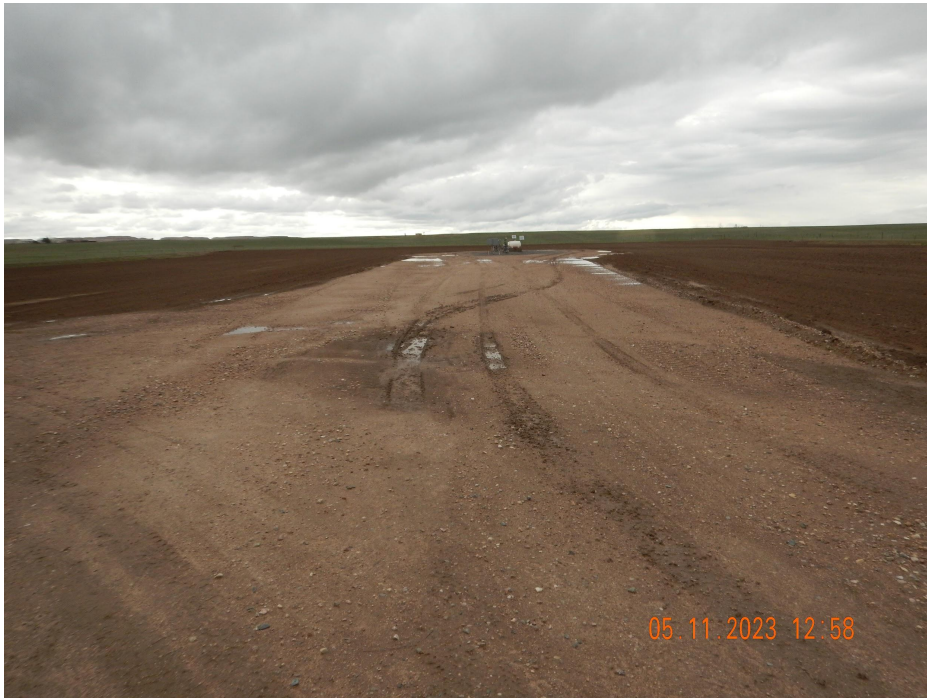
Photo 3. Photo taken from the southern location, facing North. See comments under Photo 1.

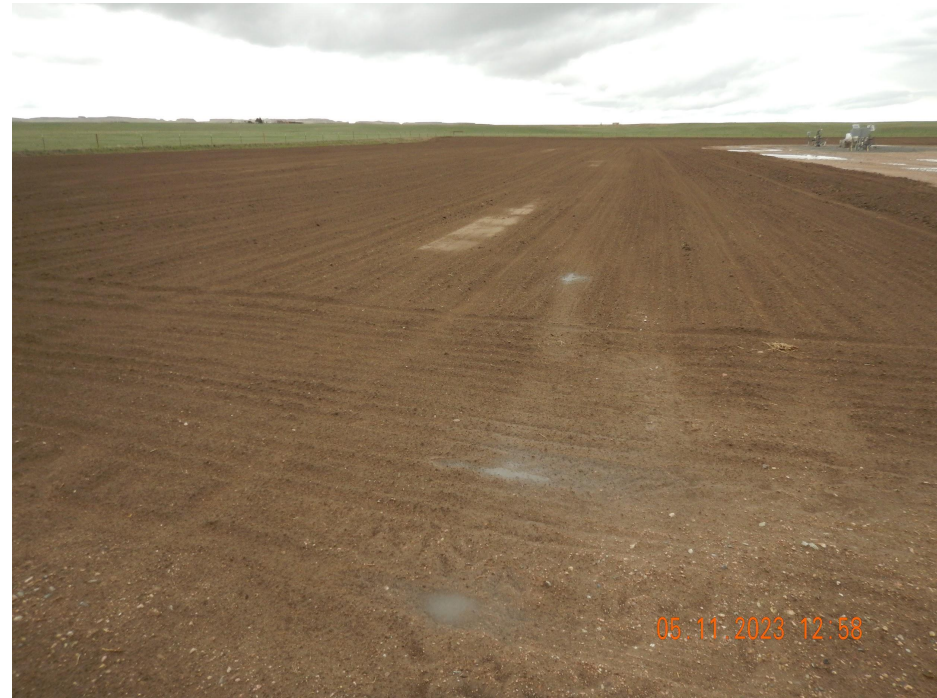
Photo 4. Photo taken from the southwestern location, facing North. See comments under Photo 1.

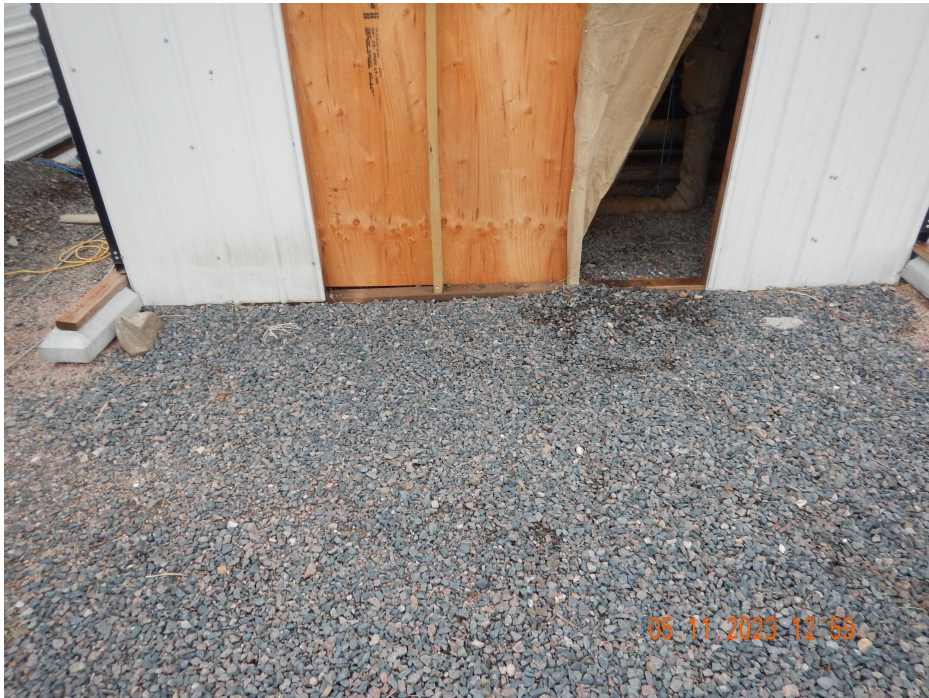
Photo 5. Photo taken from the western location, facing West. Photo illustrates stained soil around the compressors has been removed.

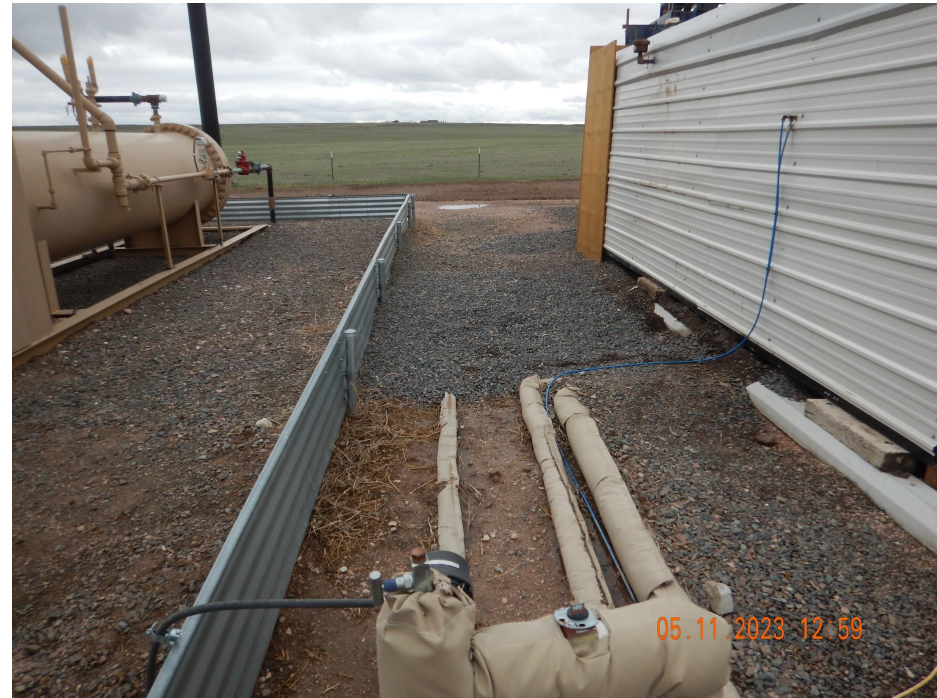
Photo 6. Photo taken from the western location, facing West. See comments under Photo 5.

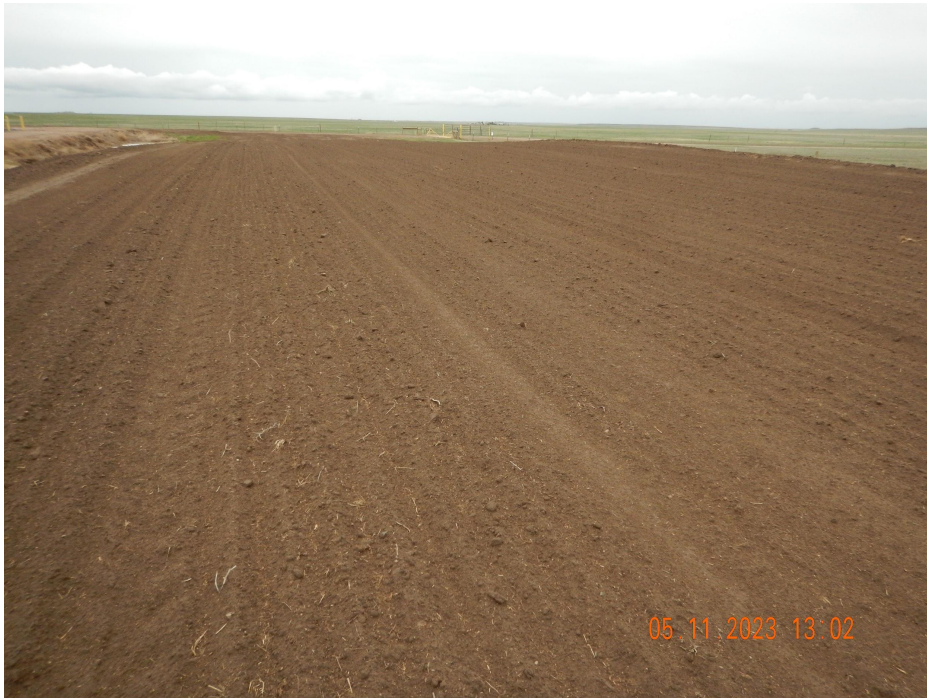
Photo 7. Photo taken from the topsoil stockpile, facing East. Photo illustrates the topsoil stockpile which has been seeded; however, the topsoil stockpile lacks soil stabilization.

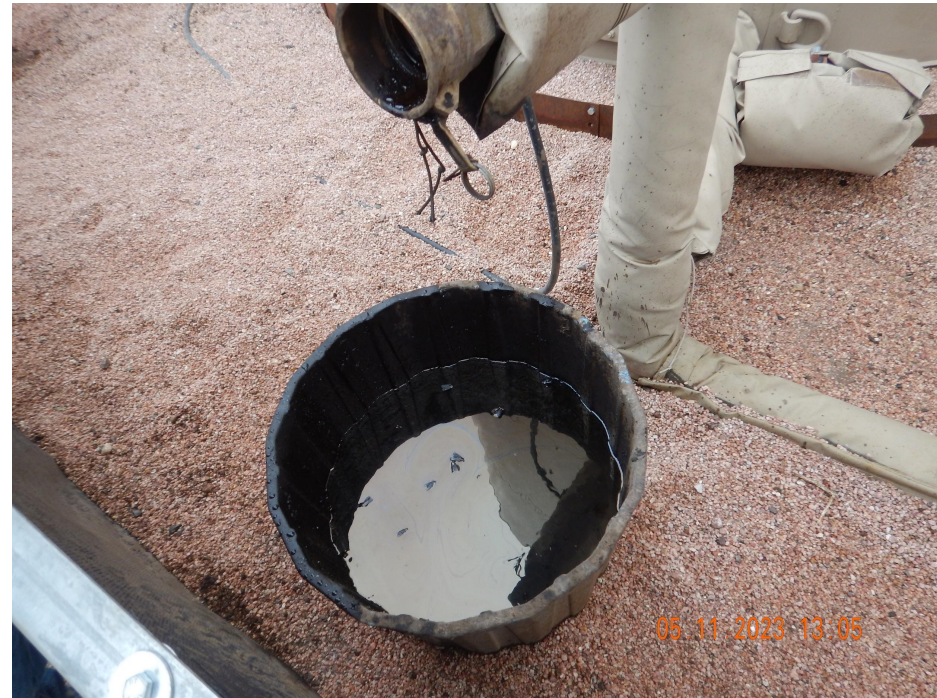
Photo 8. Photo taken from the facility location. Photo illustrates an open bucket with oil that is missing wildlife protection devices.
