Final Reclamation and Stormwater Inspection

Operator: WHITING OIL & GAS CORPORATION -
96155

Location ID: 450097

Inspection Photos
Location Name: Razor 27KW Pad
Location ID: 450097

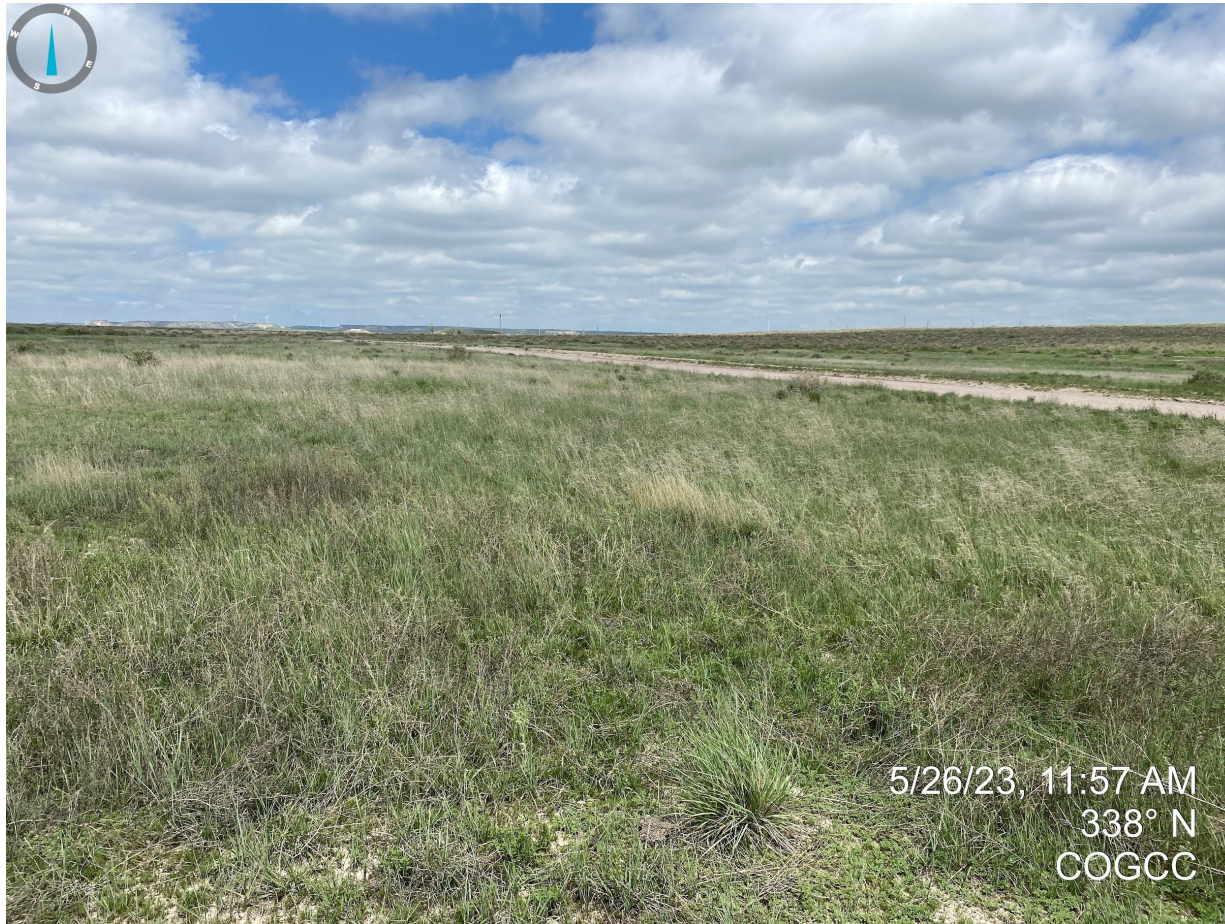
Photo 1. Facing north from the proposed location. Photo illustrates that no disturbance was detected and the location does not appear to have been constructed.

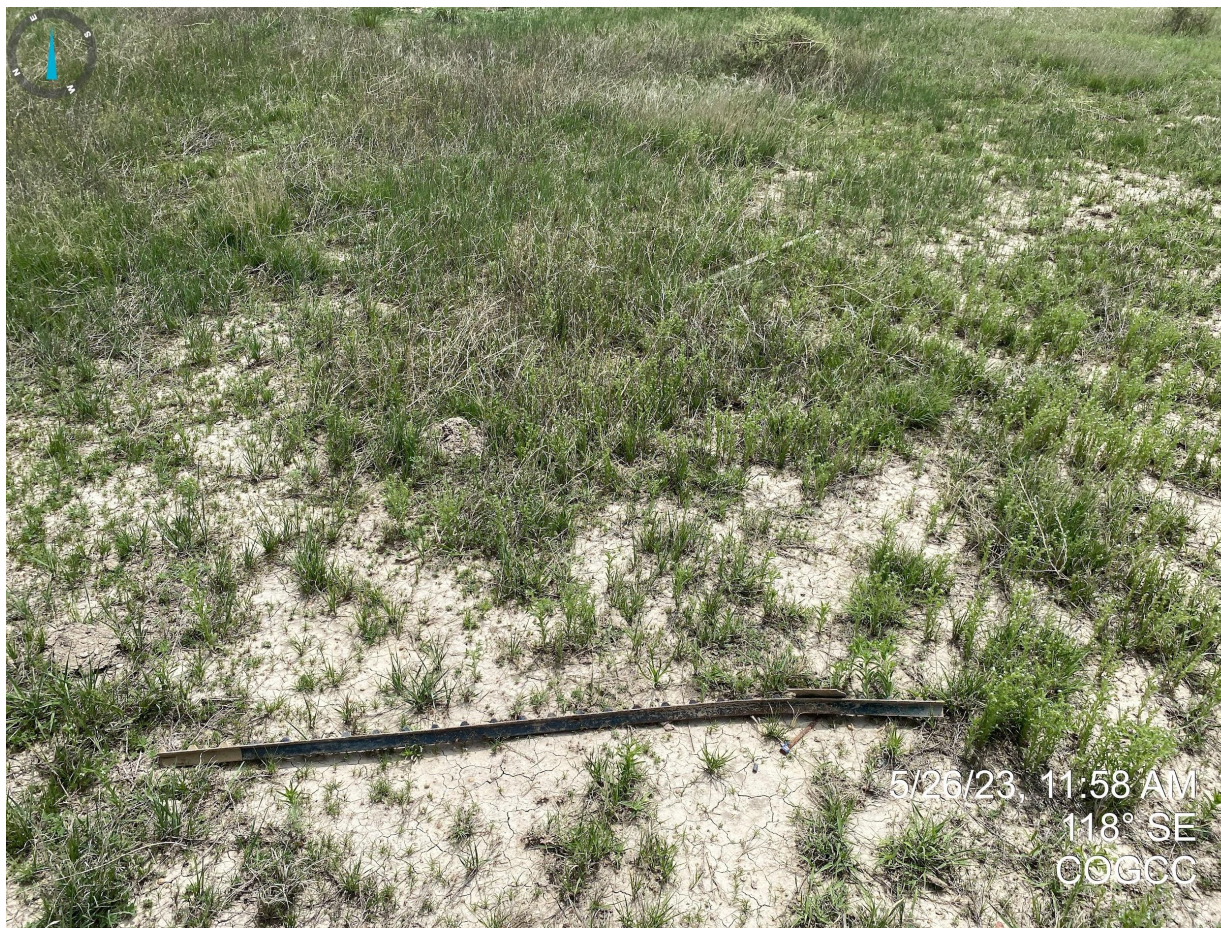
Photo 2. T posts and wooden stakes remain on location and are now considered debris. All debris will need to be removed in order to meet Rule 1004 standards.

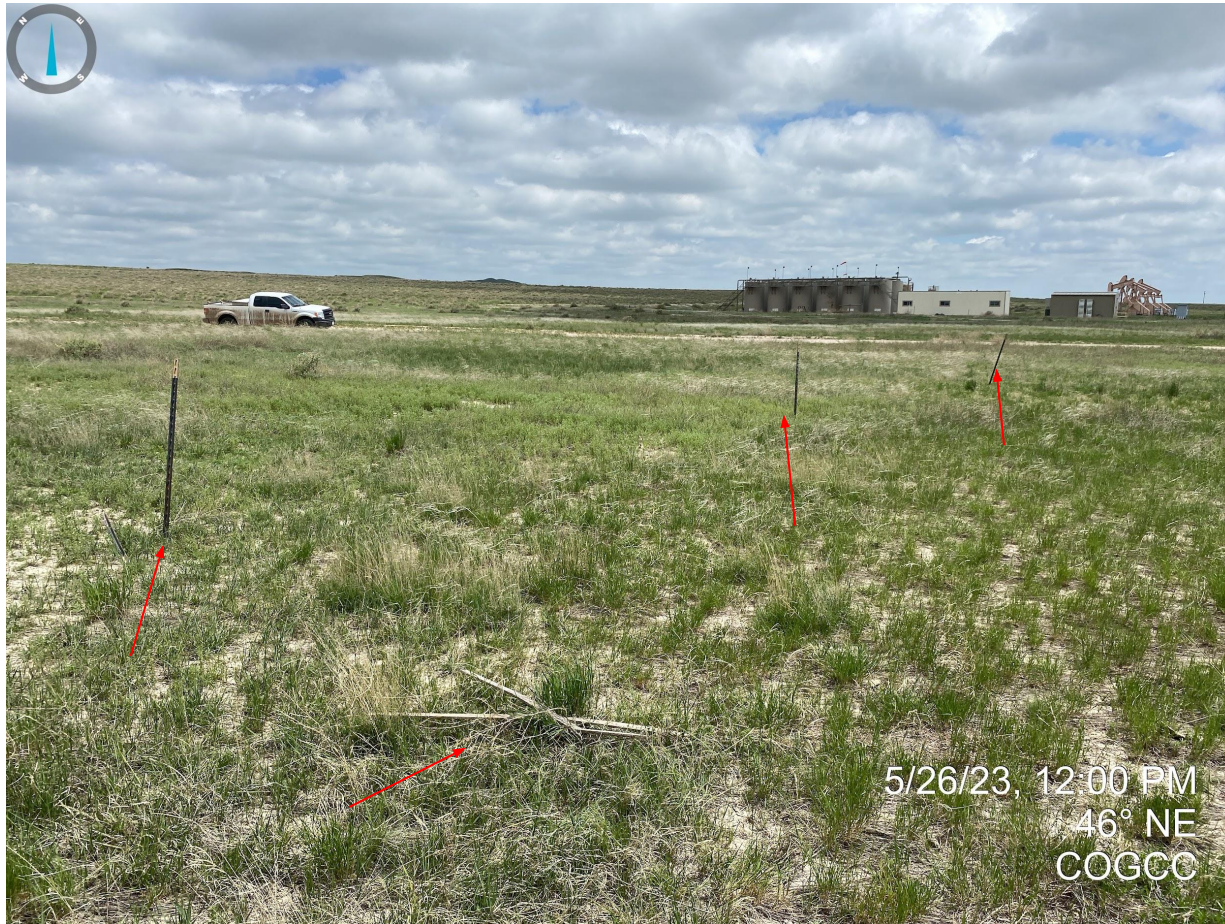
Photo 3. See comments in Photo 2.
