Operator: CRESTONE PEAK RESOURCES
Location Name: PURITAN 2N68W/34SESE
Loc ID: 336413
Inspection: 710100014

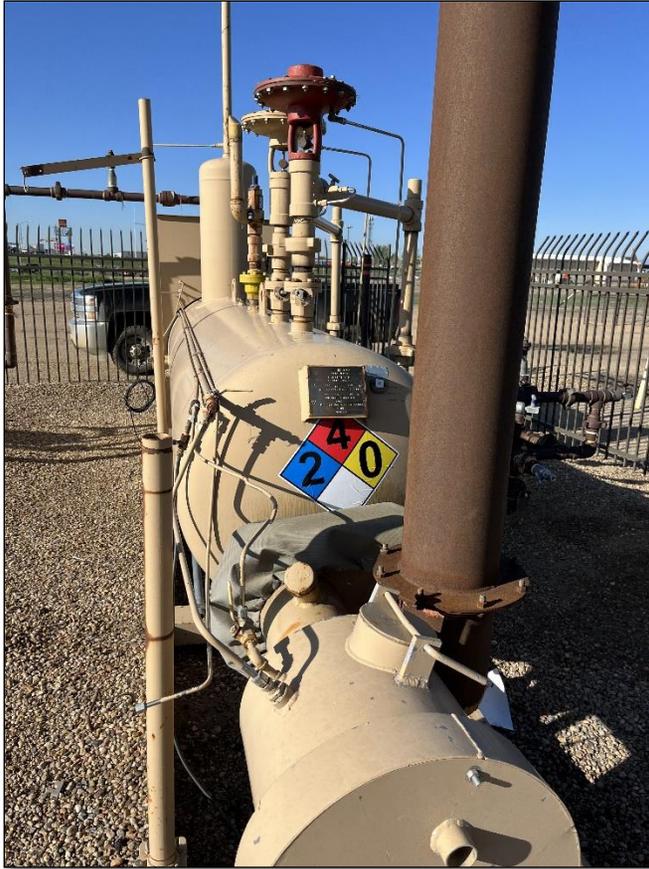
Exhibit A

CA: Missing NFPA placard and labels on horizontal separator. Install signage to comply with Rule 605.h.

CA Resolution: Operator has appropriately installed NFPA labels to comply with Rule 605.h.

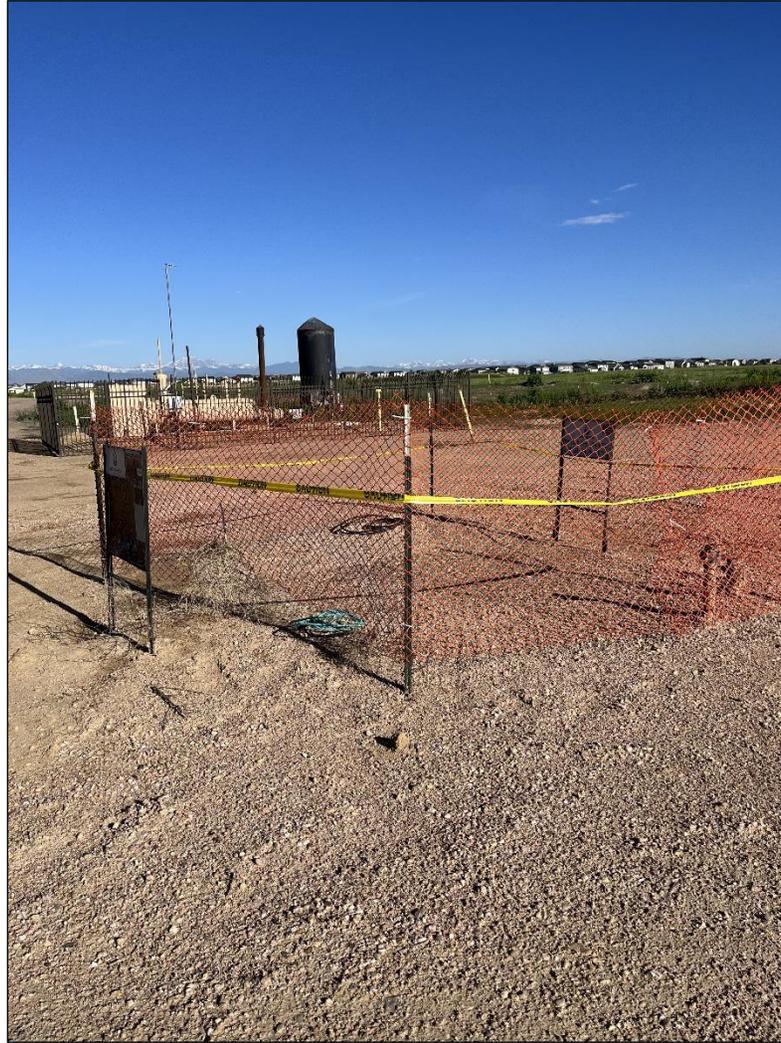
Exhibit A

CA: Inadequate fencing around excavation. Repair and maintain best management practices to protect the environment, public health, safety and welfare and the environment as required by rule 913.b(5)B.i which requires that Operators will fence or cover open remediation excavations to prevent access when sites are not attended. the site was not attended at the time of the inspection.

CA Resolution: Operator has appropriately addressed and fixed/installed adequate fencing around excavation to comply with Rule 913.b(5)B.i.
