Operator: 8 NORTH LLC
Location Name: HAYNES 1062-1-11
Loc ID: 417297
Inspection: 696304933

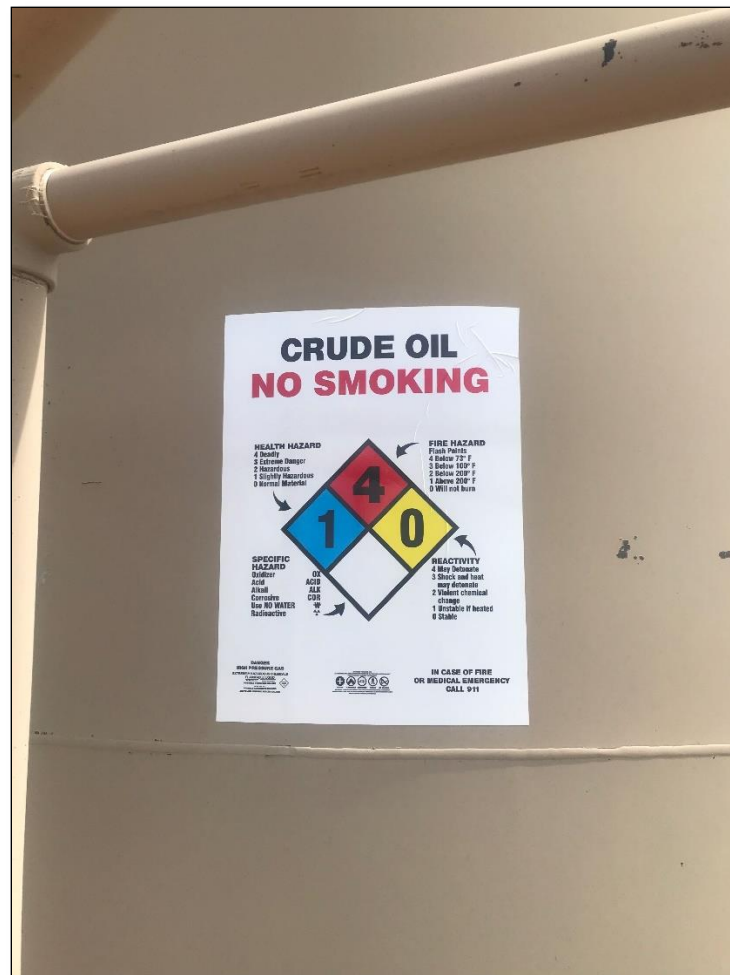
Exhibit A

CA: Oil Tank - Content has faded no longer visible. For localized stained soils or oily waste - "Properly dispose of oily waste in accordance with 905.e."

CA Resolution: Label on Oil Tank has been replaced with a new one. The Operator has been notified of Rule 905.e. regarding treatment/disposal of oily waste and Land Treatment requirements. Location will be maintained to comply with Rule 905.e.

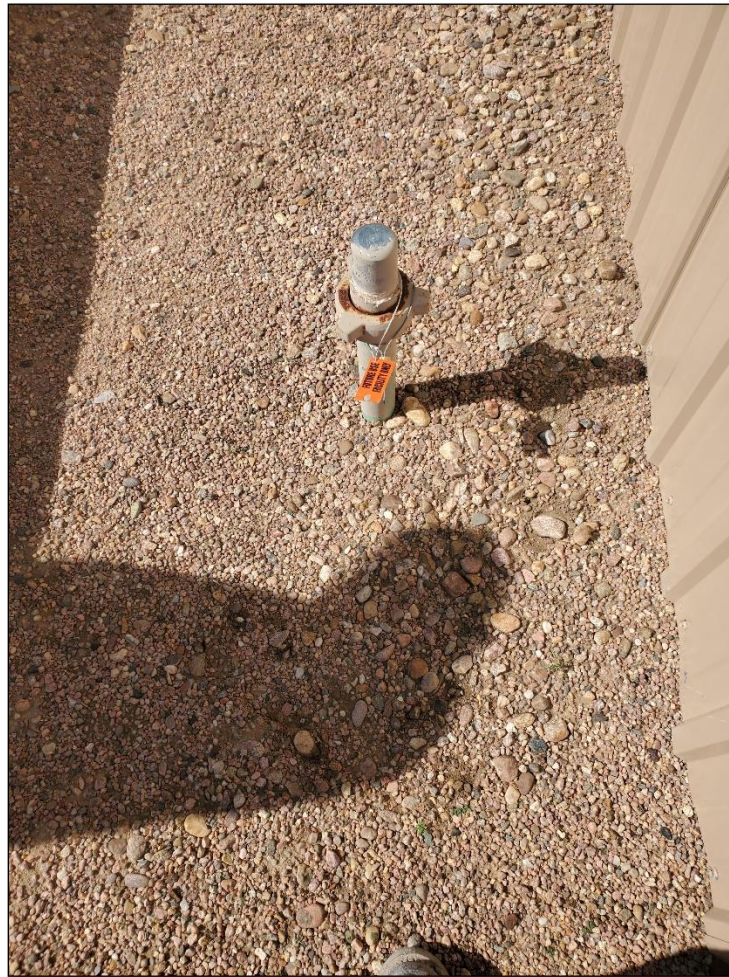
Exhibit A

CA: Unmarked Riser at Heater Treater; Comply with Rule 606.

CA Resolution: Identified Riser at Heather Treater has now been appropriately marked to comply with Rule 606.
