Final Reclamation Inspection

Operator: HIGHPOINT OPERATING CORPORATION - #10071

Location ID: 330784

Location Name: COLORADO ENERGY FEDERAL

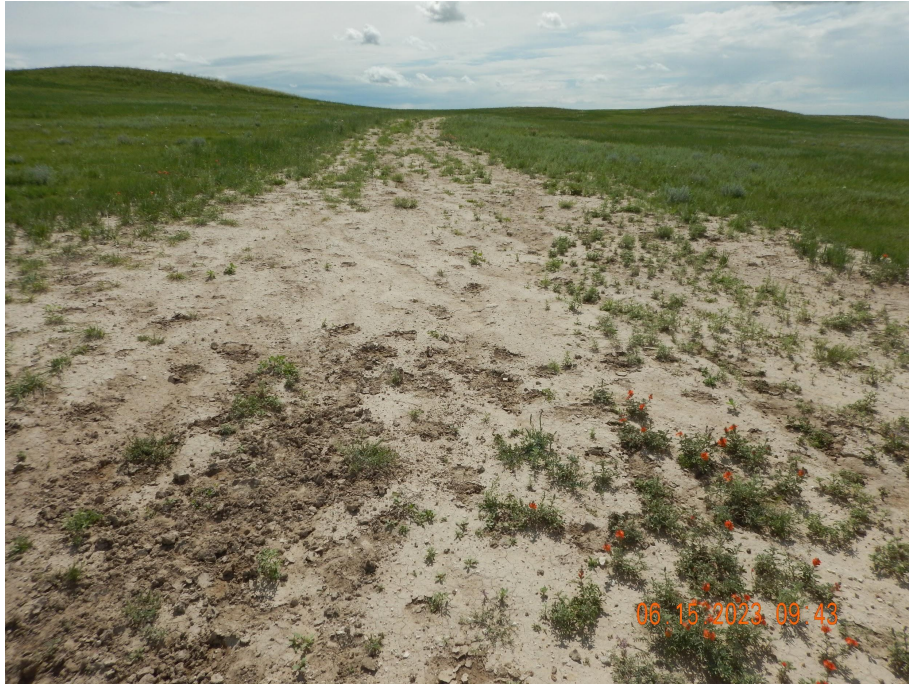
Photo 1. Photo taken from the western access road, facing East. Photo illustrates the access road has partial establishment of desirable vegetation but there is evidence of erosion.

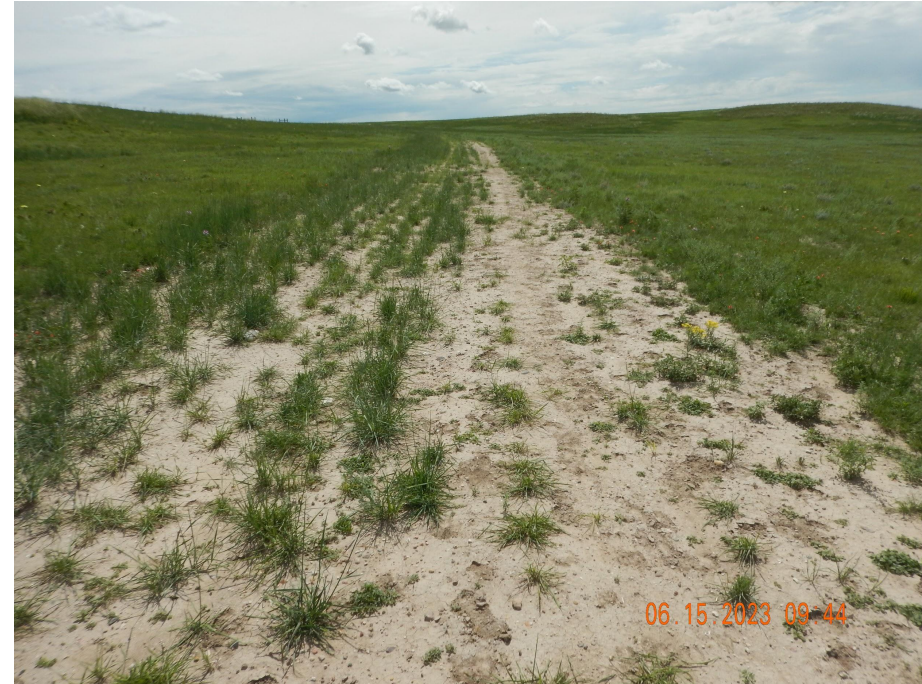
Photo 2. Photo taken from another portion of the access road, facing East. See comments under Photo 1.

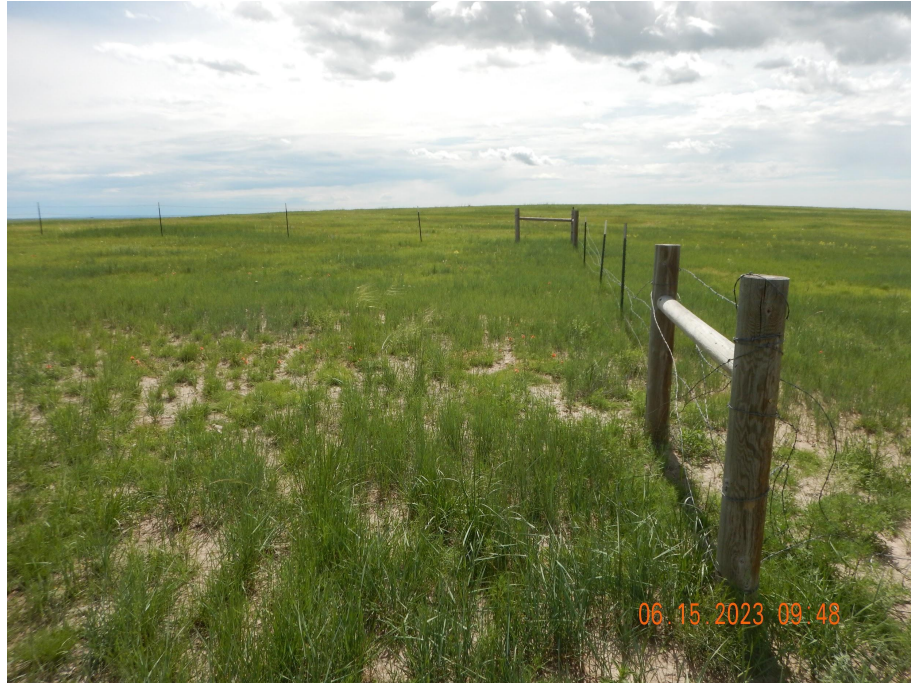
Photo 3. Photo taken from a flowline release related to the well, facing East. Flowline release area meets vegetative standards but the fencing remains.

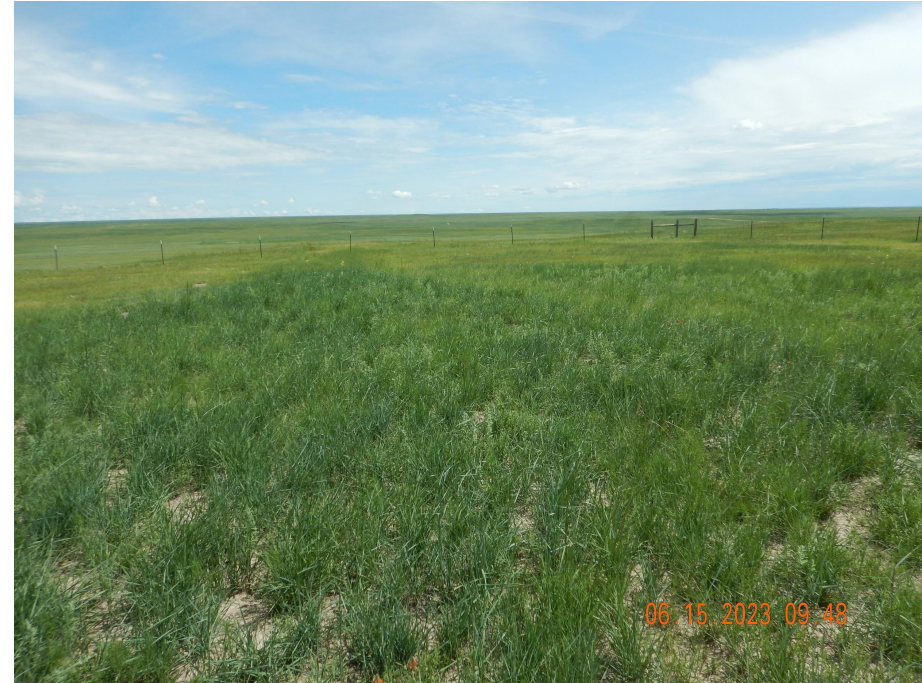
Photo 4. Photo taken from a flowline release related to the well, facing North. See comments under Photo 3.

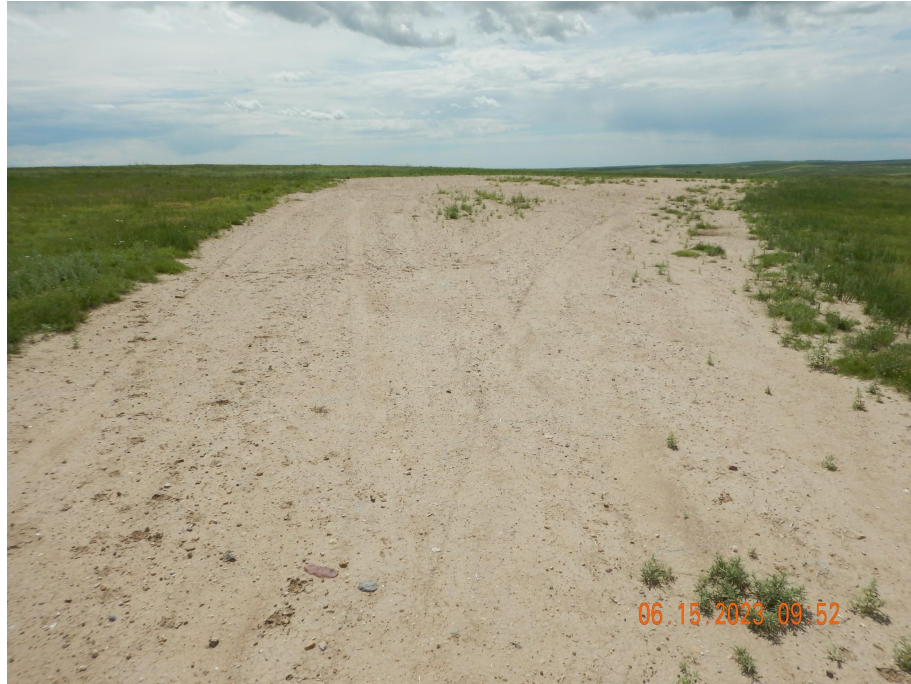
Photo 5. Photo taken from the well location, facing Southeast. Photo illustrates gravel remains throughout the location.

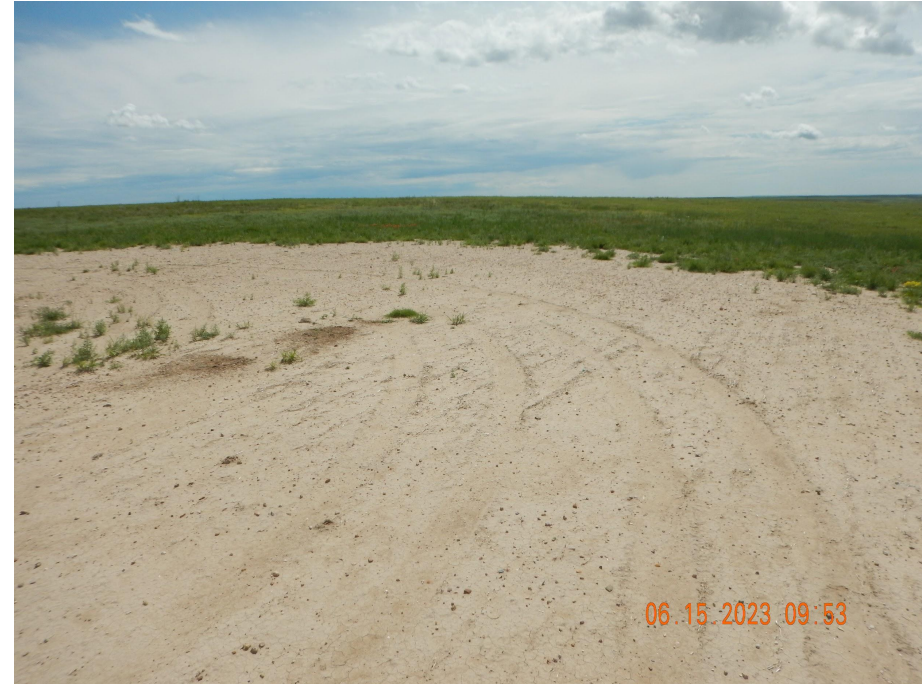
Photo 6. Photo taken from the well location, facing East. See comments under Photo 5.
