Operator: CRESTONE PEAK RESOURCES OPERATING LLC

Location Name: ARISTOCRAT ANGUS 2-4-8

Loc ID: 333183

Inspection: 709400293

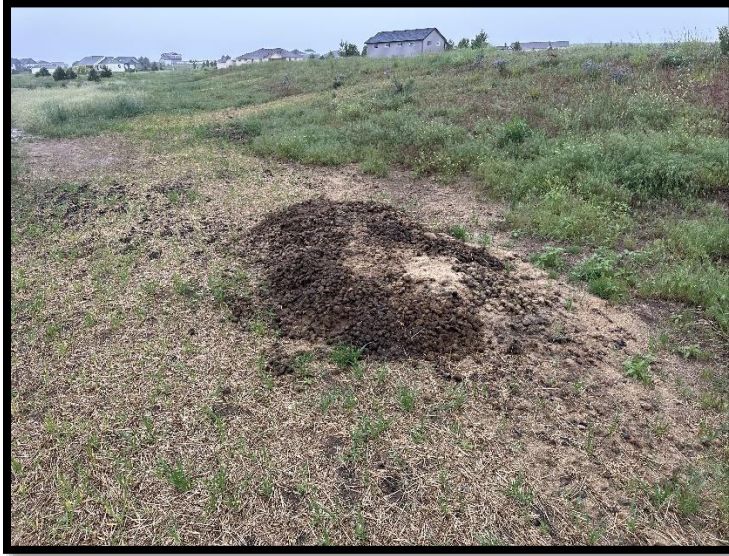
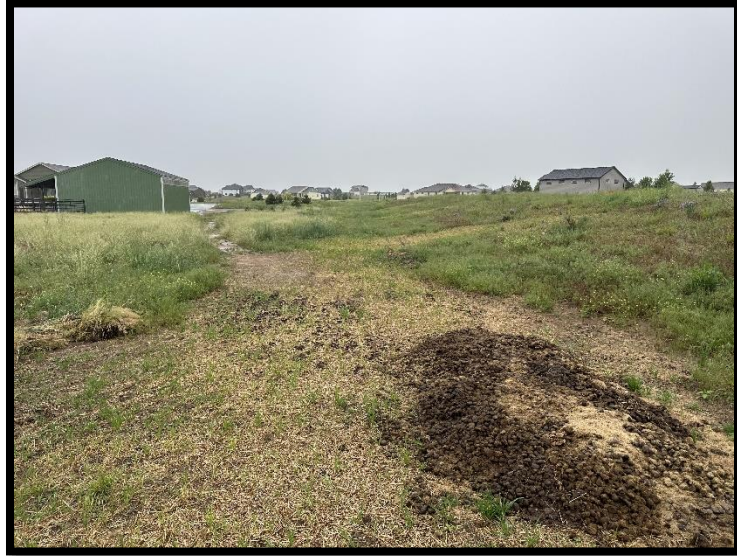
CA: Old concrete on location in reclaimed pipeline right of way. Comply with Rule 606.d.

CA Resolution: Location has been cleaned and cleared of trash and debris (identified concrete) to comply with Rule 606.d. It is important to note that Operator has reported that landowner has been disposing of horse manure on one of the flowline sections.

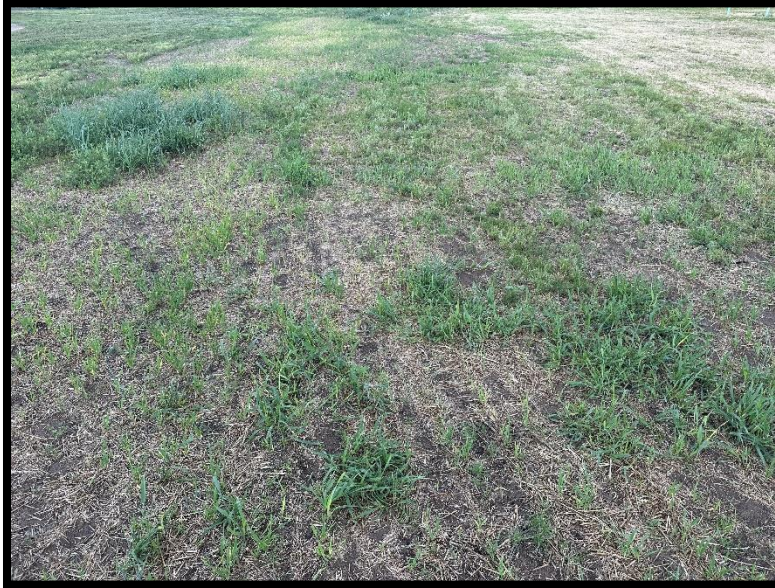
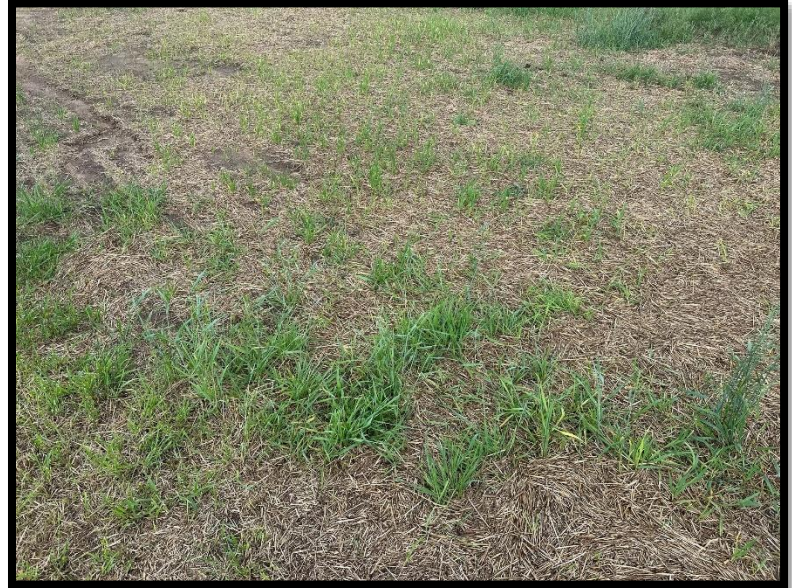
CA: Weeds starting to emerge on pipeline right of way, in disturbed areas. Comply with Rule 606.c.

CA Resolution: Operator has addressed the emerging weeds and will monitor the location to manage weeds appropriately to comply with Rule 606.c.

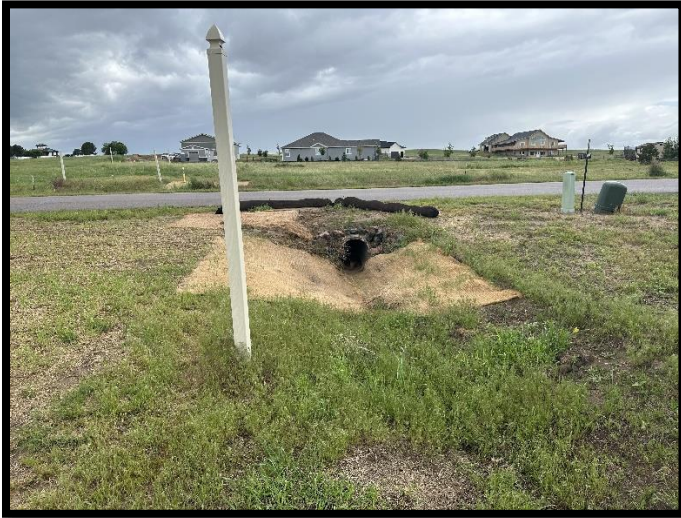
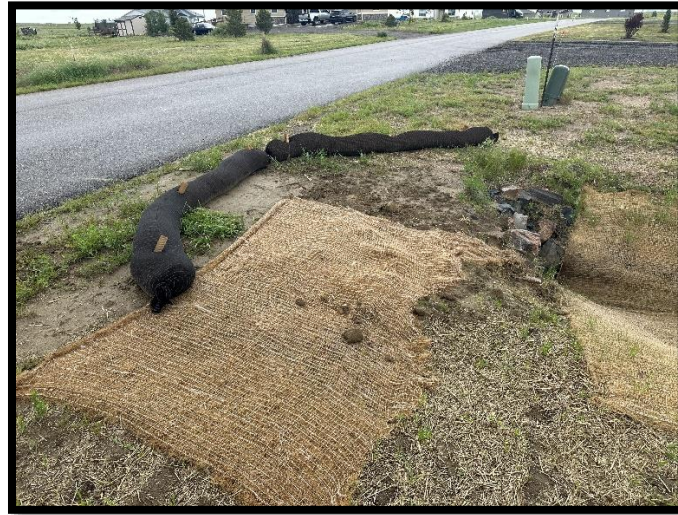
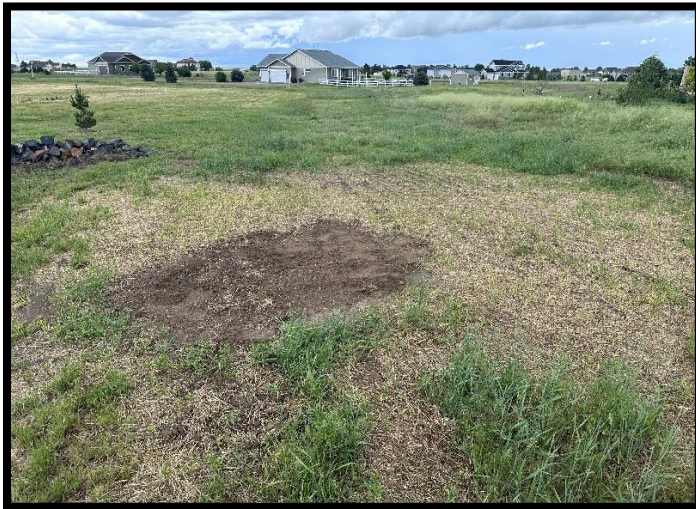
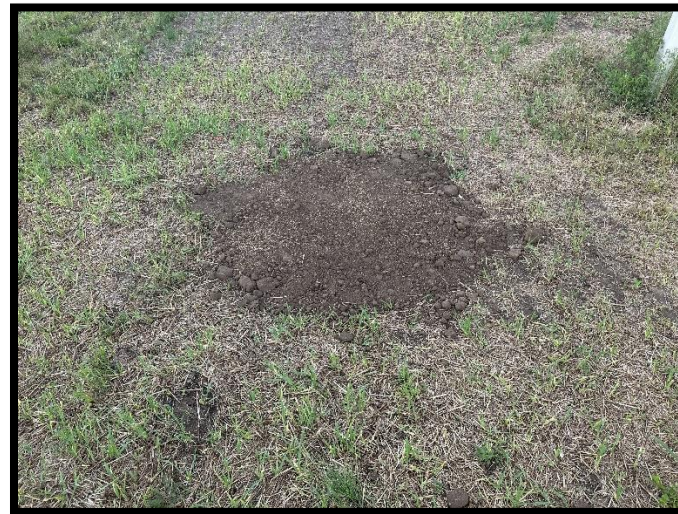
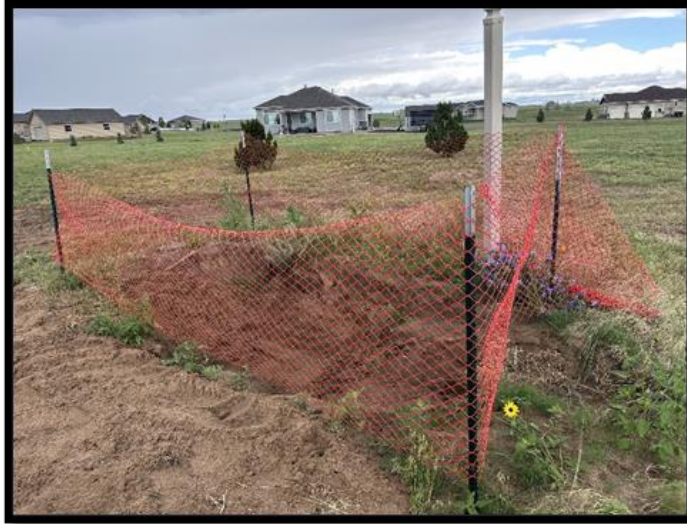
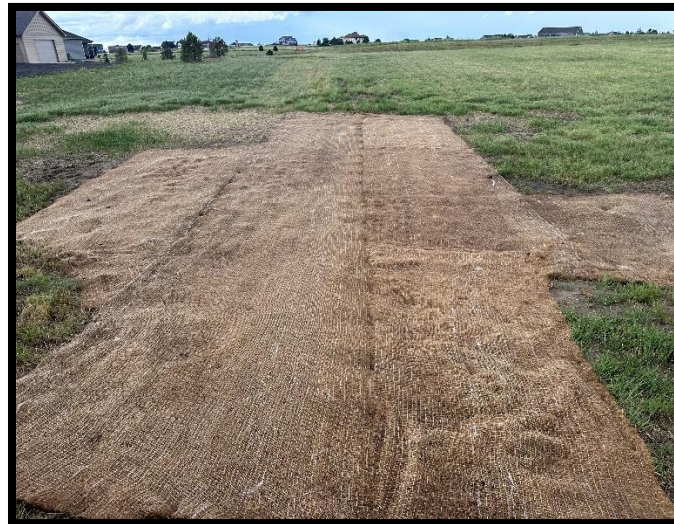
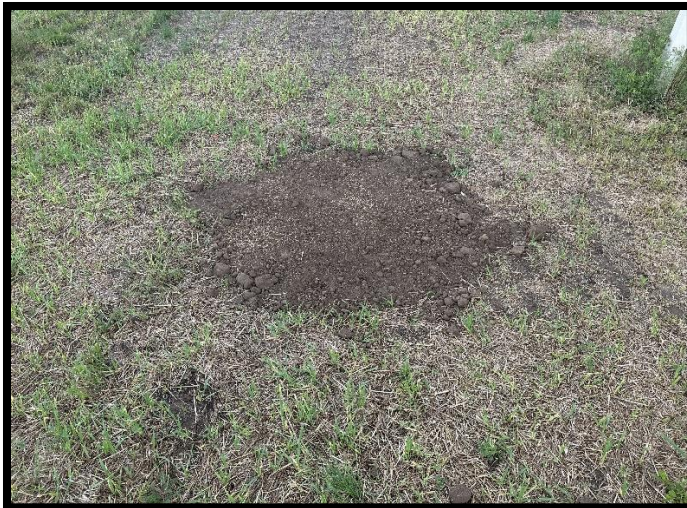
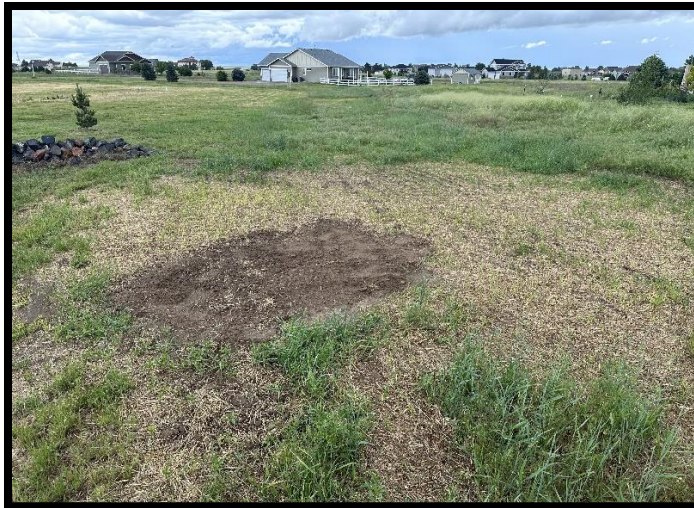
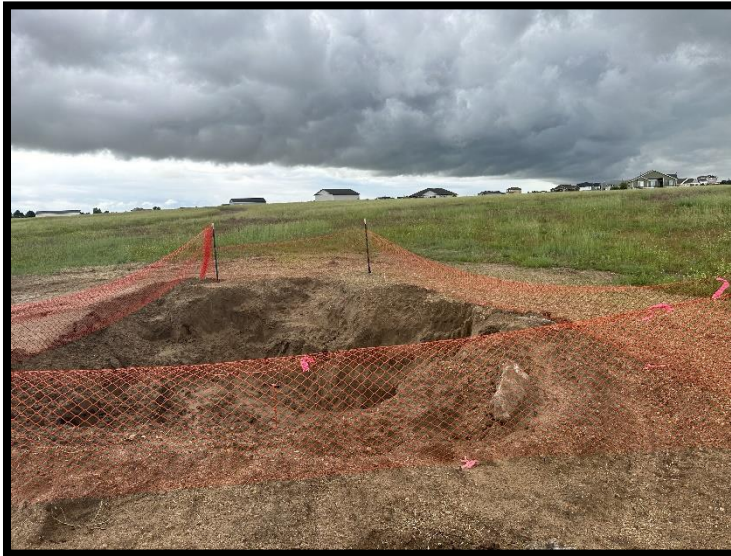
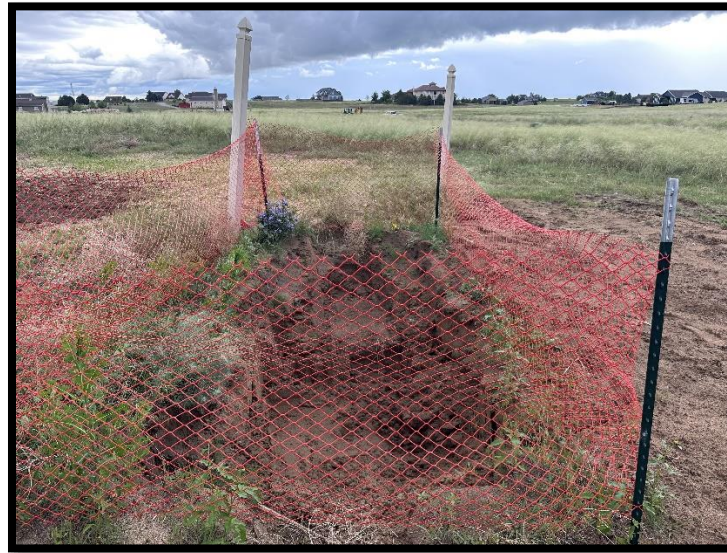
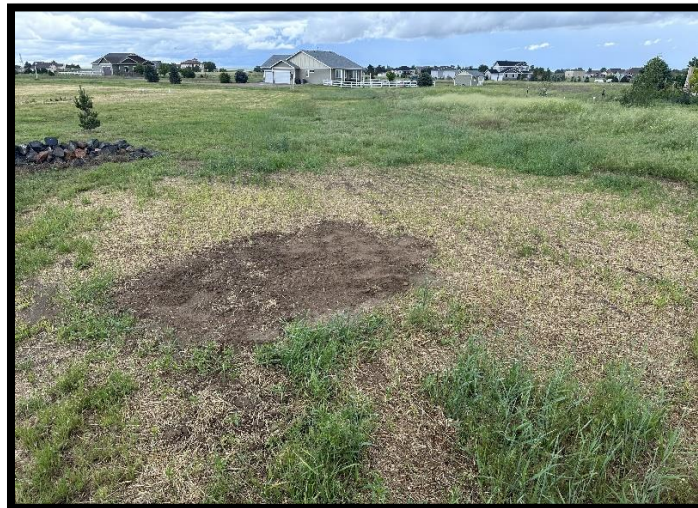
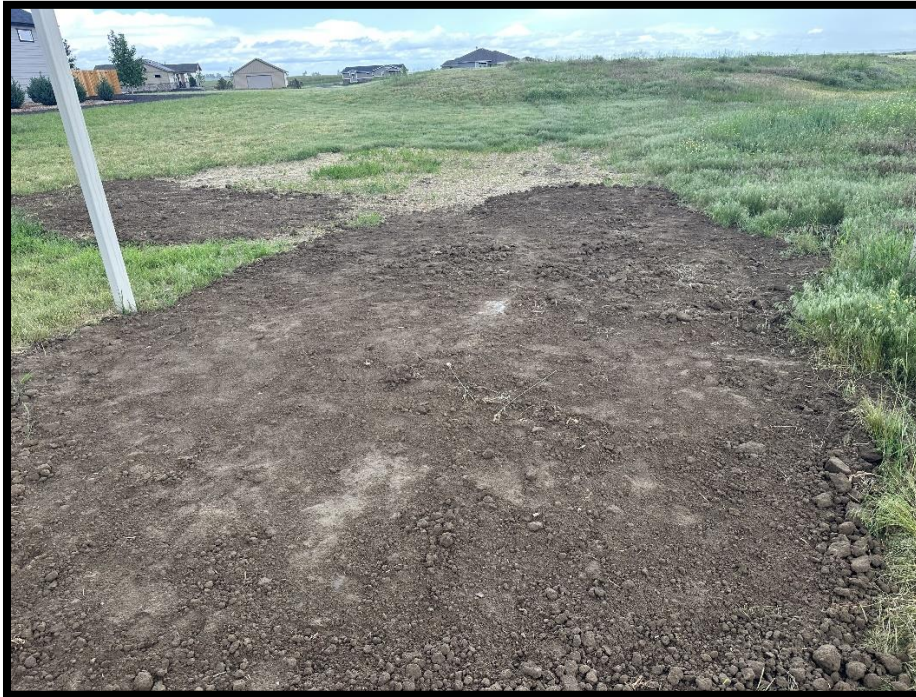
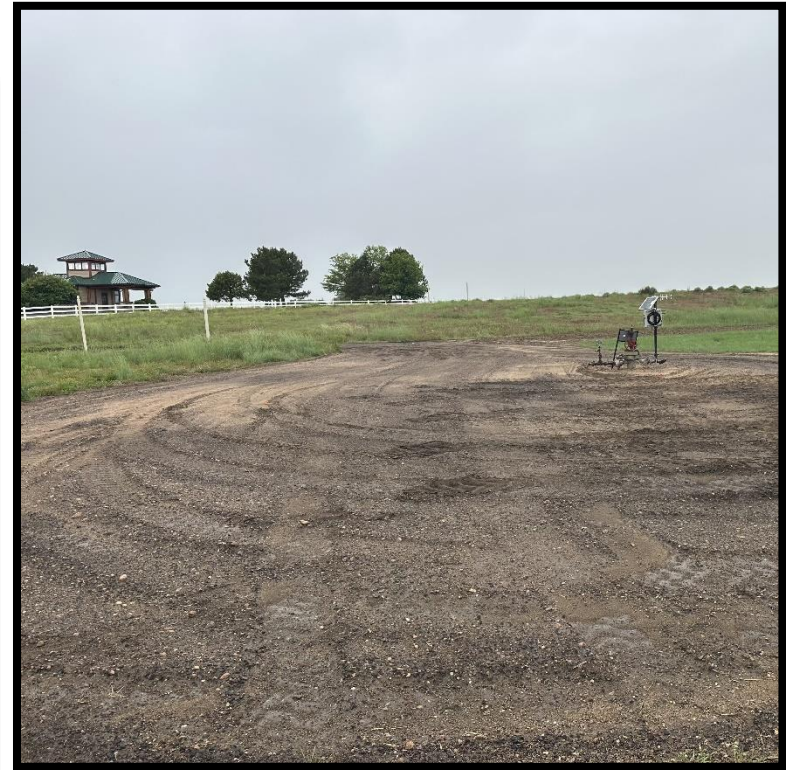
CA: Soil erosion accruing in disturbed areas of pipeline right of way, from removal of flowlines. Recent rains have caused run on into reseeded areas below culvert. Comply with Rule 1002.f.

CA Resolution: Operator has effectively addressed the soil erosion issue by installing appropriate support, stabilizing/protecting vulnerable areas of the location, properly cleaning the area, and reseeded as needed. Location will be managed and maintained to comply with Rule 1002.f.
