Operator: BONANZA CREEK ENERGY OPERATING COMPANY LLC

Location Name: State Antelope 41-3HZ

Loc ID: 422884

Inspection: 696305110

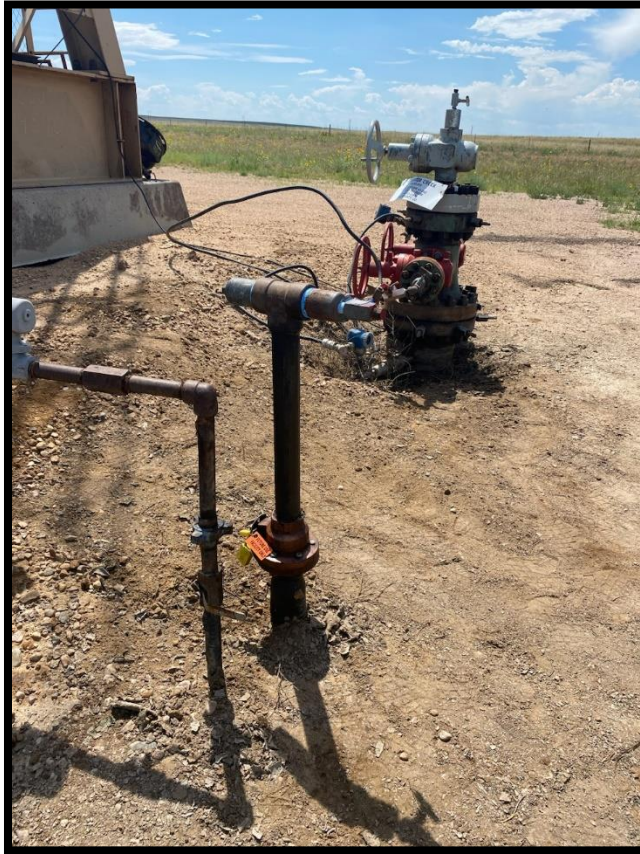
Exhibit A

CA: Stained Soil at Wellhead; see photos. Handle waste in accordance with Rule 906 and conduct maintenance on equipment, cleanup stained material and review self-inspection processes per Rule 1002.f.(2). D.

CA: Unmarked Riser at Wellhead; see photos. Comply with Rule 606.

CA: Unused Master Valves at Wellhead; see photos. Comply with Rule 606.

CA Resolution: Operator has provided photo evidence of the appropriately cleaned location/equipment and noted that they stained soil has been properly disposed of at this time.

CA Resolution: Operator has reported that the flowline has been plugged and marked with a “future use” tag to comply with Rule 606.

CA Resolution: Operator has reported that the unused master valves at the Wellhead have been removed.
