Operator: BONANZA CREEK ENERGY OPERATING COMPANY LLC

Location Name: Antelope P-17 PAD

Loc ID: 428964

Inspection: 696305112

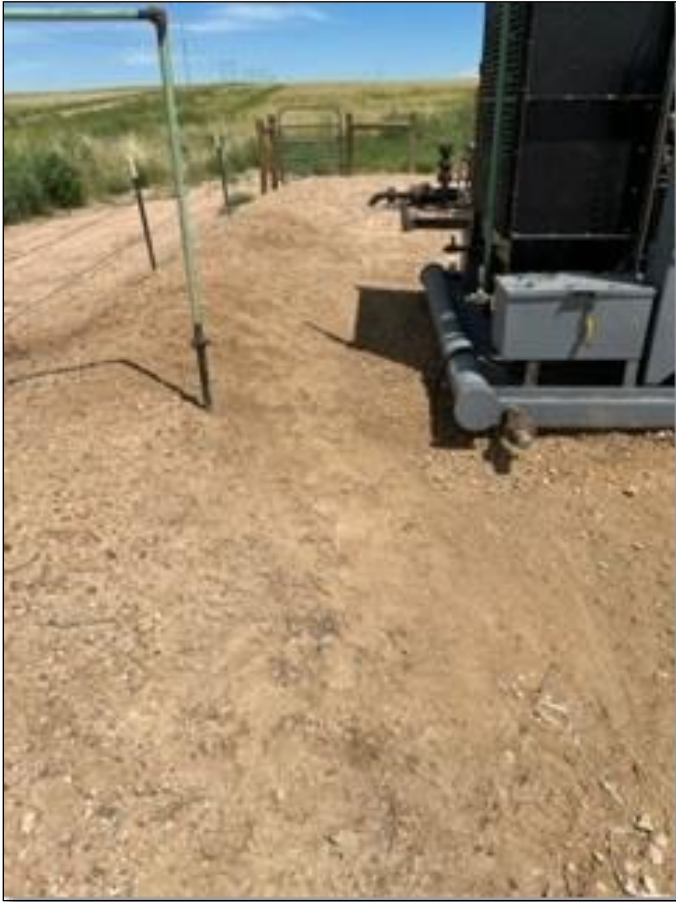
Exhibit A

CA: Stained Soil at Compressor; see photos. Handle waste in accordance with Rule 906 and conduct maintenance on equipment, cleanup stained material and review self inspection processes per Rule 1002.f.(2).D.

CA Resolution: Field has addressed the stained soil identified at the compressor. Waste has been cleaned and disposed of appropriately.
