**Operator: BONANZA CREEK ENERGY OPERATING COMPANY LLC**

**Location Name: Antelope J-20 Pad**

**Loc ID: 430128**

**Inspection: 696305122**

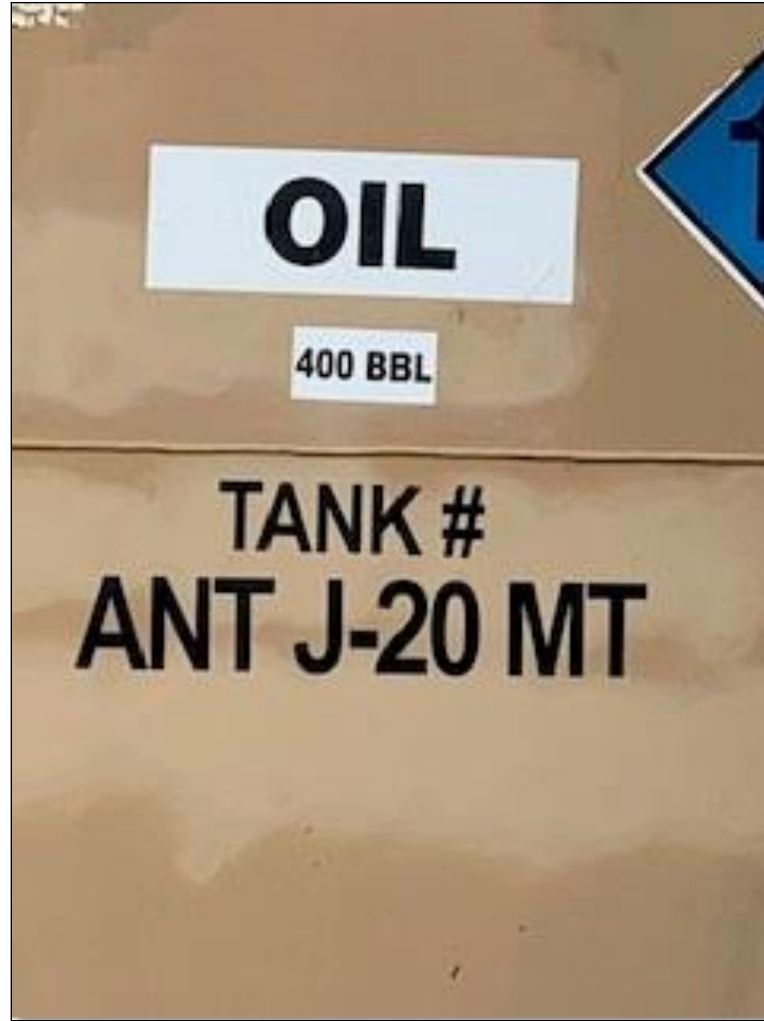
**Exhibit A**

**CA:** Tank missing Capacity Label; see photos. Install sign to comply with Rule 605.h.

**CA Resolution:** Operator has appropriately installed capacity label to comply with Rule 605.h.

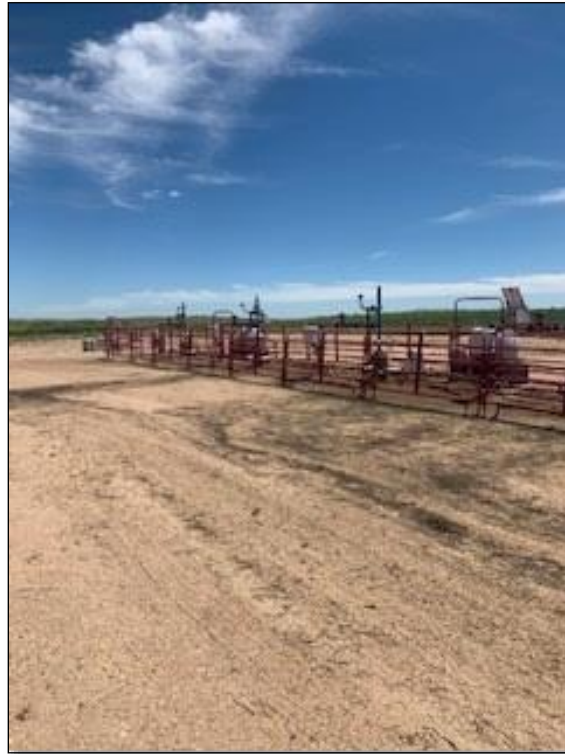
**Exhibit B**

**CA:** Tumbleweed Debris at Wellheads; see photos. Comply with Rule 606.

**CA Resolution:** Operator reports that tumbleweed debris identified at the Wellheads have been properly cleared to comply with Rule 606.
