Operator: CIVITAS NORTH LLC
Location Name: BASHOR-69N60W18SWNW
Loc ID: 323023
Inspection: 696305169

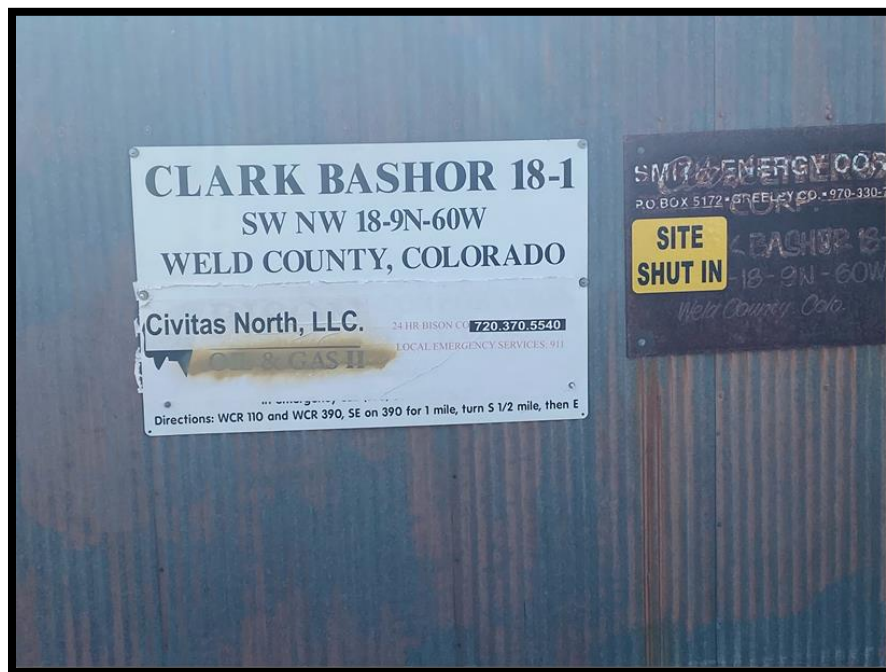
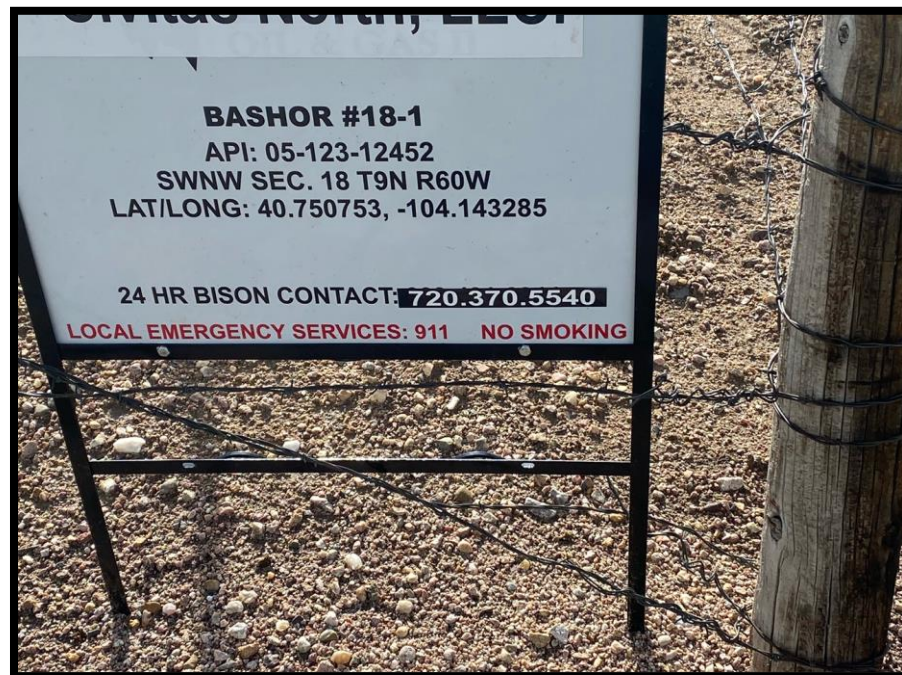
Exhibit A

CA: 24 Hour Emergency Contact Number does not Reflect Current Operator on Wellhead Sign and Tank Battery Sign; see photos. Install sign to comply with Rule 605.e.

CA Resolution: Operator has added 24 Hour Emergency Contact Number to Wellhead Sign and Tank Battery to comply with Rule 605.e.

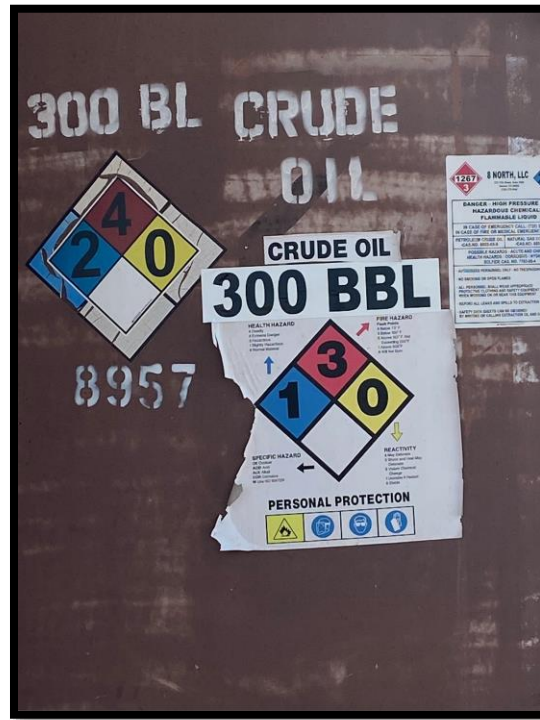
Exhibit C

CA: East Tank - Capacity Label no longer visible; see photos. Install sign to comply with Rule 605.h.

CA Resolution: Operator has installed Capacity Label on the East Tank to comply with Rule 605.h.
