Final Reclamation and Stormwater Inspection

Operator: MOUNTAIN PETROLEUM CORP - 60890

Location ID: 410482

Inspection Photos
Location Name: Fitch 1-9
Location ID: 410482

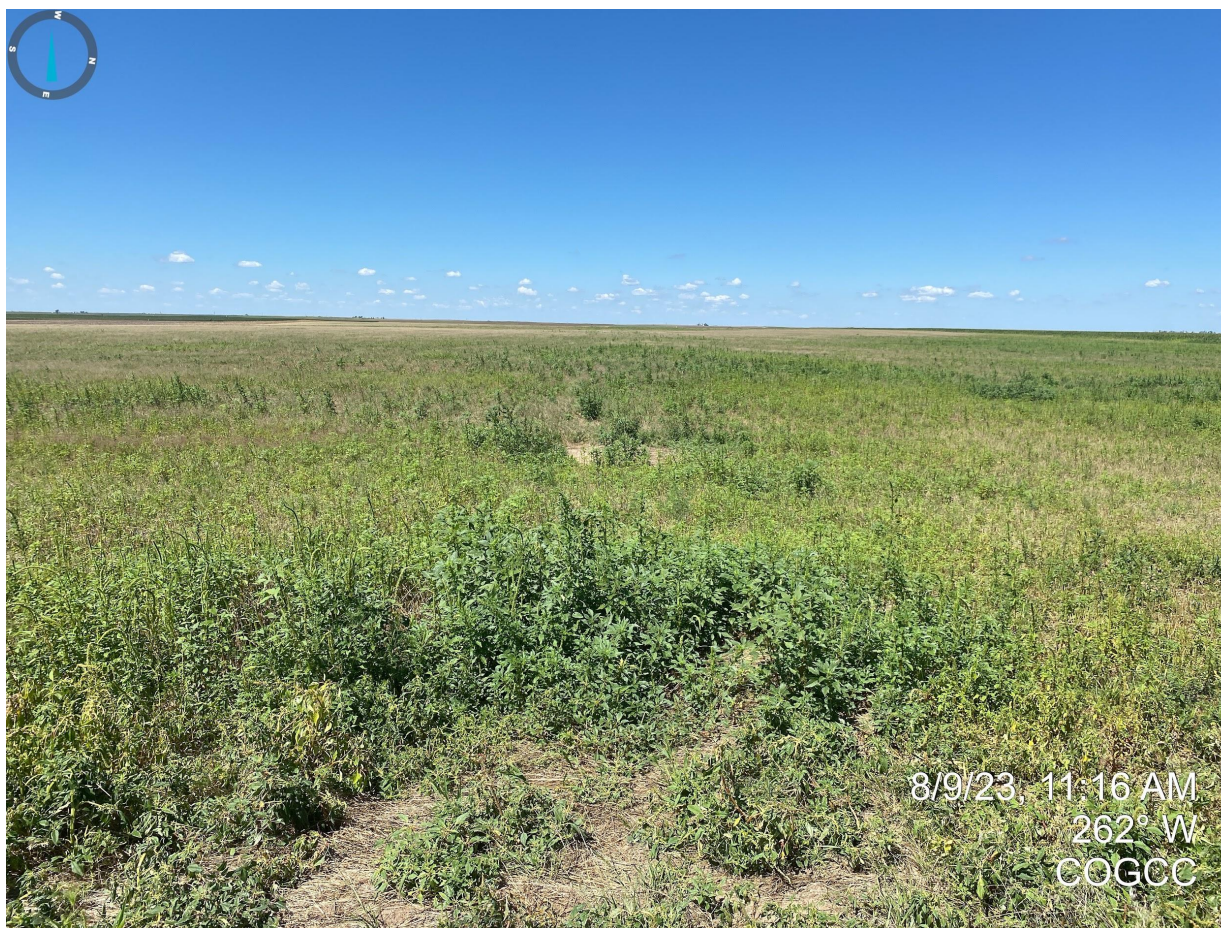
Photo 1. Facing west at the former well location. The reclaimed portion is currently in fallow cropland comprised of wheat stubble and annual weeds. Staff was unable to verify vegetative compliance at the time of this inspection, therefore, it is being left “In Process” until it can be inspected at a future date to verify crop establishment in accordance with Rule 1004 regulations and standards.
