WELL NAME: MAFIA 14-32, API #: 071-06767, INSP. # 695108567

COLORADO
Energy & Carbon Management
Commission
Department of Natural Resources

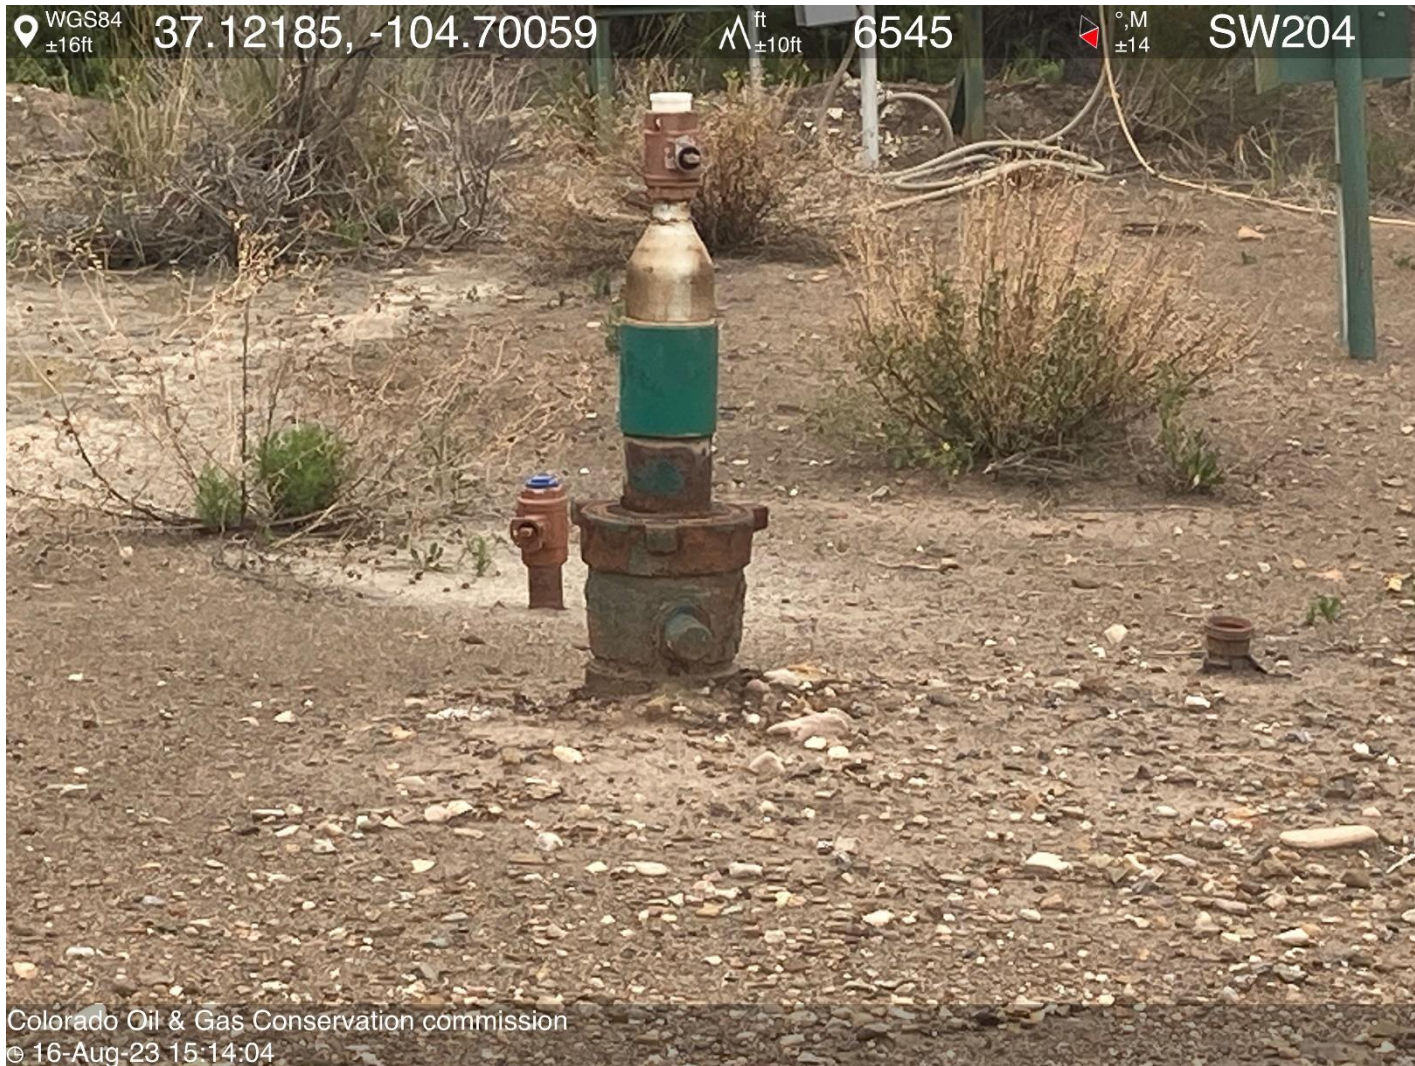
PHOTO 4: UNUSED EQUIPMENT (TWO-2" RISERS NEAR THE WELLHEAD). REMOVE OR MARK UNUSED RISERS PER RULE 606. CA DATE 9-16-2023.

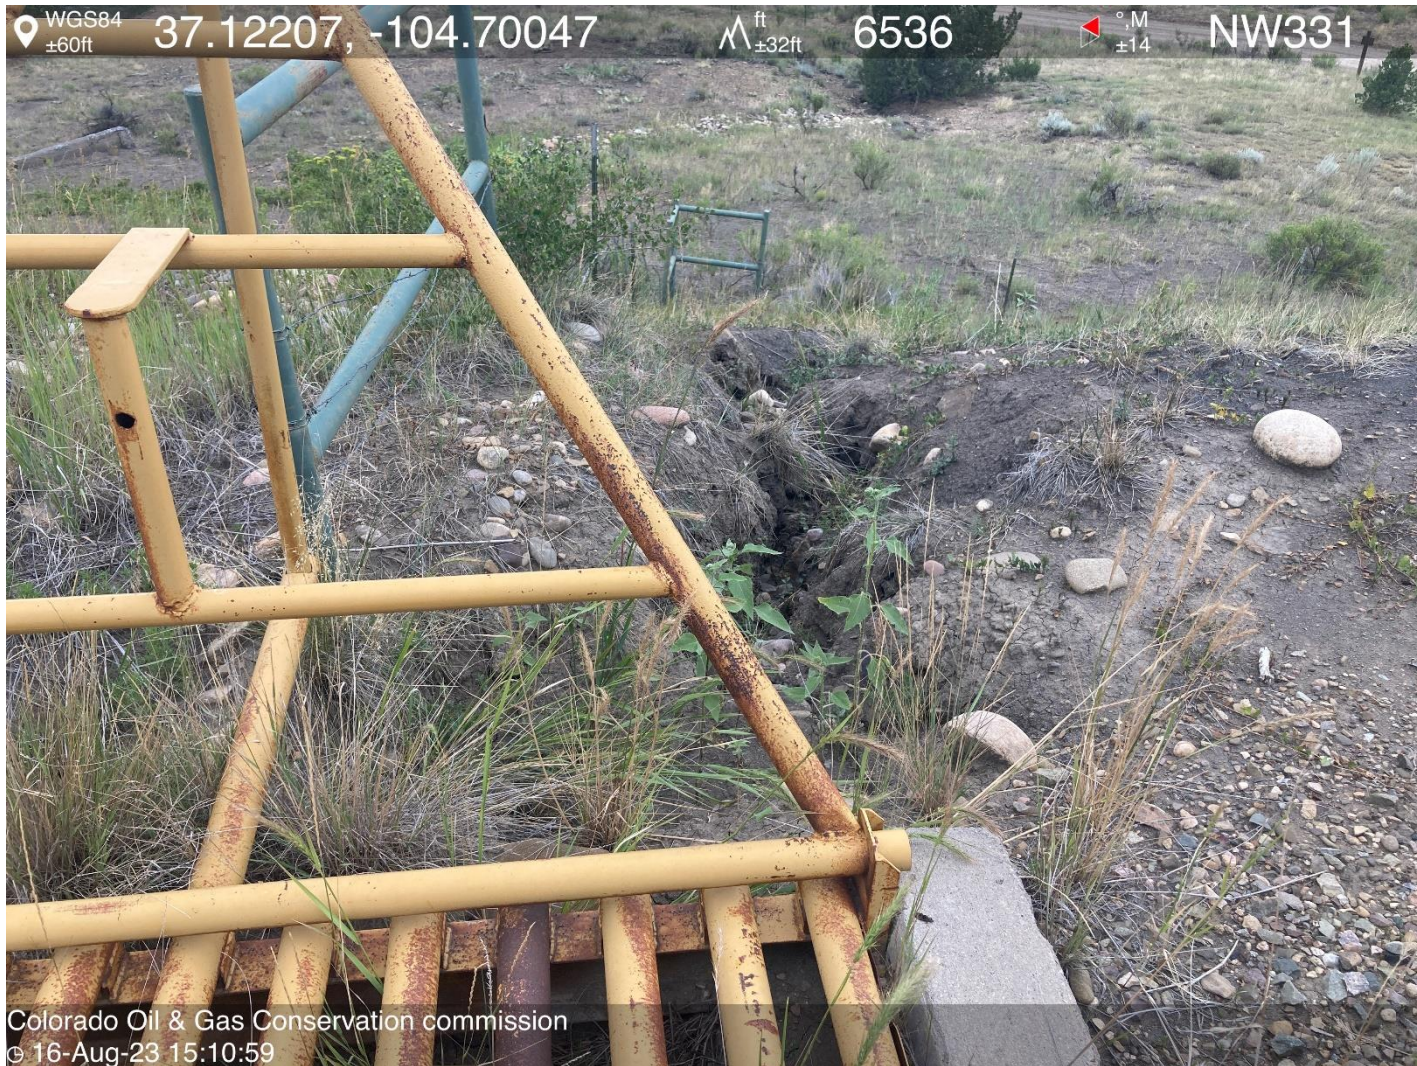
**PHOTO 6: STORM WATER MANAGEMENT IS INADEQUATE ON DOWN SLOPE SIDE OF CATTLE GUARD AT ENTRANCE OF LOCATION.
INSTALL STORM WATER MANAGEMENT BMP'S PER RULE 1002. CA DATE 9-16-2023.**

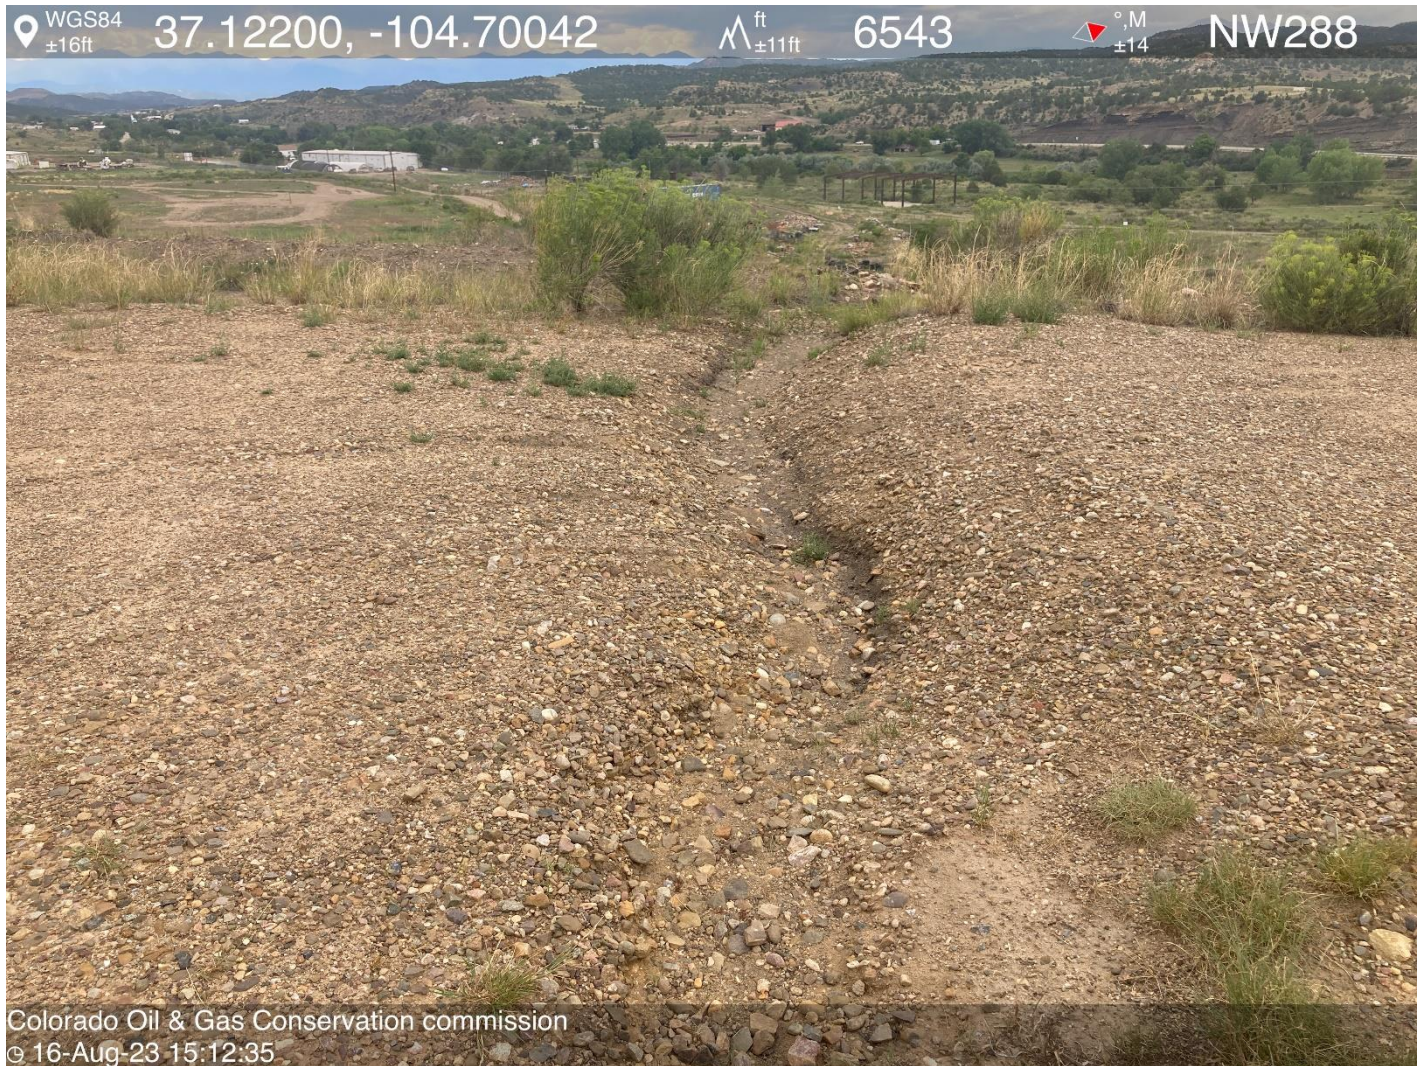
PHOTO 6: STORM WATER MANAGEMENT IS INADEQUATE AT ENTRANCE OF LOCATION, THERE IS A DITCH THAT IS WASHING OUT AND MAKING IT DIFFICULT FOR VEHICLES TO ENTER LOCATION. **INSTALL OR MAINTAIN STORM WATER MANAGEMENT BMP'S PER RULE 1002. CA DATE 9-16-2023.**

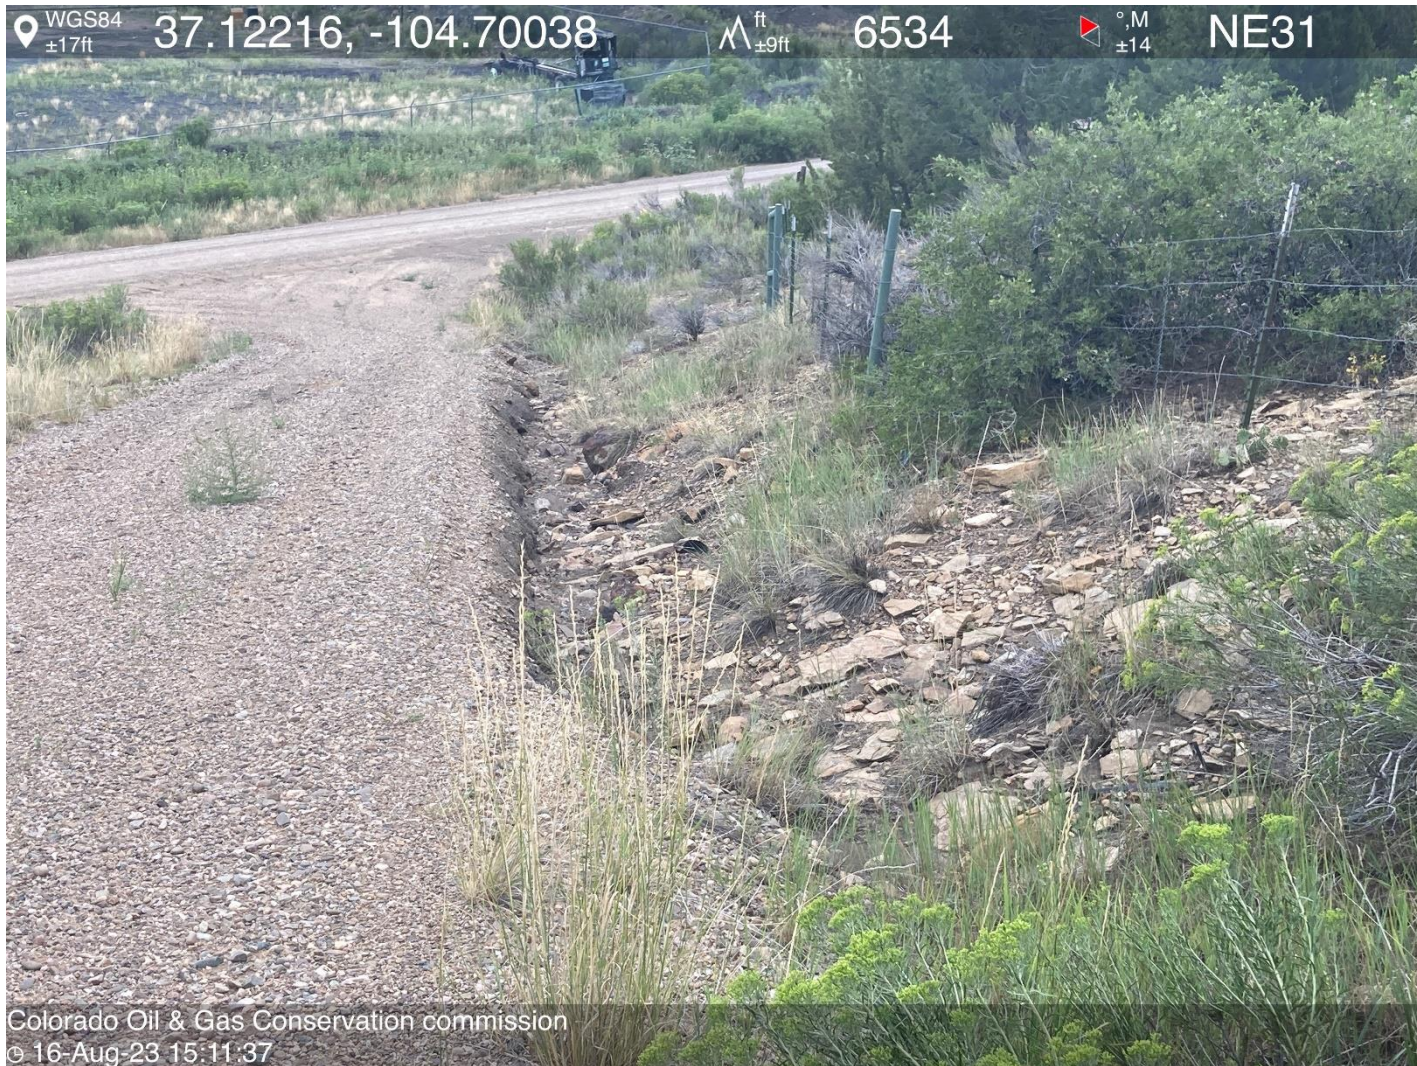
PHOTO 7: STORMWATER HAS ERODED THE DITCH ON EAST SIDE OF ROW. INSTALL OR MAINTAIN STORM WATER MANAGEMENT BMP'S PER RULE 1002. CA DATE 9-16-2023.
