Subject: Third Party Flowline Abandonment-in-place Verification Letter

Oster 43-28
(Location ID: 332725)
40.281382, -104.66104
NESE 28 4N65W
Weld County, Colorado

Oster 43-28
(Location ID: 332725)
"Flowline Abandon-in-Place
Map"

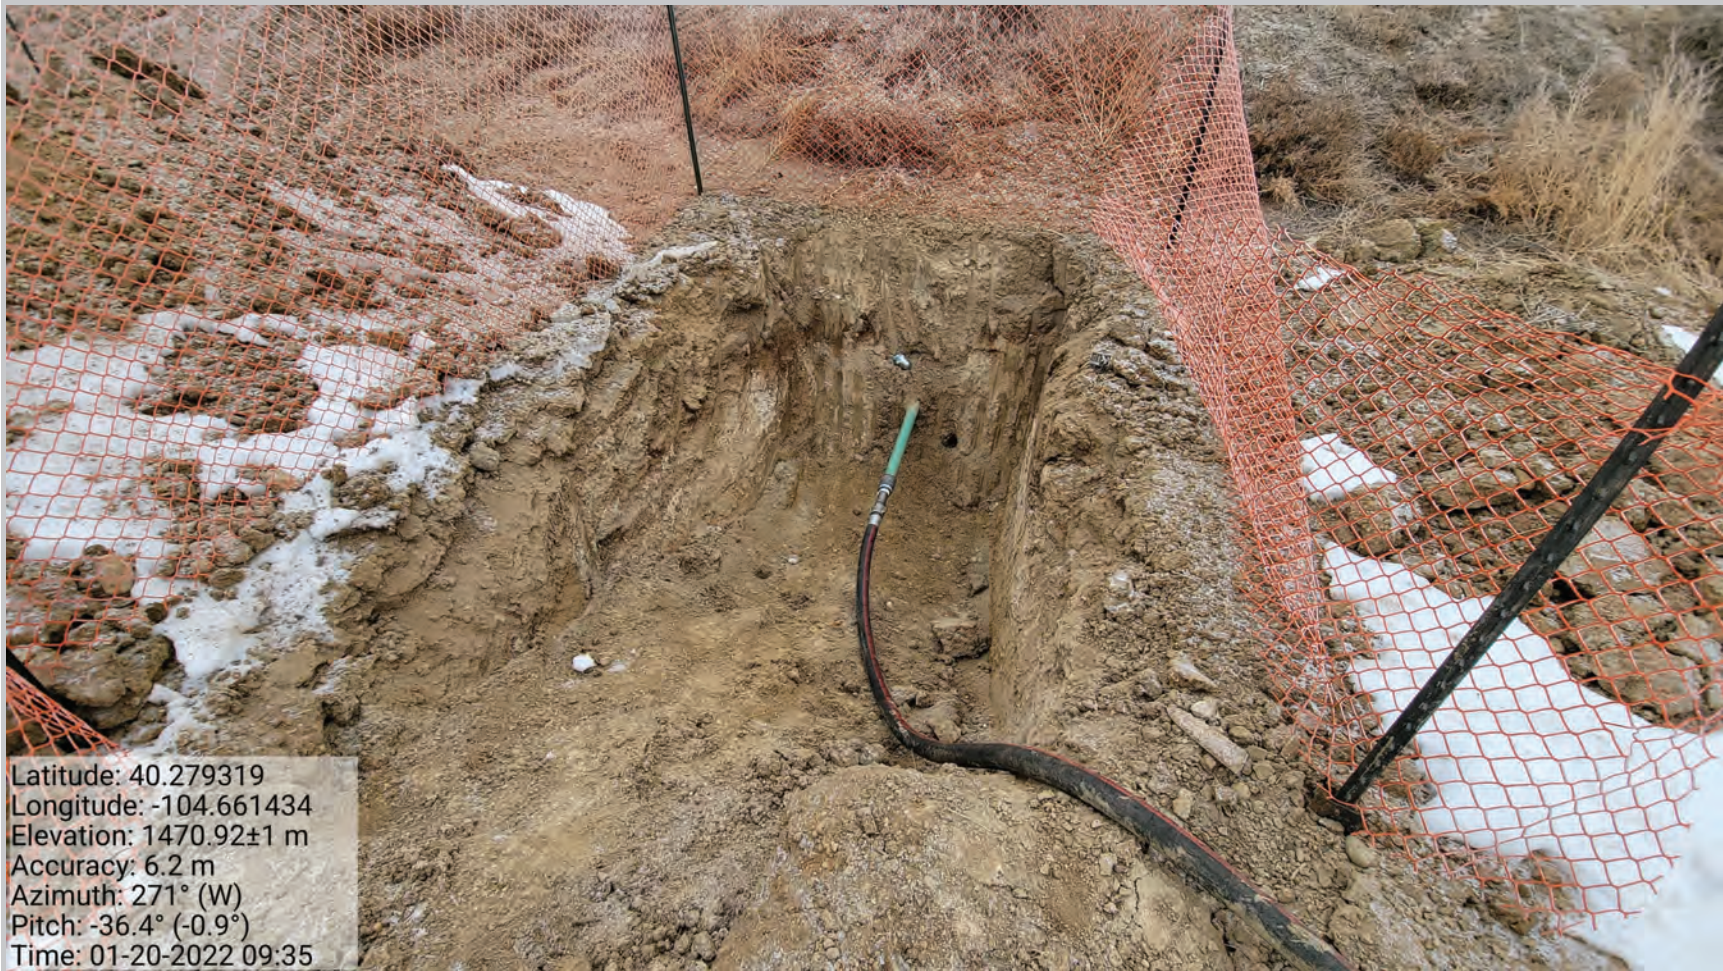
Hydro-vacuum truck for flushing flowline at End A

On January 20, 2022, an Apex Field Geologist was dispatched to the Oster 43-28 location to observe the depletion of the flowline to atmospheric pressure (Rule 1105.e.2), evacuation of any remaining hydrocarbons or produced water from the flowline (Rule 1105.e.1) and flushing with freshwater of approximately 950 feet of 2.5-inch flowline. Each riser end of the flowline was uncapped and the flowline allowed to deplete to atmospheric pressure. The pipe was then made safe and inert by flushing 32 barrels of fresh water through the full length of flowline until clear water was observed at the receiving end, evacuating any remaining hydrocarbons or produced water from the flowline.

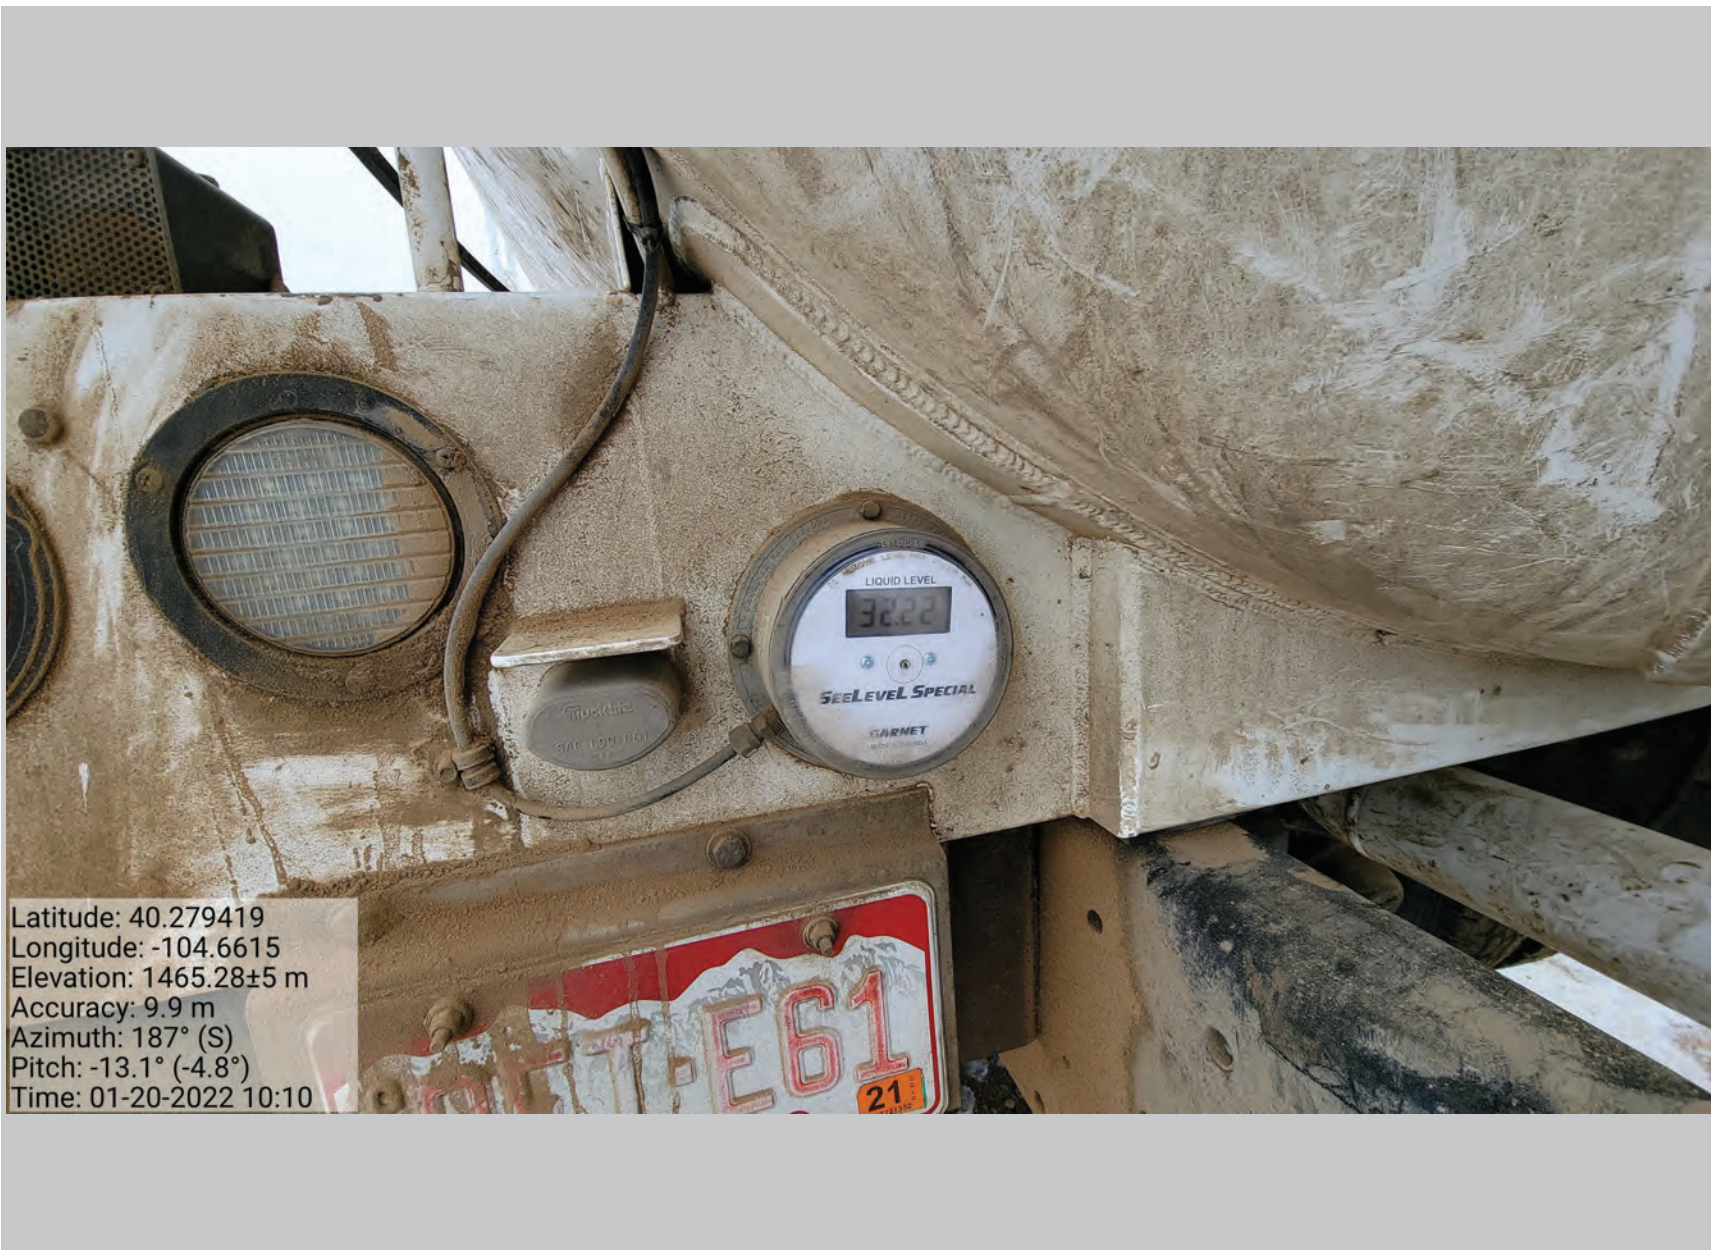
Latitude: 40.279319
Longitude: -104.661434
Elevation: 1470.92±1 m
Accuracy: 6.2 m
Azimuth: 271° (W)
Pitch: -36.4° (-0.9°)
Time: 01-20-2022 09:35

Hydro-vacuum hose connected to End A of flowline.

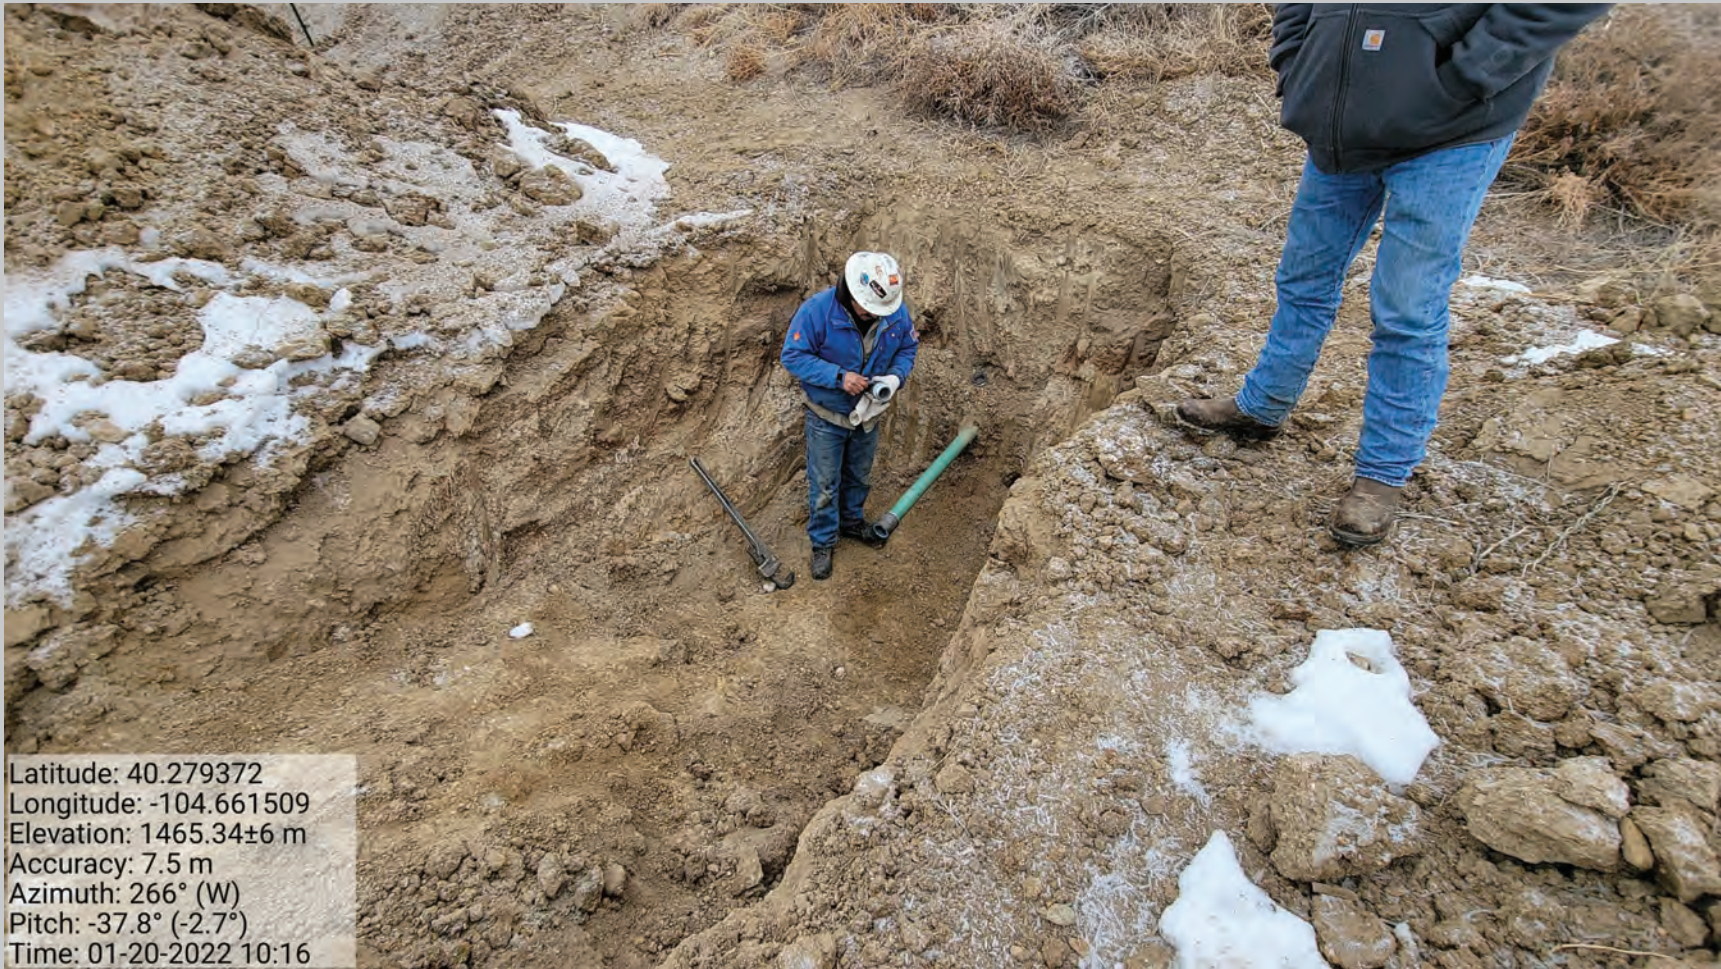
Hydro-vacuum truck gauge at End B, displaying number of barrels flushed through flowline.

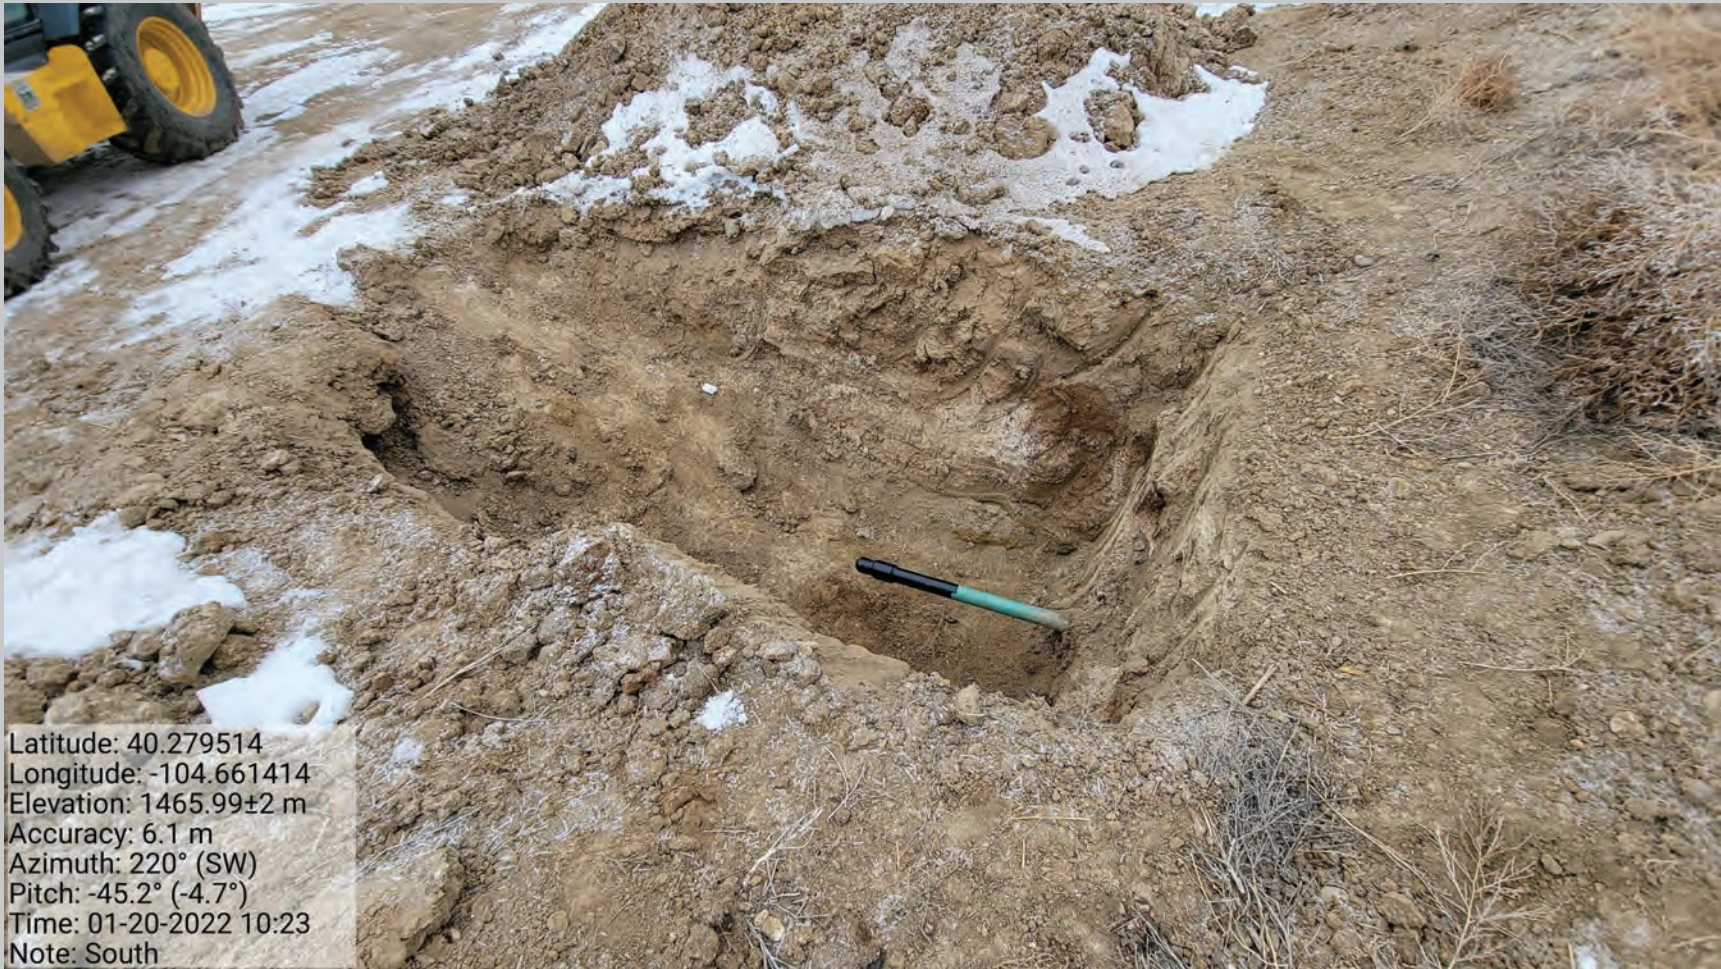
End B of flowline, cut and threaded.

Following flushing activities, Apex observed the flowline being cut (Rule 1105.e.3) and sealed (Rule 1105.e.4) at both ends of abandonment, ends A and B. The flowline was cut at the utility depth, approximately 3-feet at both End A and End B. Both ends of the off-location portion of flowline then had threads cut into the outside surface, and a threaded cap was installed and sealed with black tape.

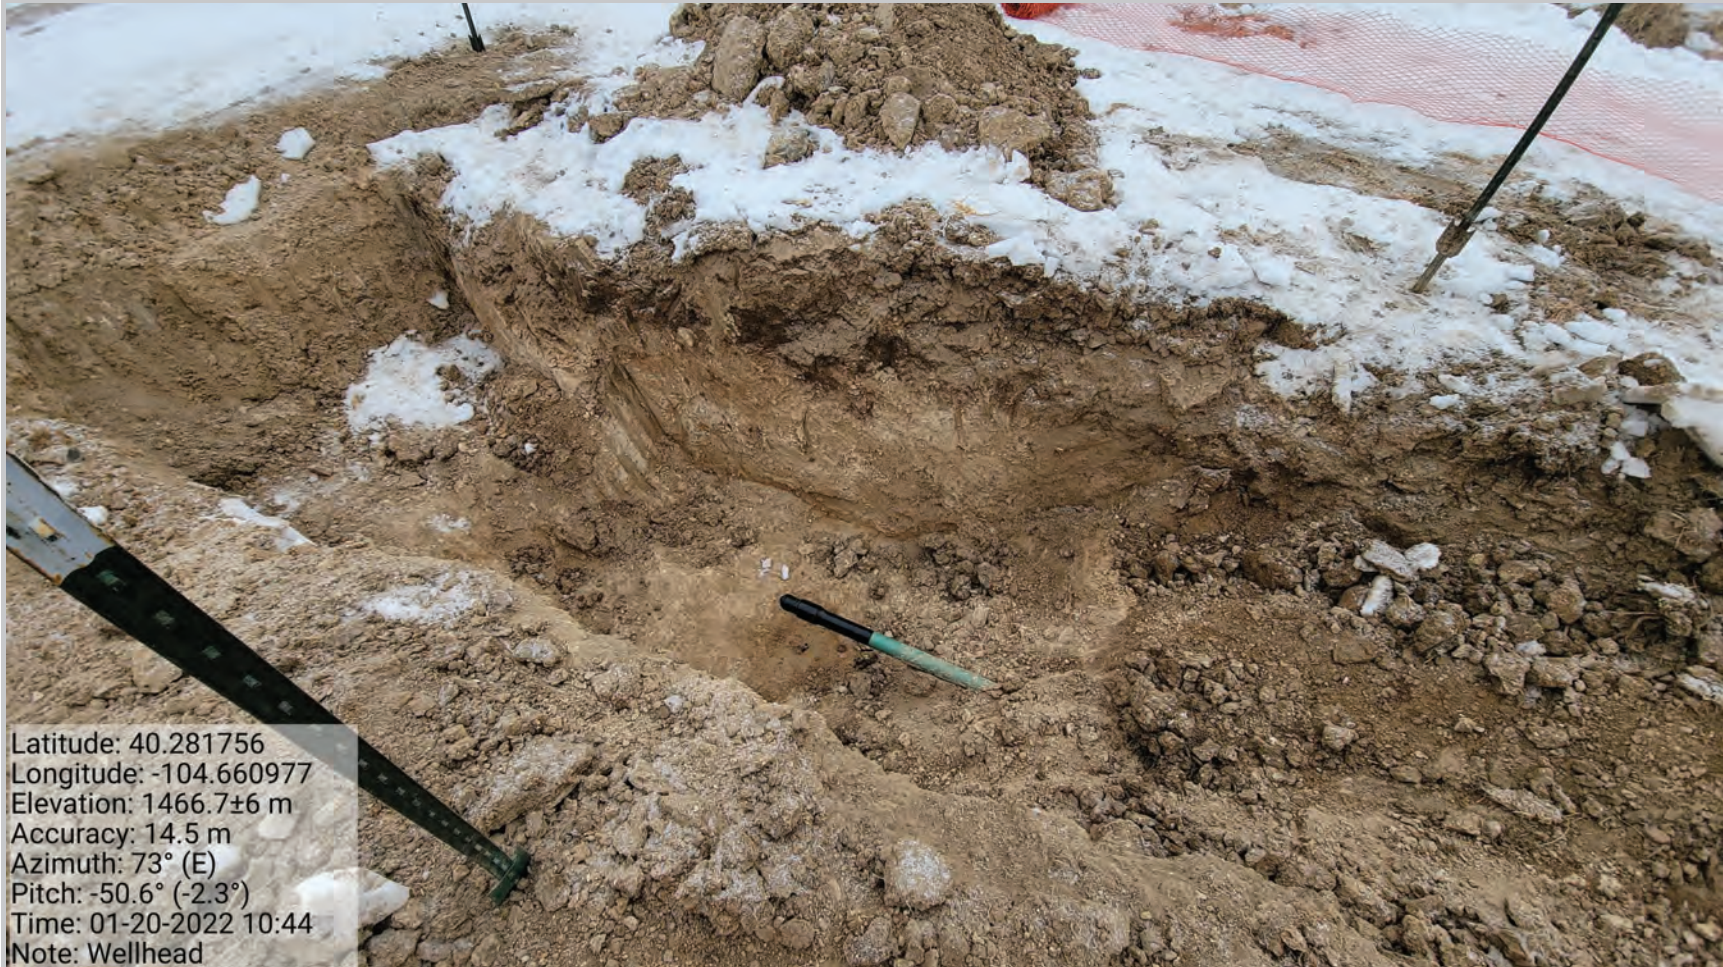
Latitude: 40.279514
Longitude: -104.661414
Elevation: 1465.99±2 m
Accuracy: 6.1 m
Azimuth: 220° (SW)
Pitch: -45.2° (-4.7°)
Time: 01-20-2022 10:23
Note: South

Cut, threaded, capped, and taped End B.
