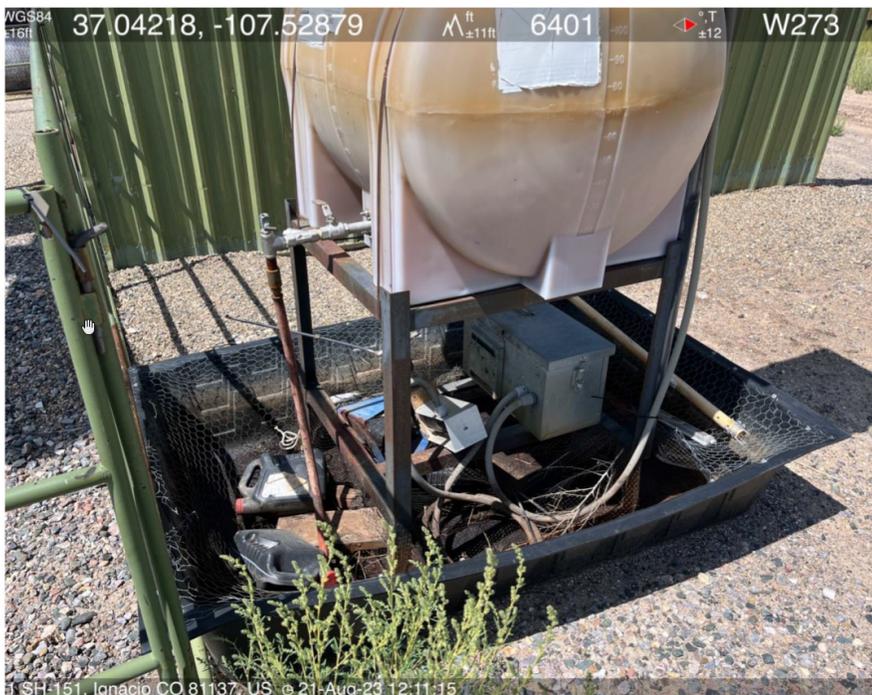
Comment: Empty containers and miscellaneous parts within methanol tank containment. See Photo #2.

Photo from INC showing empty containers within containment.

Corrective actions taken—Removed empty container and other trash from within the containment.

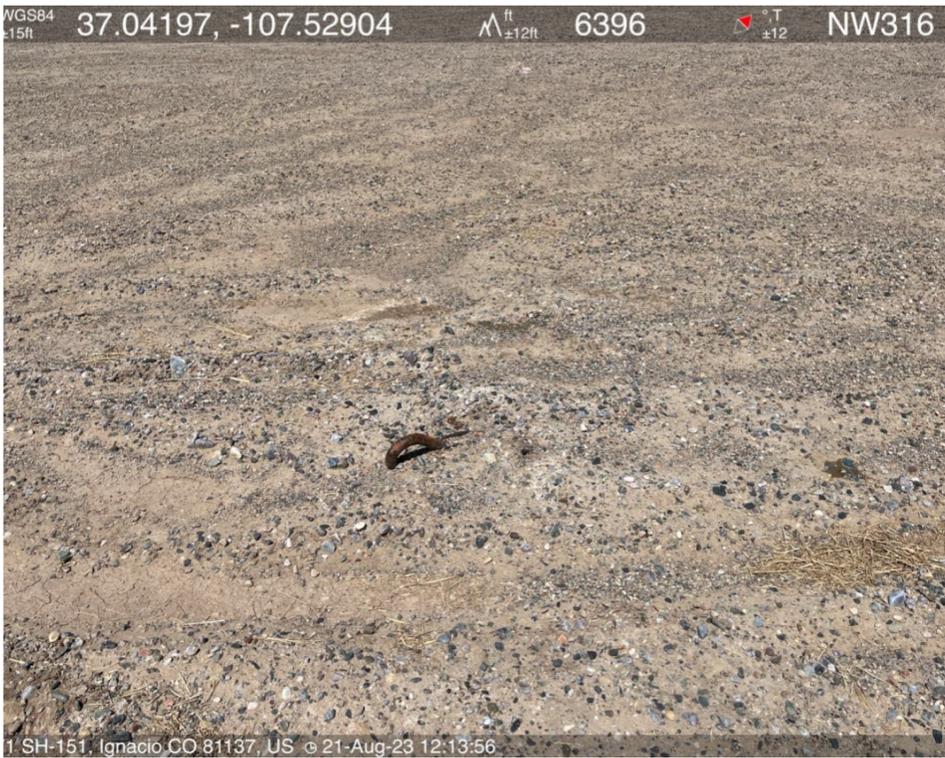
Comment: 2 unmarked guy anchors. See Photo #3.

Picture from INC showing unmarked guy line anchor.

Corrective Action: Install proper guy line markers per Rule 1003.a or remove if non-serviceable or not needed for ongoing operations. Date: 09/04/2023

Corrective action taken—Installed new guy line anchor marker.

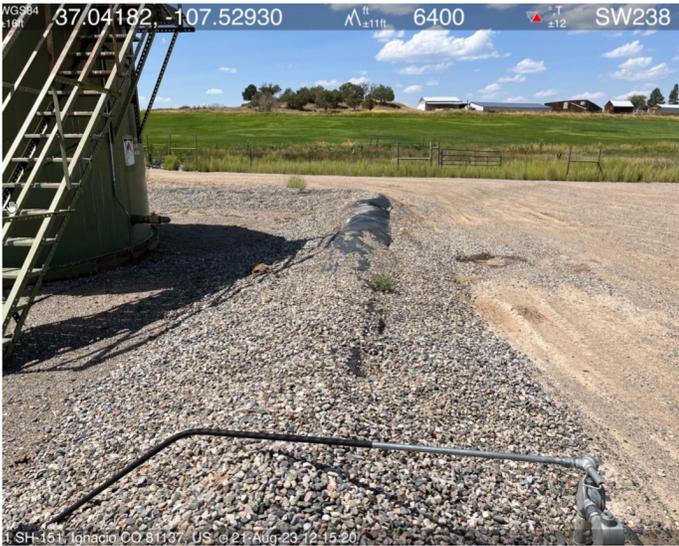
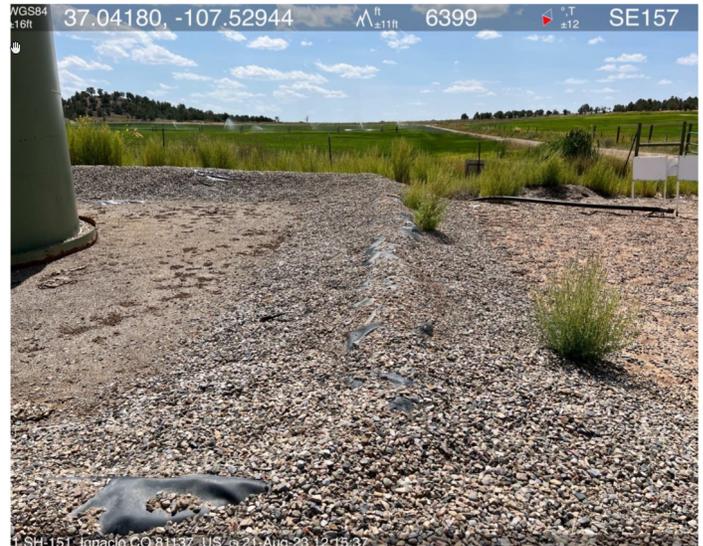
Comment: Berm walls constructed of plastic liner, chicken wire, and washed gravel. Berm walls in need of repair. See Photos #4 & #5.

Pictures from INC of the berm walls in need of repair.

Corrective Action: Repair or install berms or other secondary containment devices per Rule 912.d.(1). Date: 09/10/2023

Corrective action taken—Rebuilt/Repaired the berm wall.
