HILL RANCH-635S67W9NWSW – OGRIS OPERATING
COGCC OPERATOR NUMBER 10758 - DATE: SEPTEMBER 11, 2023
CORRECTIVE ACTIONS COMPLETED REGARDING COGCC FIR DOCUMENT #690203935 & #713600181

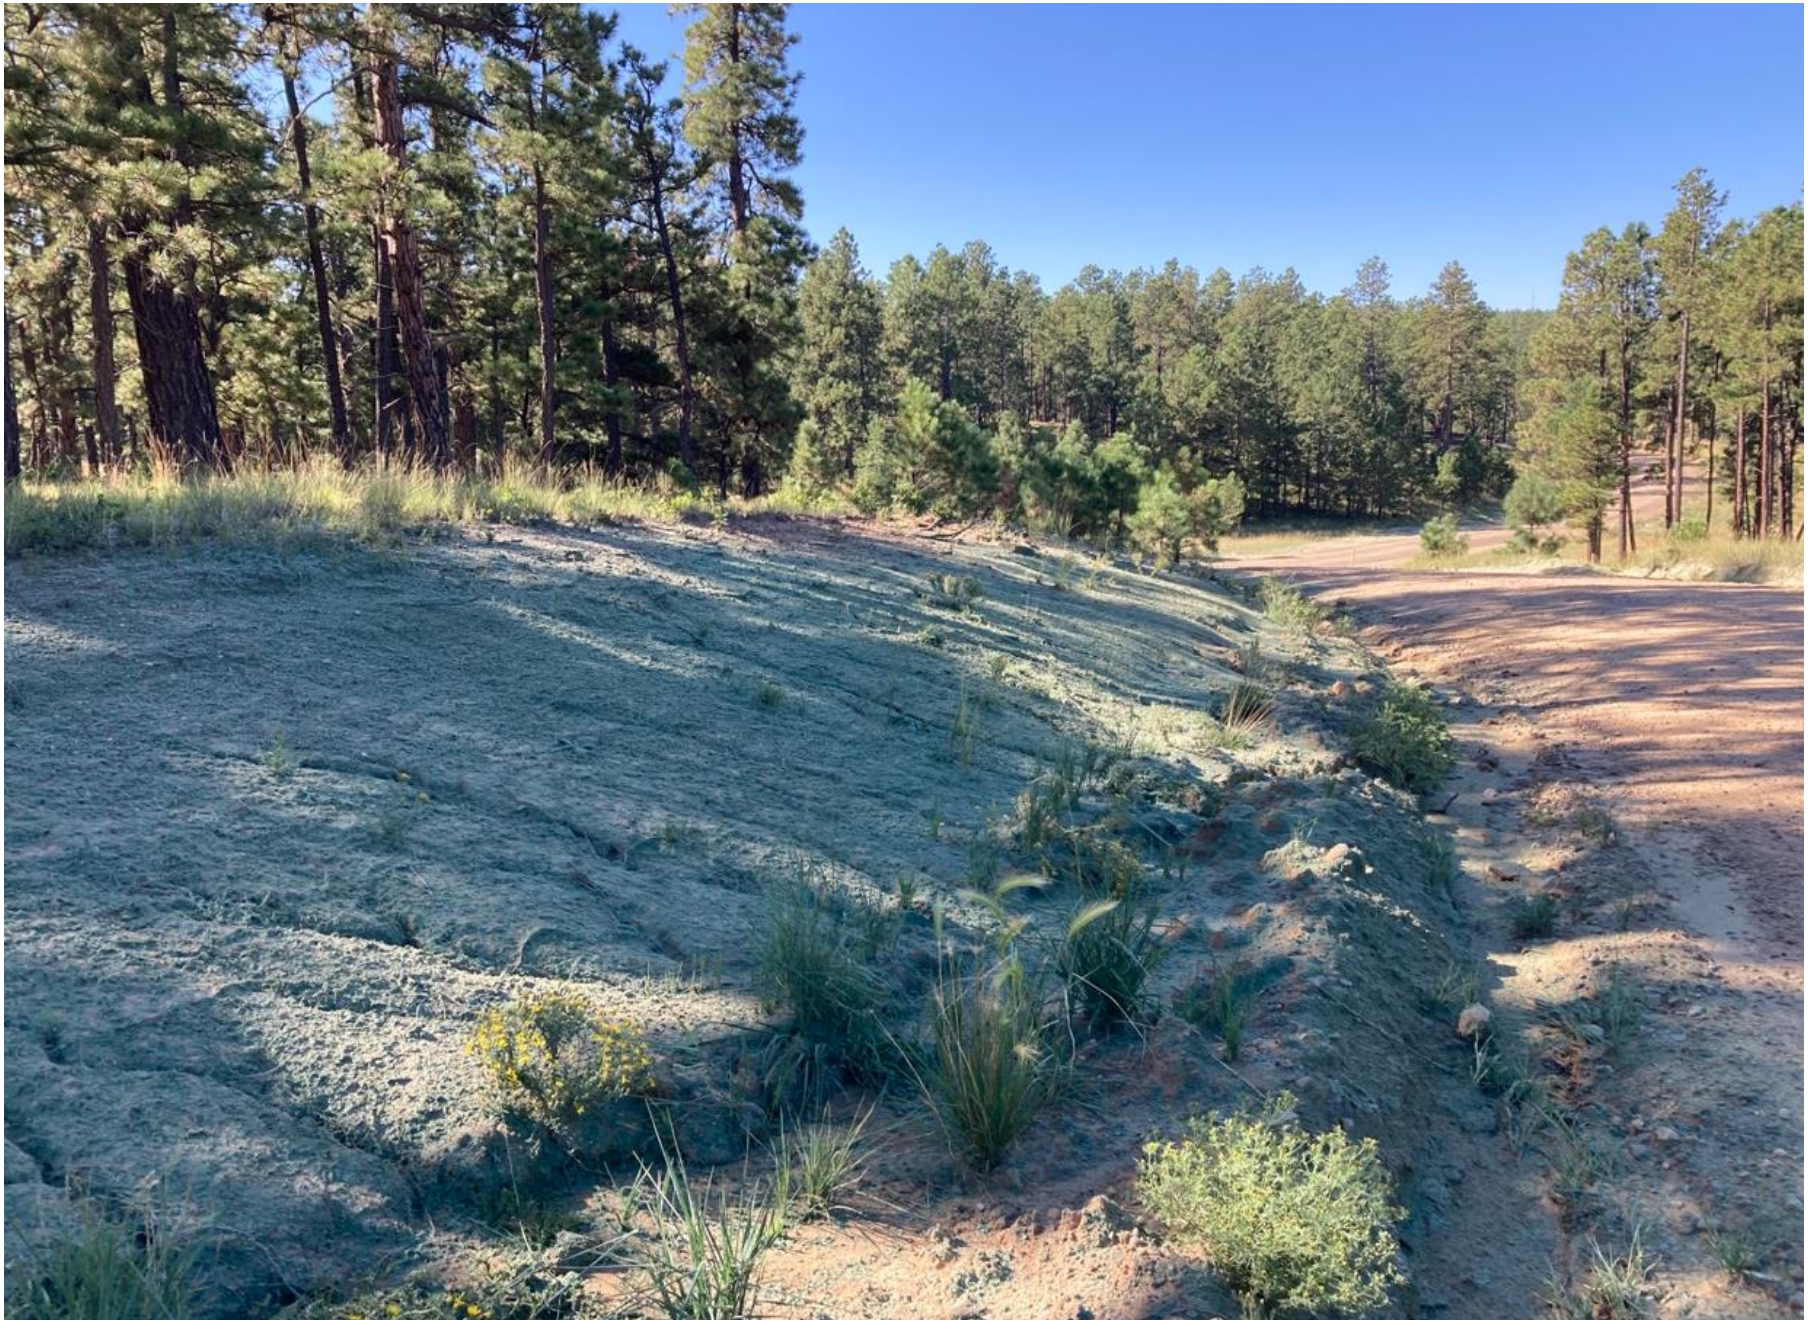
PHOTO 1: THE CUT SLOPE IDENTIFIED IN DOCUMENT #690203935 HAS BEEN SEEDED TO ESTABLISH STABILIZATION.

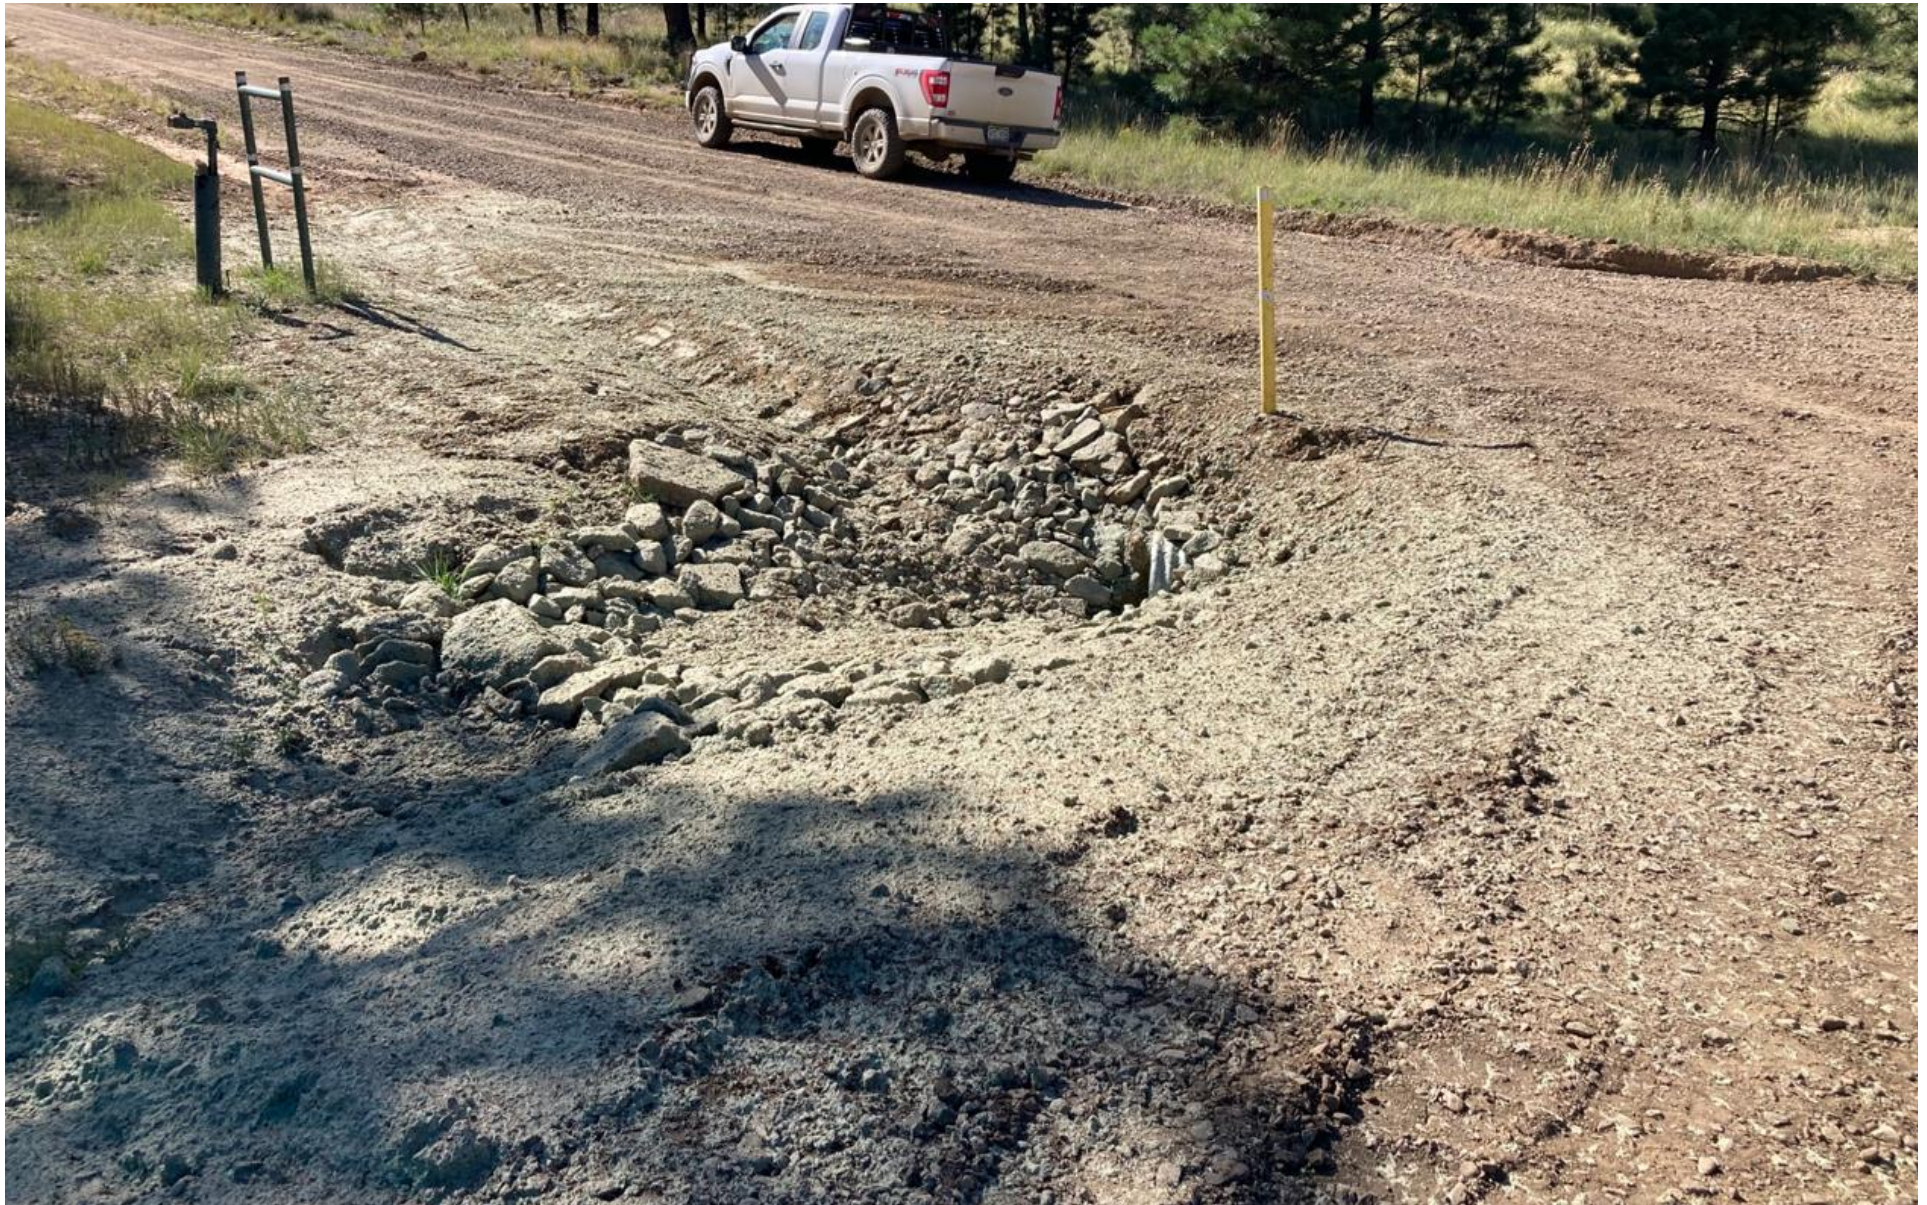
PHOTO 2: A CULVERT HAS BEEN INSTALLED AT THE INTERSECTION IDENTIFIED IN DOC #690203935 TO PROPERLY DIVERT STORMWATER. BOTH THE INLET AND OUTLET HAVE BEEN DEFINED AND ROCKED. ALL DISTURBED AREAS HAVE BEEN SEEDED TO PROMOTE VEGETATIVE STABILIZATION.

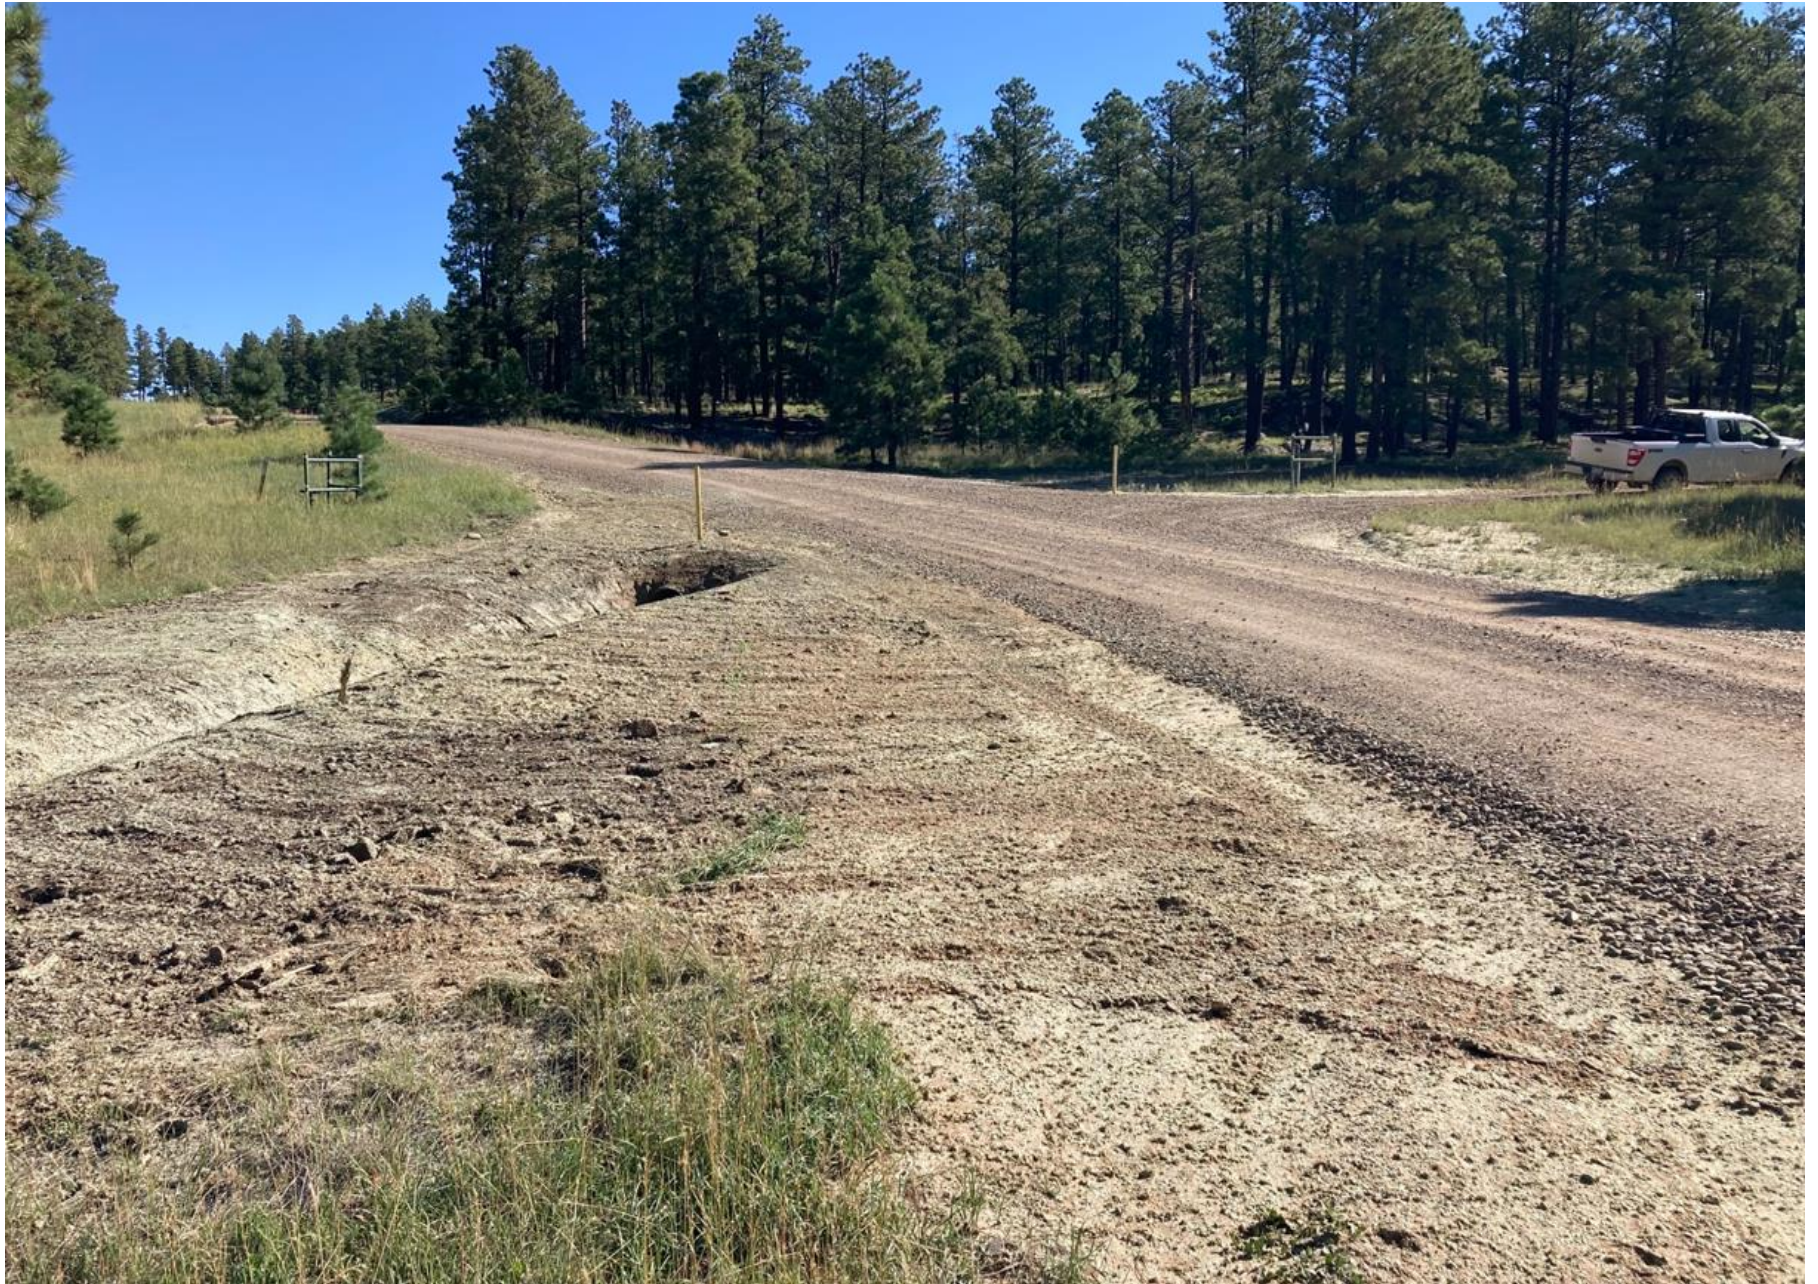
PHOTO 3: ADDITIONAL ROAD MATERIAL HAS ALSO BEEN ADDED TO THE INTERSECTION.

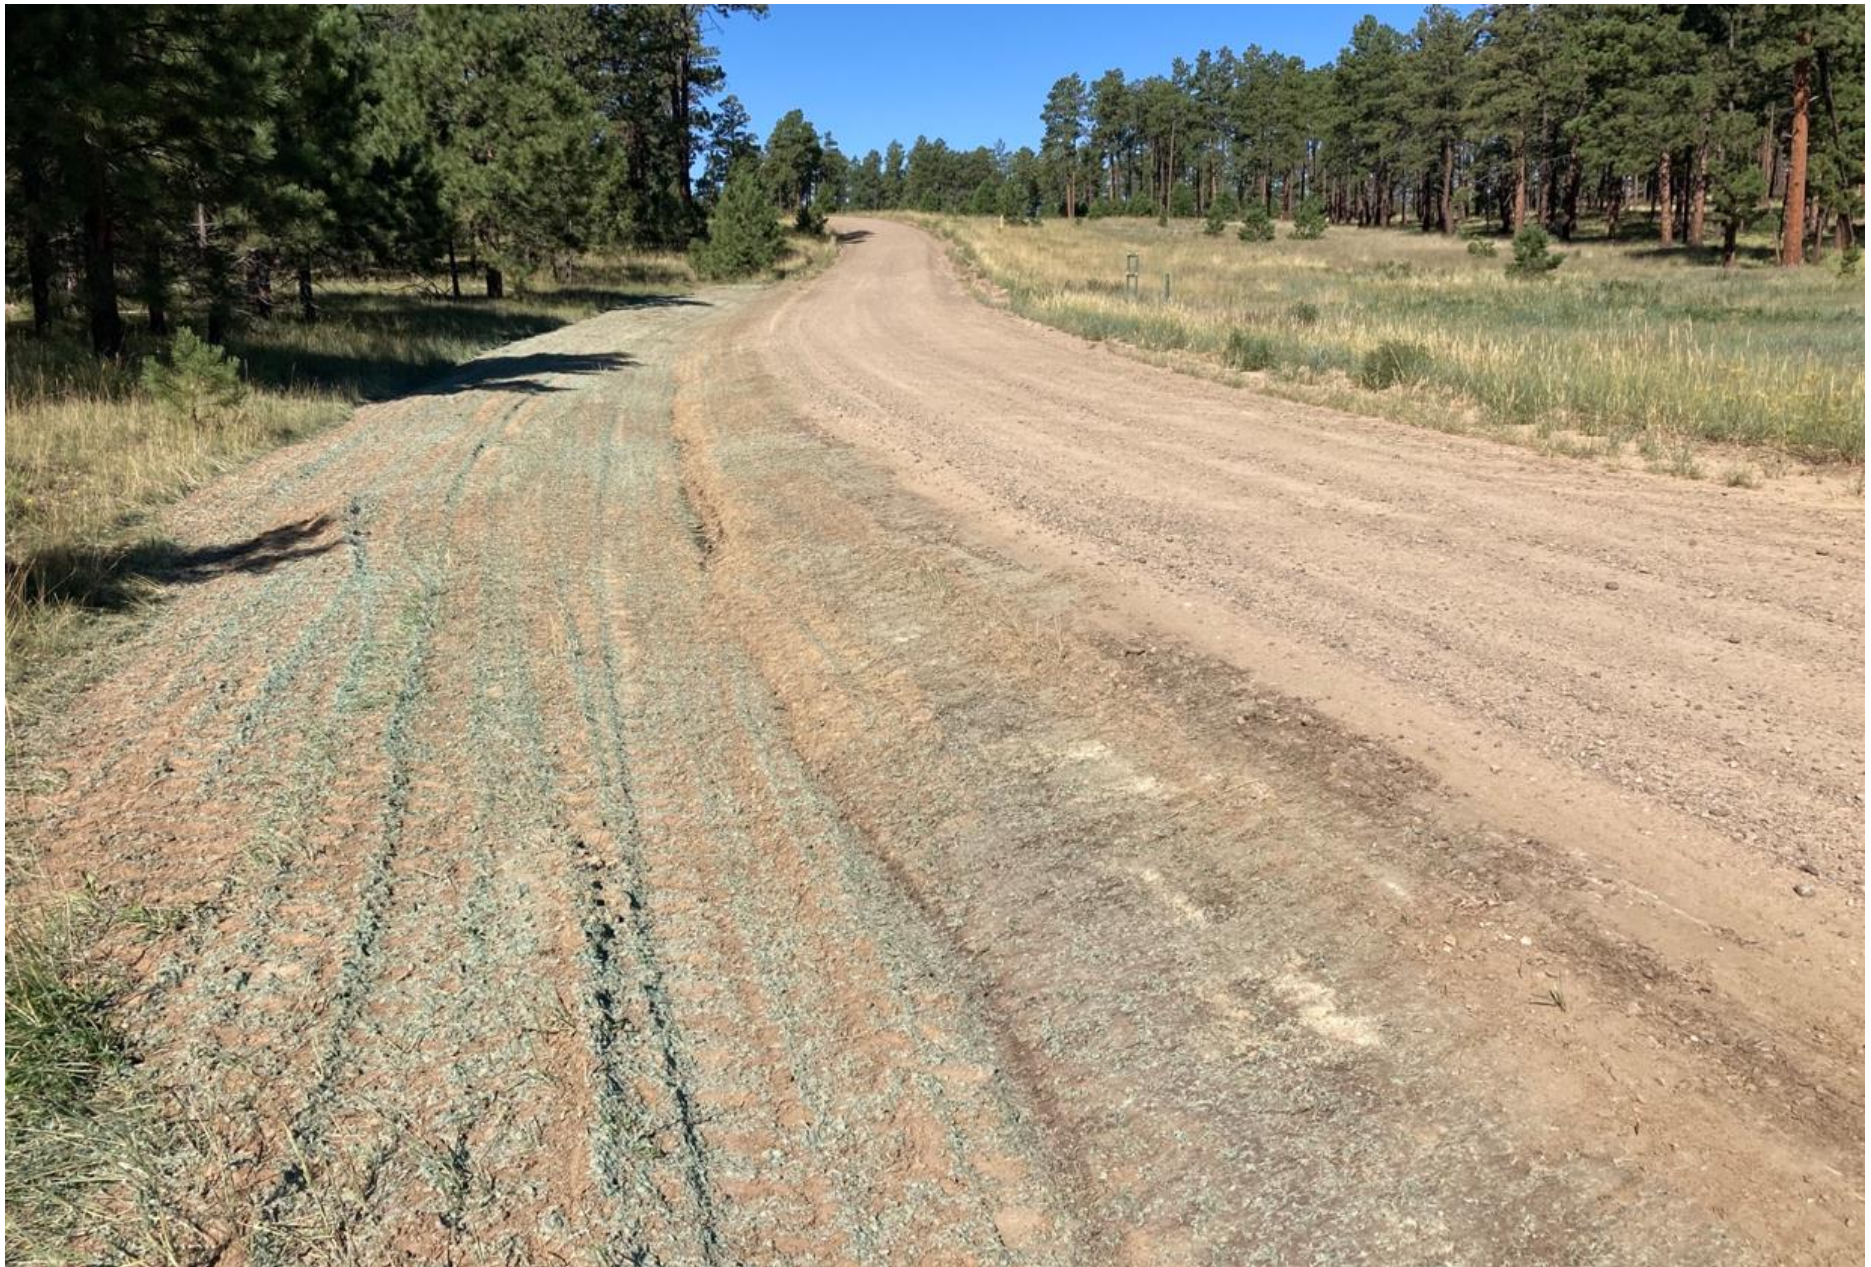
PHOTO 4: THE BAR DITCH THROUGHOUT THE AREA HAS BEEN RECONFIGURED TO ELIMINATE EROSION AND THE SOIL WAS COMPACTED AND TRACKED FOR STABILIZATION. ALL DISTURBED AREAS HAVE BEEN HYDRO-MULCHED & SEEDDED.

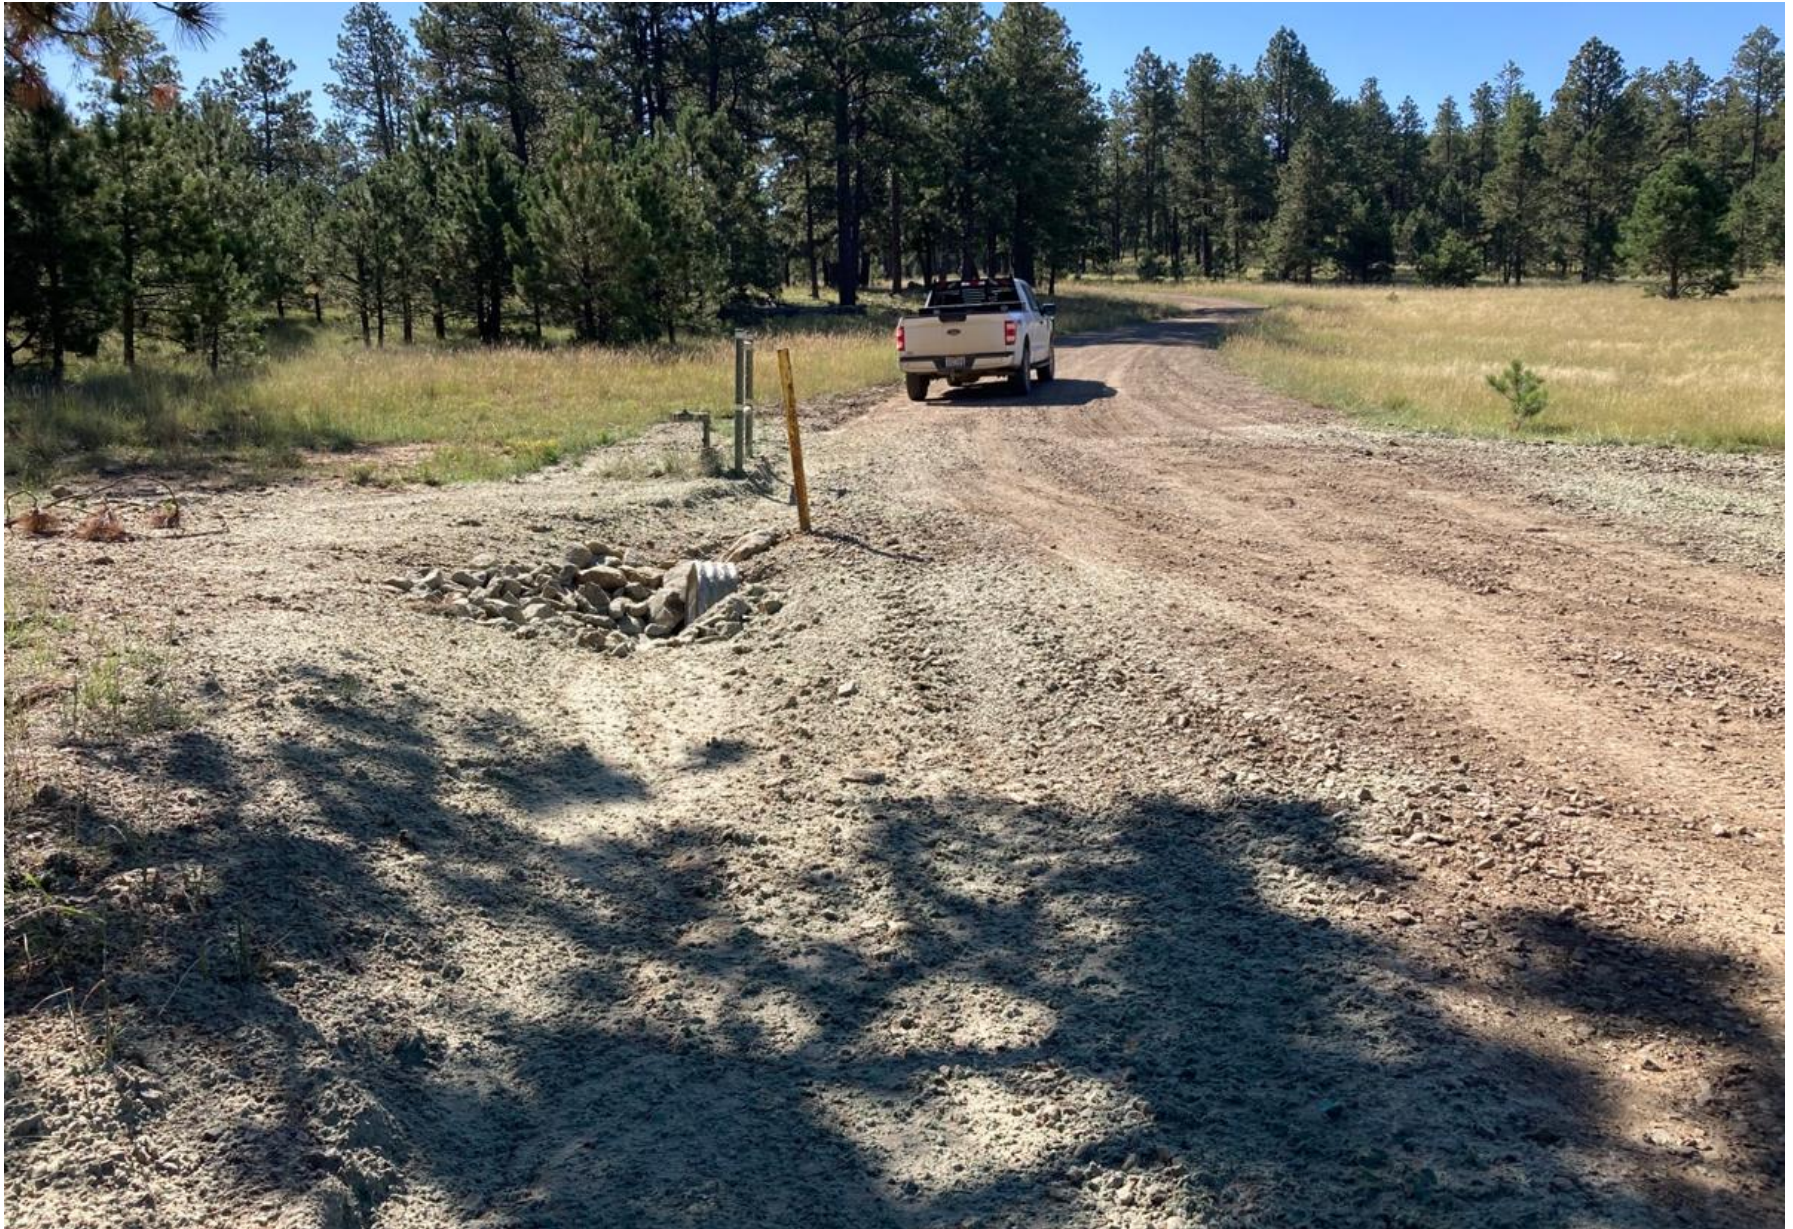
PHOTO 5: ALL CULVERTS IN THE AREA ASSOCIATED WITH THE INITIAL CORRECTIVE ACTION HAVE BEEN CLEANED OF SEDIMENT ACCUMULATION TO ALLOW PROPER FLOW THROUGH THE CULVERT. INLETS AND OUTLETS HAVE BEEN REDEFINED/ROCKED. ALL DISTURBED AREAS HAVE BEEN HYDRO-MULCHED AND SEEDED TO PROMOTE VEGETATIVE STABILIZATION. THE AREA WILL BE FURTHER MONITORED FOR GROWTH, NOXIOUS WEEDS, SEDIMENT MOVAL AND STORMWATER IMPACT.

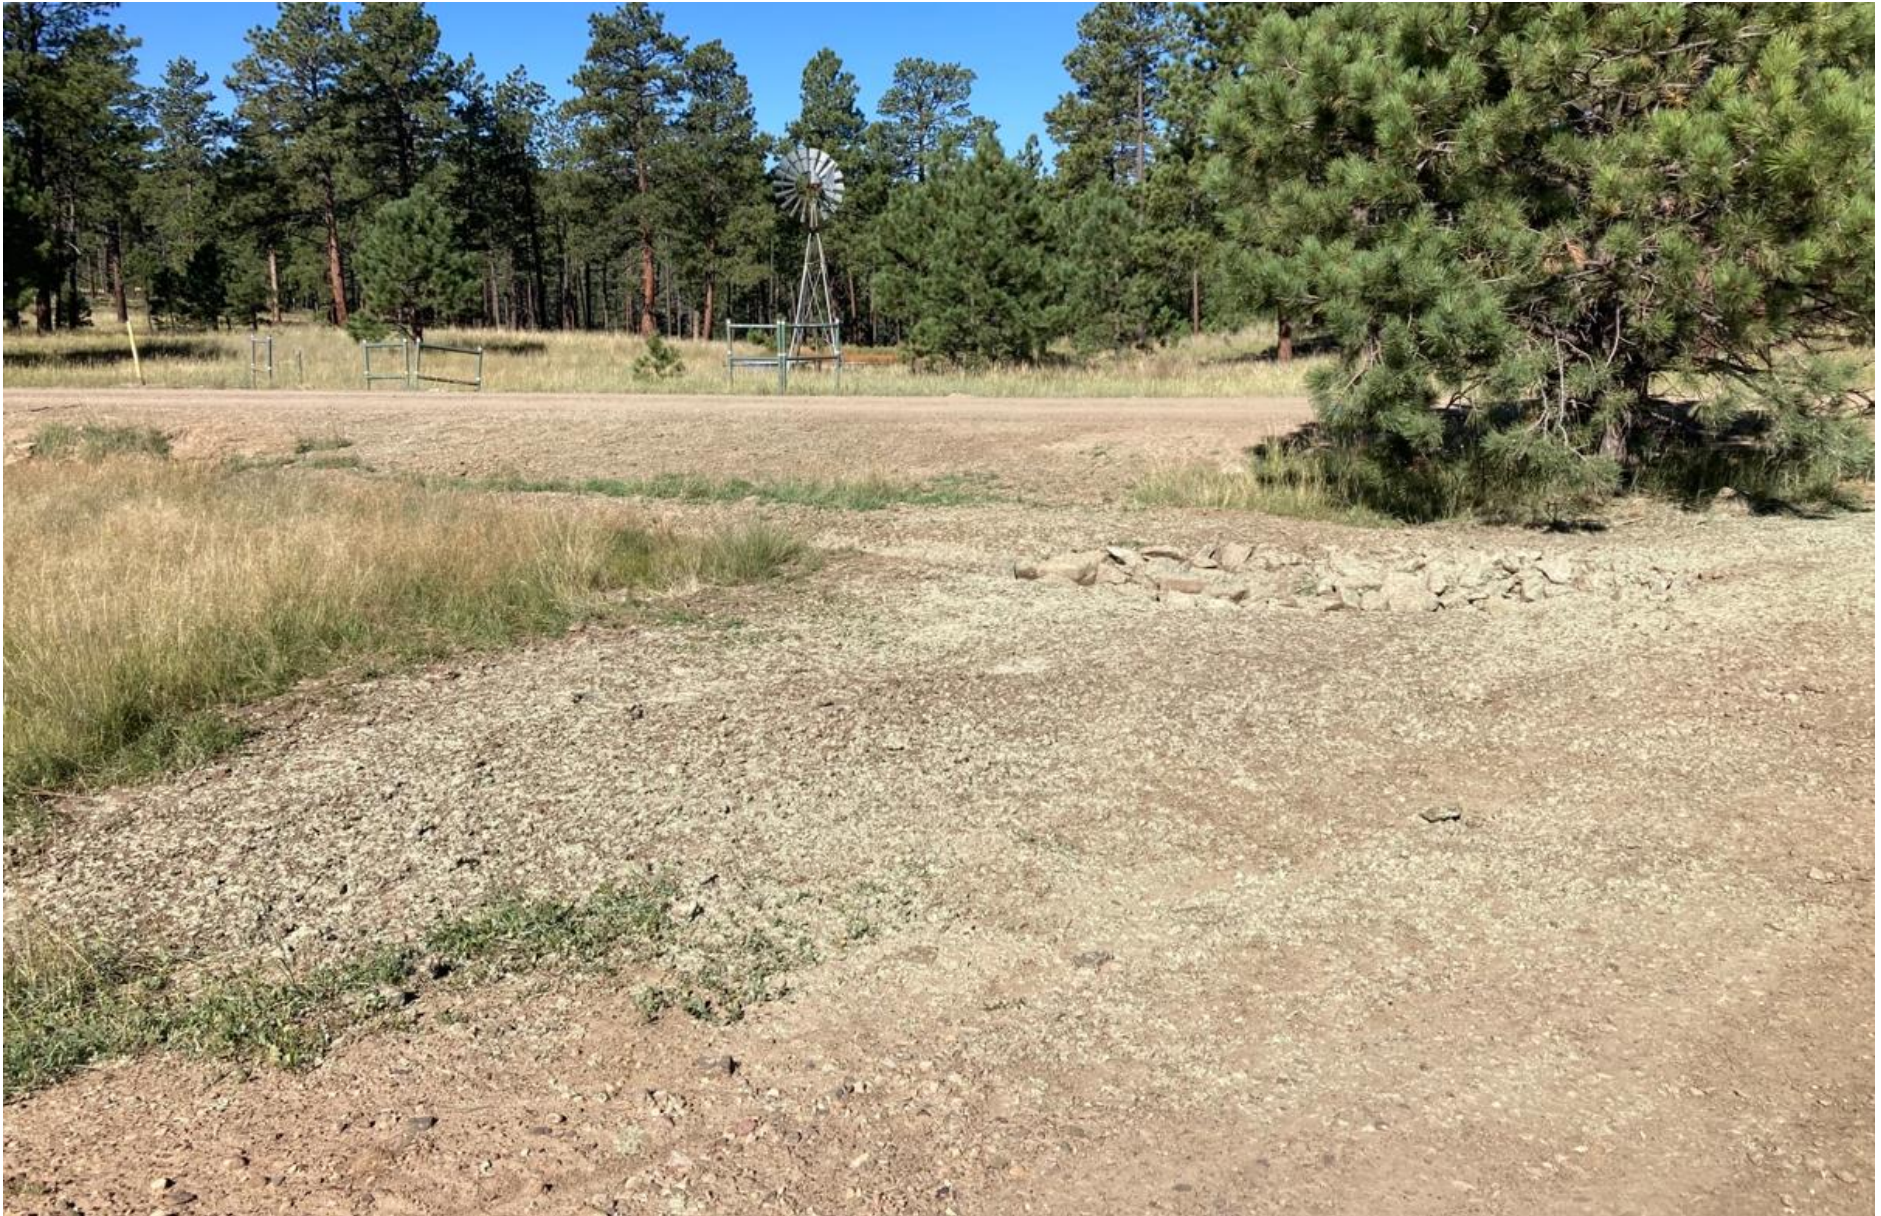
PHOTO 7: ROCKED OUTLET AND DIVERSION DITCH. THIS AREA IS ALSO RELATED TO INSPECTION DOC #713600179 AND FIRR DOC #403521679. THE DISTURBED AREA HAS BEEN THOROUGHLY HYDRO-MULCHED AND SEEDED POST REMOVAL OF ROCK STOCK PILE.

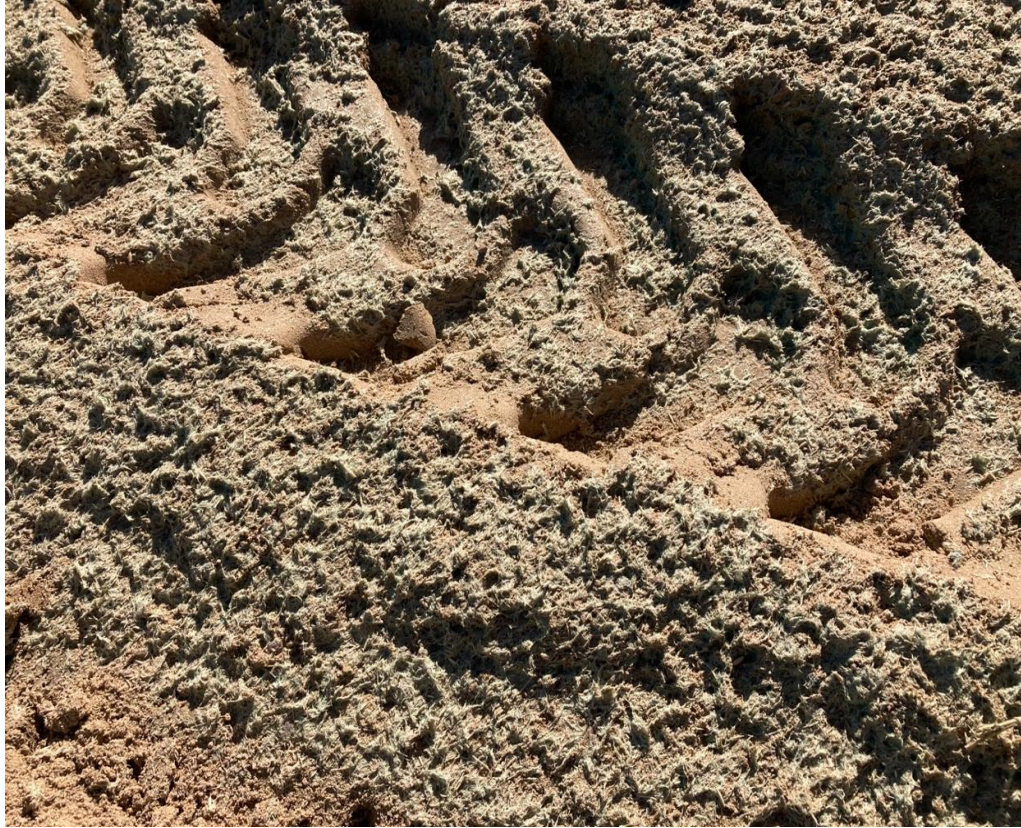
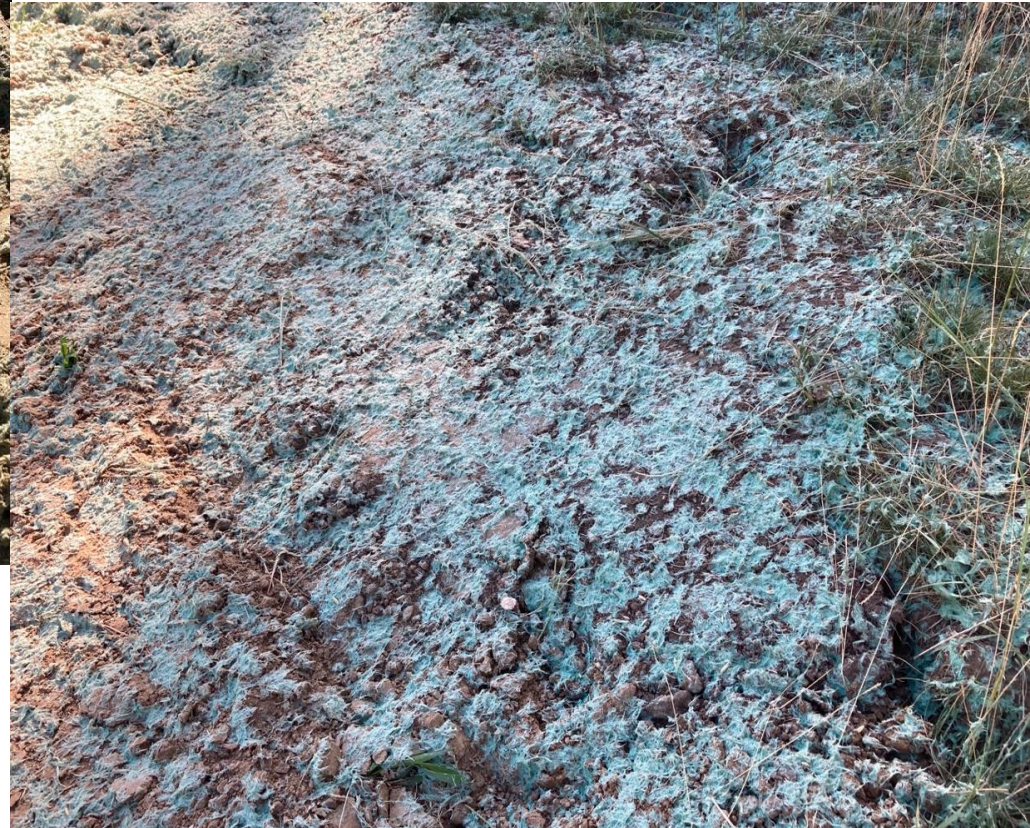
PHOTOS 8 & 9: HYDRO-MULCH/SEED APPLICATIONS

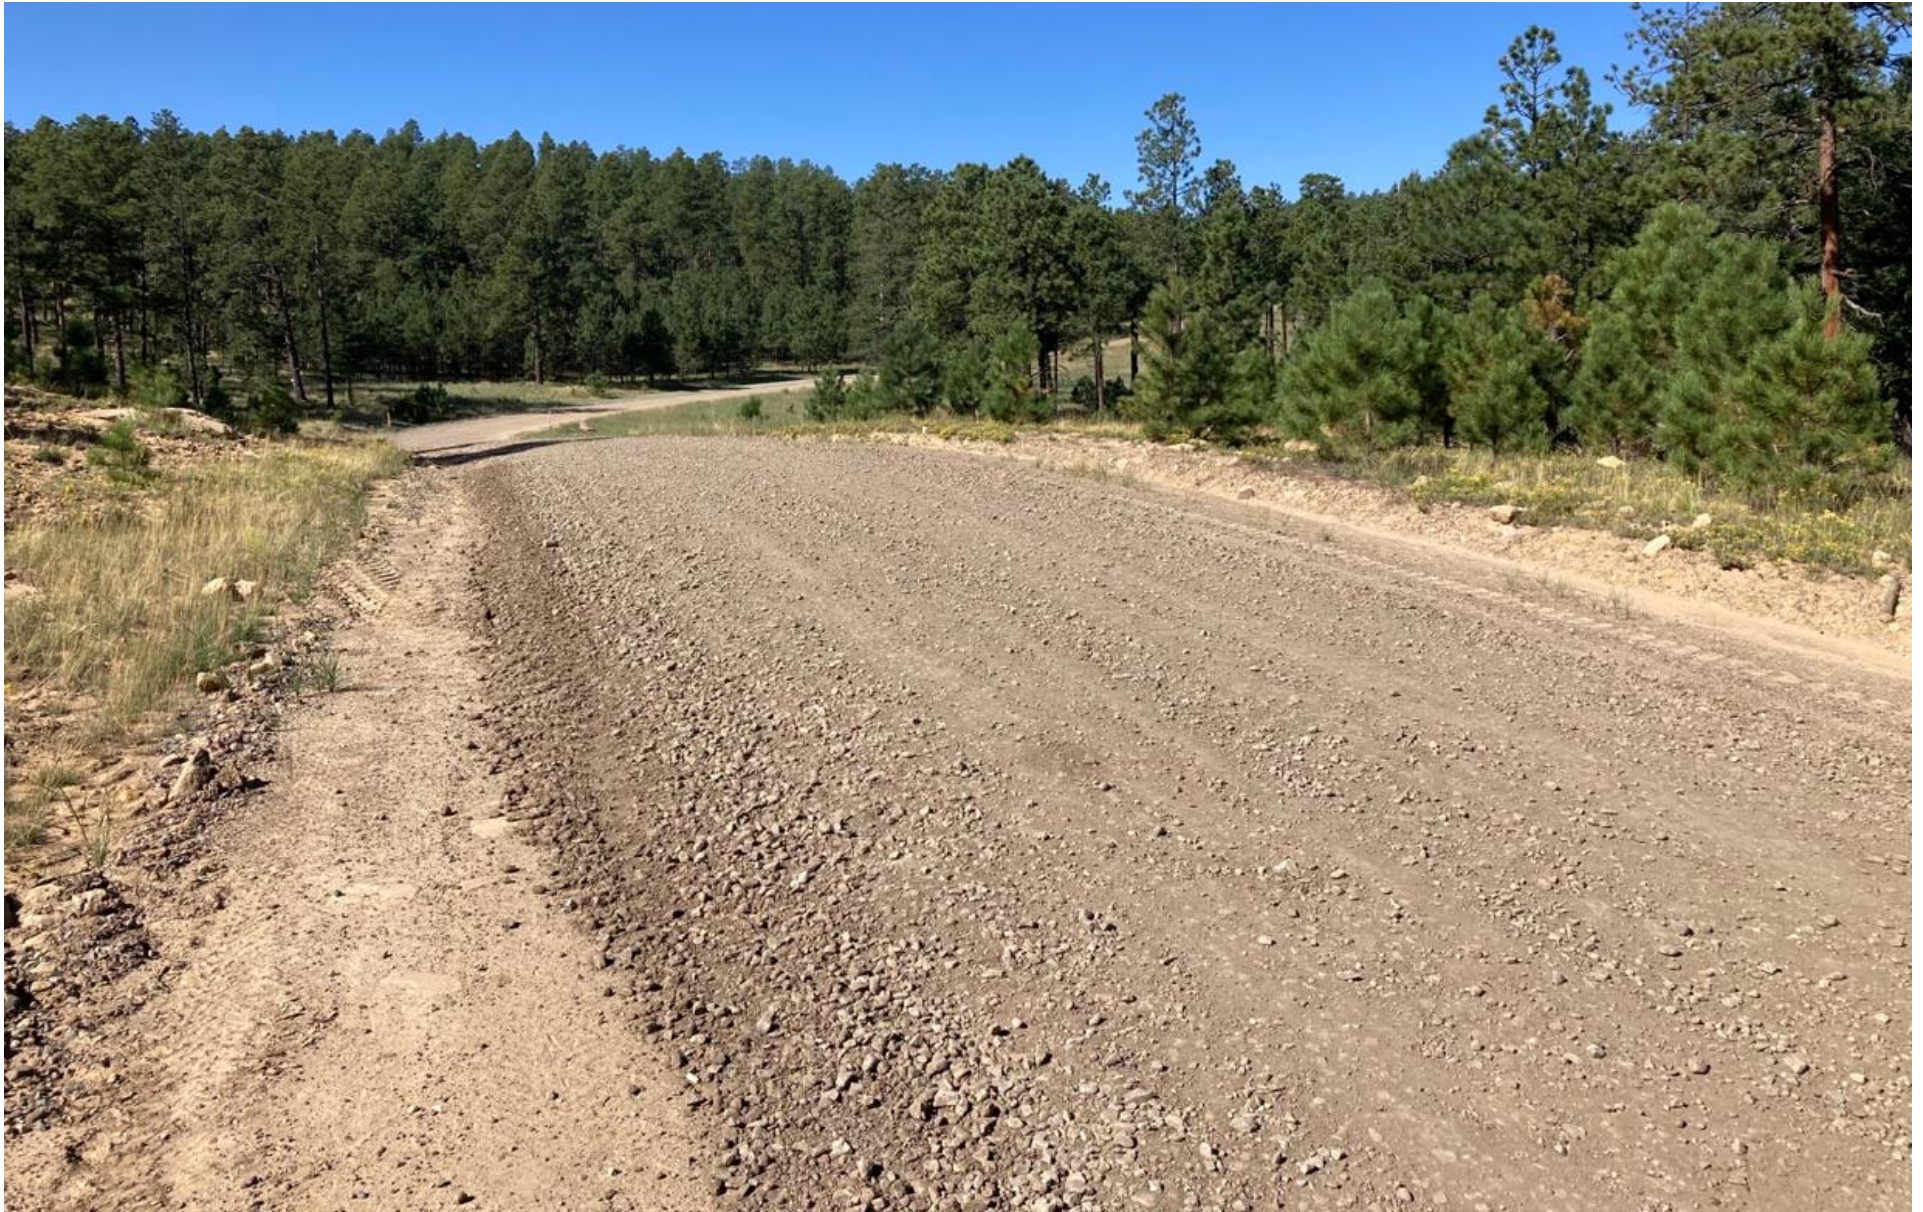
PHOTO 13: THE ROAD SURFACE WAS CROWNED THROUGHOUT THE AREA TO CREATE SHEET FLOW AND ELIMINATE THE TIRE RUTS. ADDITIONAL GRAVEL MATERIAL WAS INSTALLED TO THE ROADWAY SURFACE TO PROVIDE ADDED STABILIZATION.
