Operator: BONANZA CREEK ENERGY OPERATING COMPANY LLC

Location Name: Antelope 43-17

Inspection: 709100060

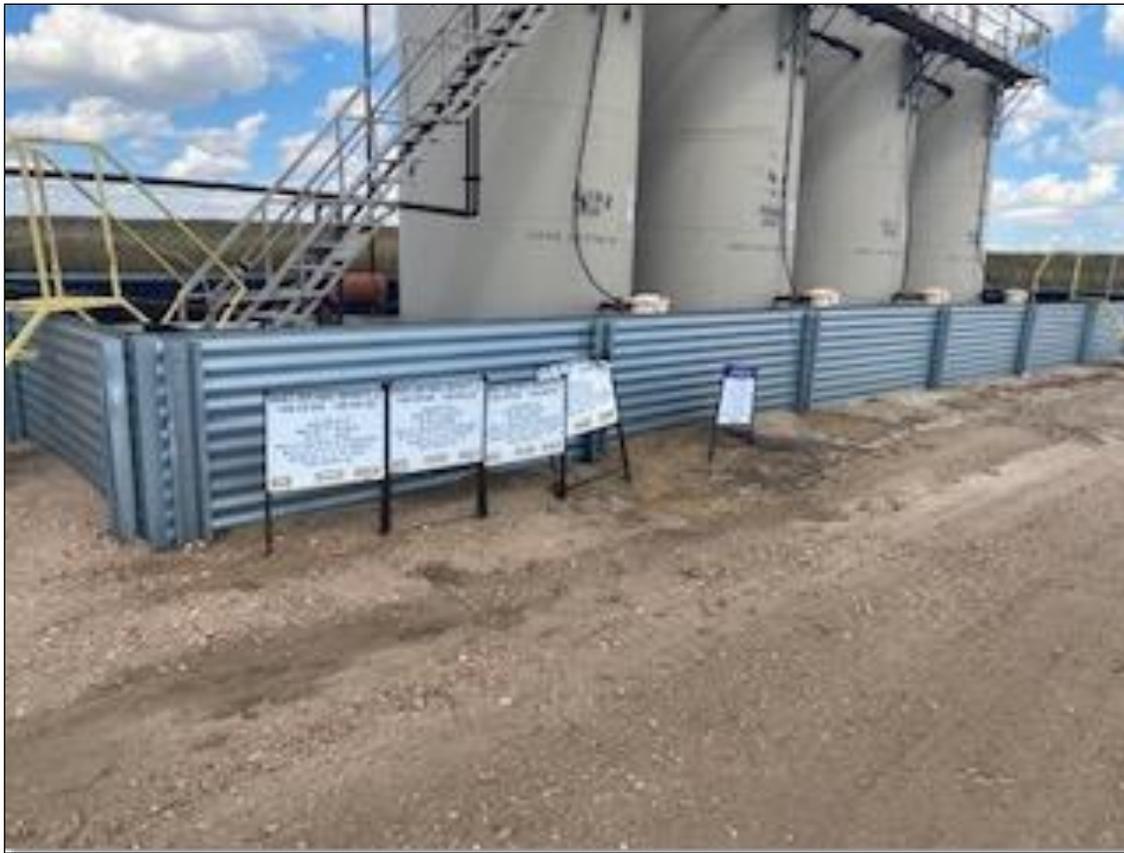
Exhibit A

CA: Illegible wellhead signs, sign at tank battery is not installed properly, and emergency contact number on tanks illegible from a distance. Install signs to comply with Rule 605.a.

CA Resolution: Operator has properly re-installed sign at tank battery. Additional matters regarding signage, including installing legible emergency contact number(s) on tanks, are currently being addressed to comply with Rule 605.a.

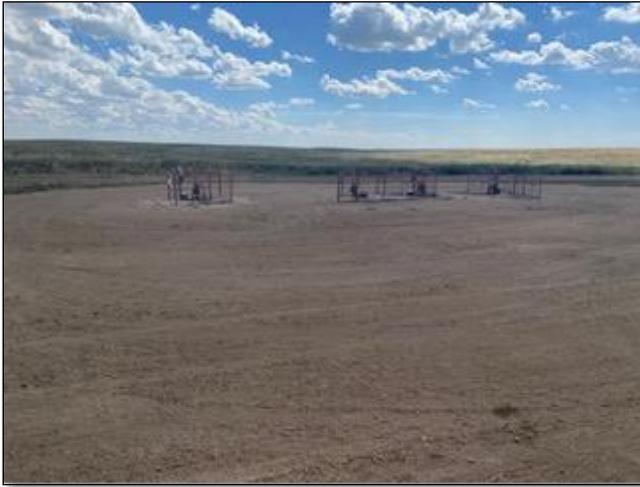
Exhibit E

CA: Undesirable plant species located throughout the site. Comply with rule 606.c.

CA Resolution: Field has appropriately addressed the identified tumbleweeds and debris on location and have properly cleared/cleaned the area to comply with Rule 606.c.
