Final Reclamation and Stormwater Inspection

Operator: KERR MCGEE OIL & GAS ONSHORE LP -
47120

Location ID: 329063

Location Name: Lorenz L Federal #30-12

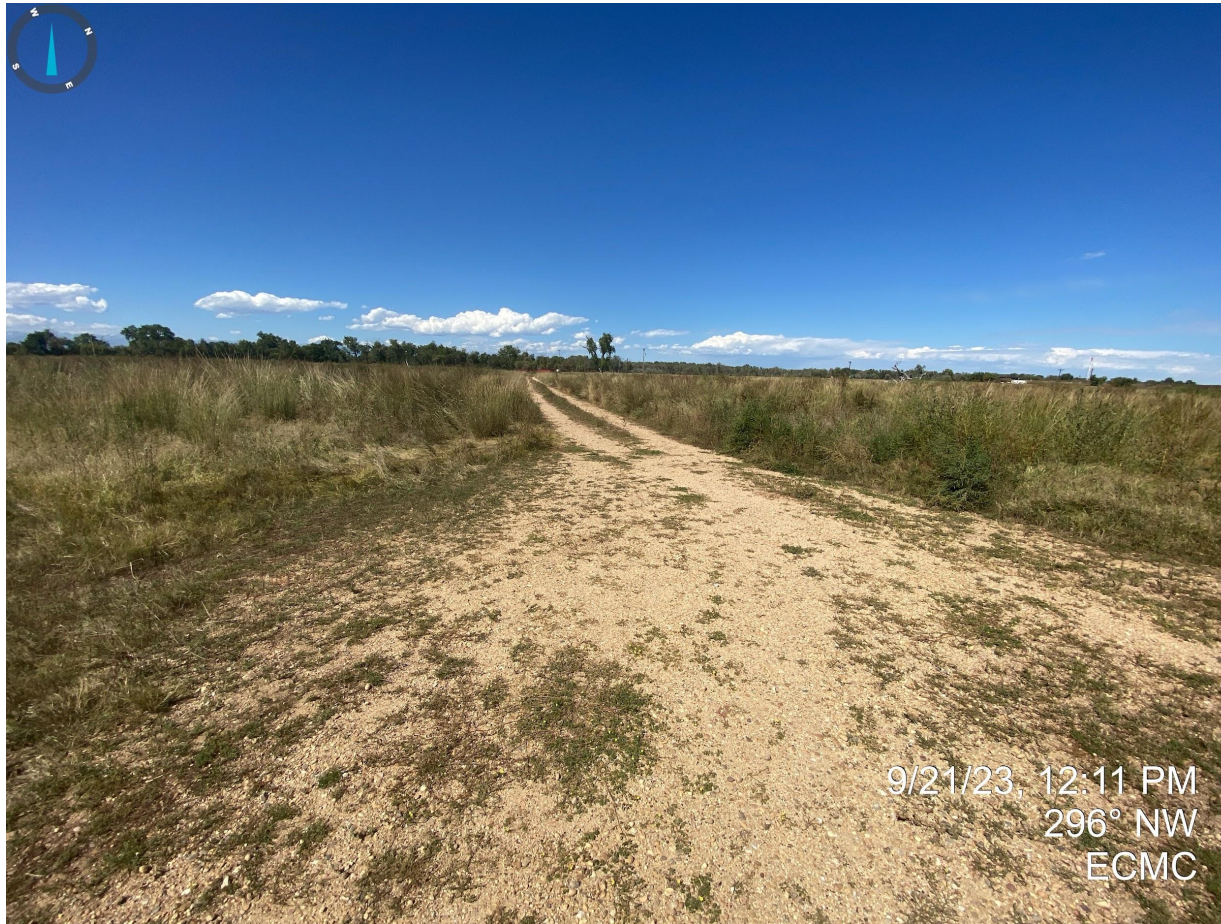
Photo 1. Taken east of the location along the former access road. It does not appear the access road has been reclaimed per 1004 Rules.

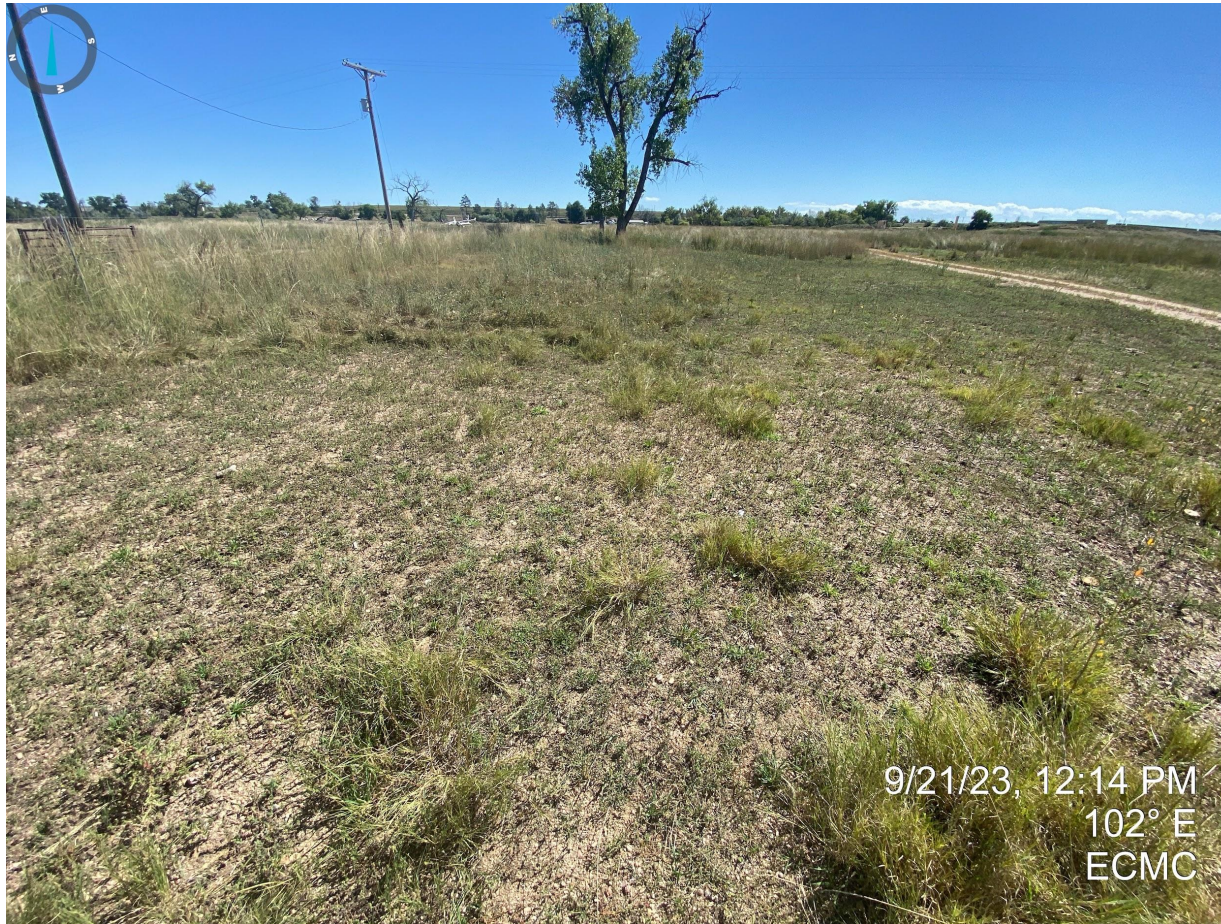
Photo 2. Taken at the former wellhead location. Gravel and undesirable vegetation (e.g. kochia) were observed around the former location. Additional reclamation activities are required.

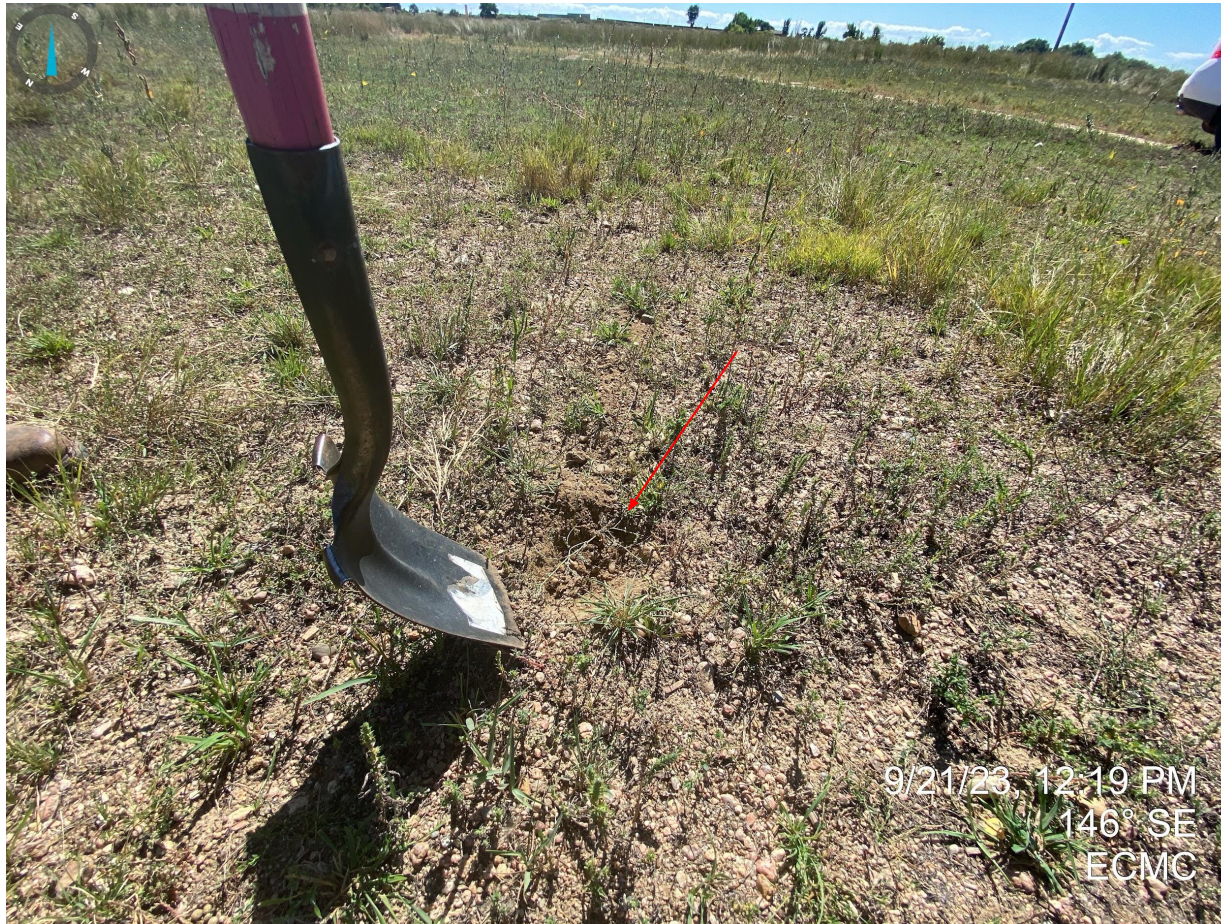
Photo 3. Taken within the former wellhead location. It does not appear the location was properly decompacted; hole is approximately 2-3" deep with road base/gravel present.

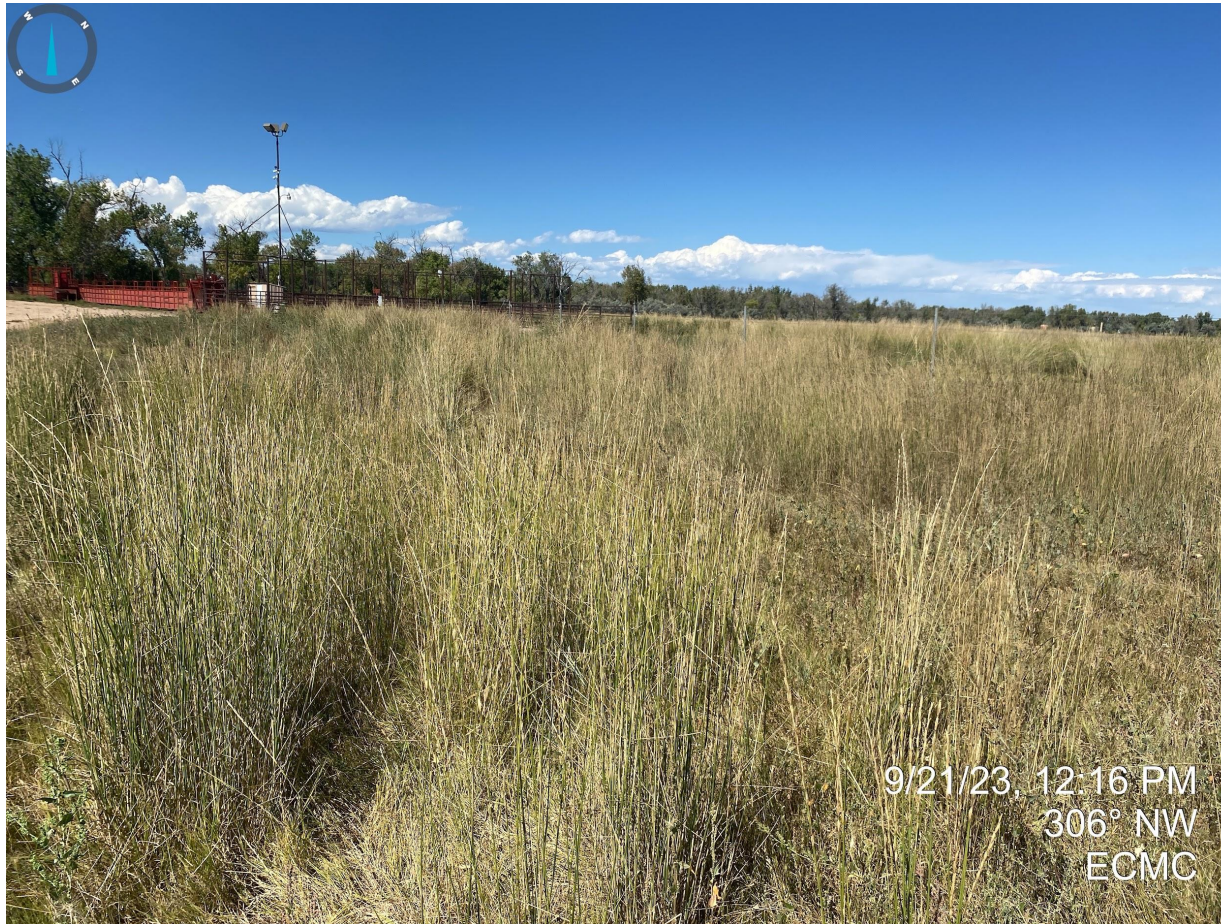
Photo 4. Reference area photo taken immediately west of the former location.

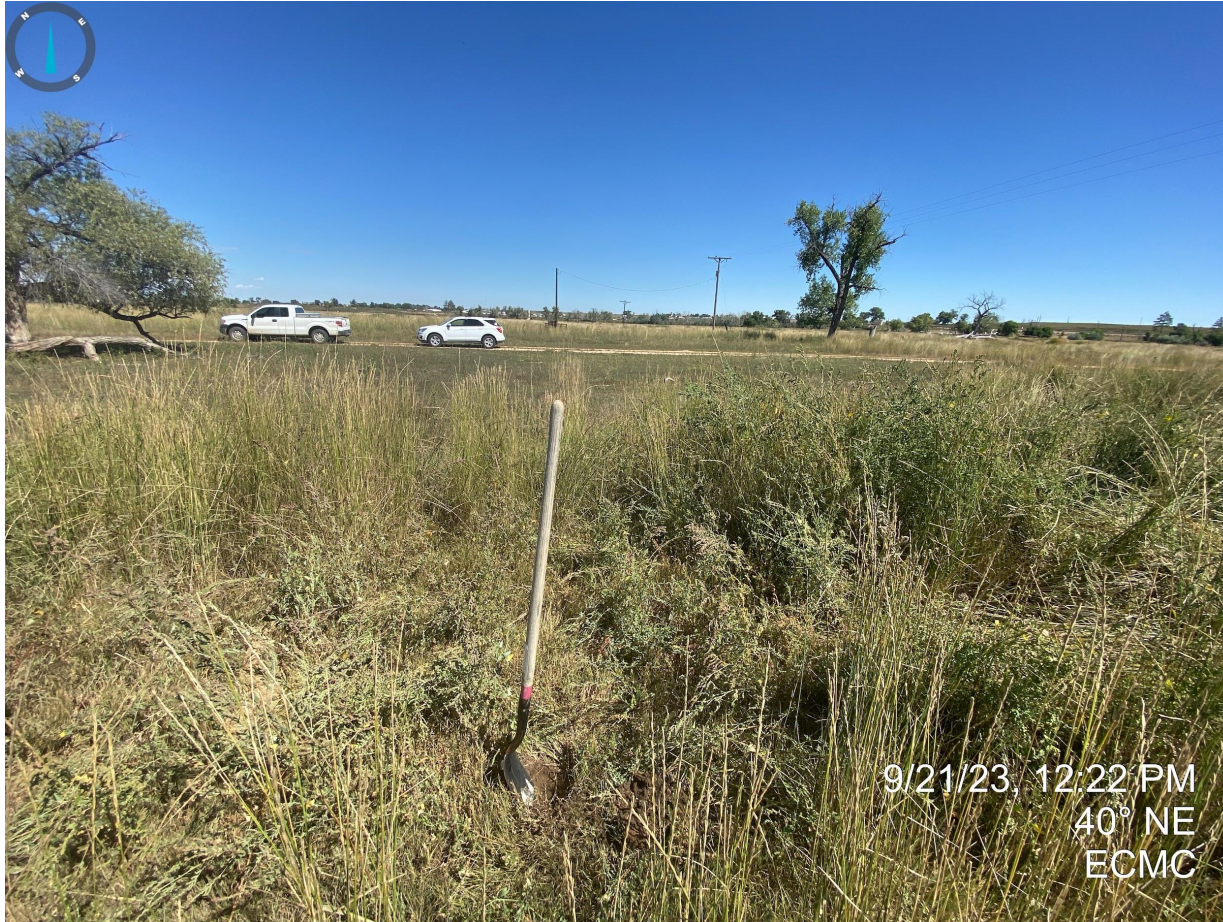
Photo 5. Taken south of the former location. Staff performed a compaction test in reference area soil and dug approximately 6" with minimal effort.
