Location Name: State Antelope / F-30 Pad

Loc ID: 432809

Inspection: 709100058

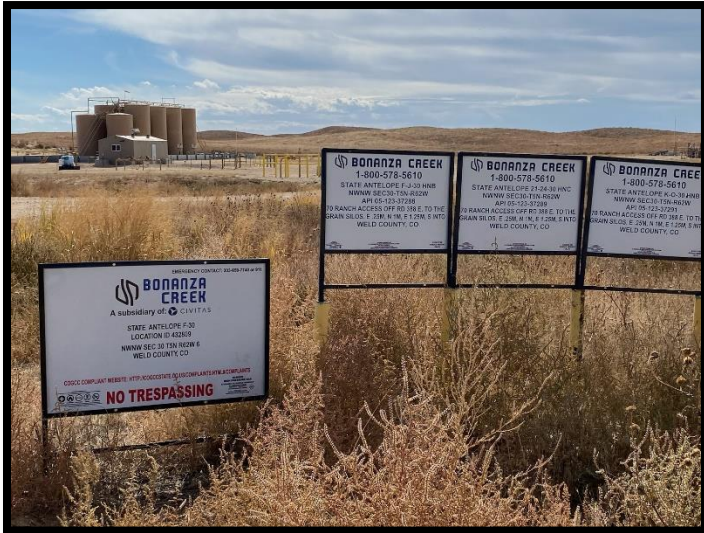
Exhibit A

CA: Sign not posted, and information written on wellhead is illegible at the K-O-30HNB wellhead. Install sign to comply with Rule 605.a.

CA Resolution: Operator has installed new signage at identified areas on location to comply with Rule 605.a.
