**Operator: 8 North**

**Location Name: DF RANCH PC GK02-77HN**

**Loc ID: 428119**

**Inspection: 696305279**

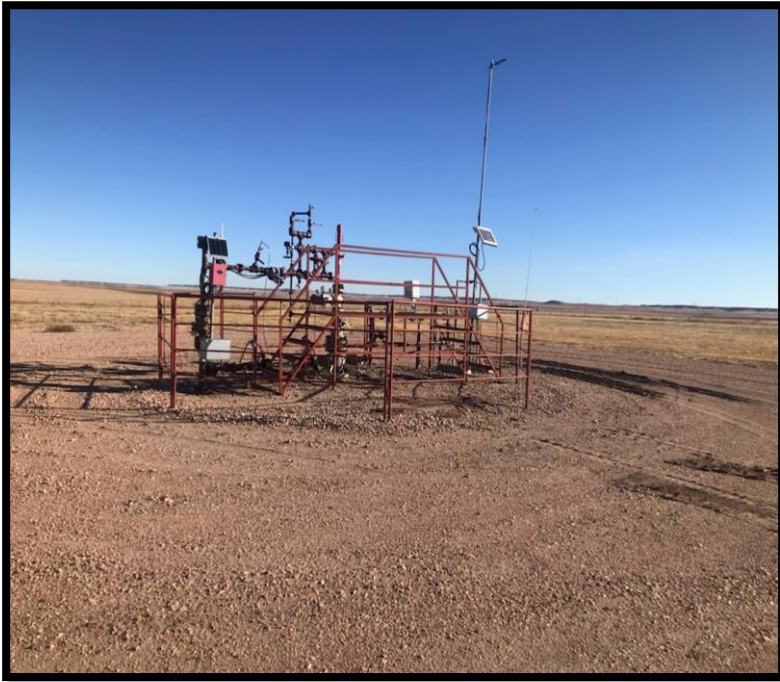
**Exhibit A**

**CA:** Label missing on Container at Wellhead; see photos. Install sign to comply with Rule 605.h.

**CA Resolution:** The container identified at the Wellhead has been addressed and completely removed from the location.
