Final Reclamation and Stormwater Inspection

Location ID: 435851

Inspection Document #: 708200647

Inspection Photos
Location Name: Horsetail 29H Pad
Location ID: 435851

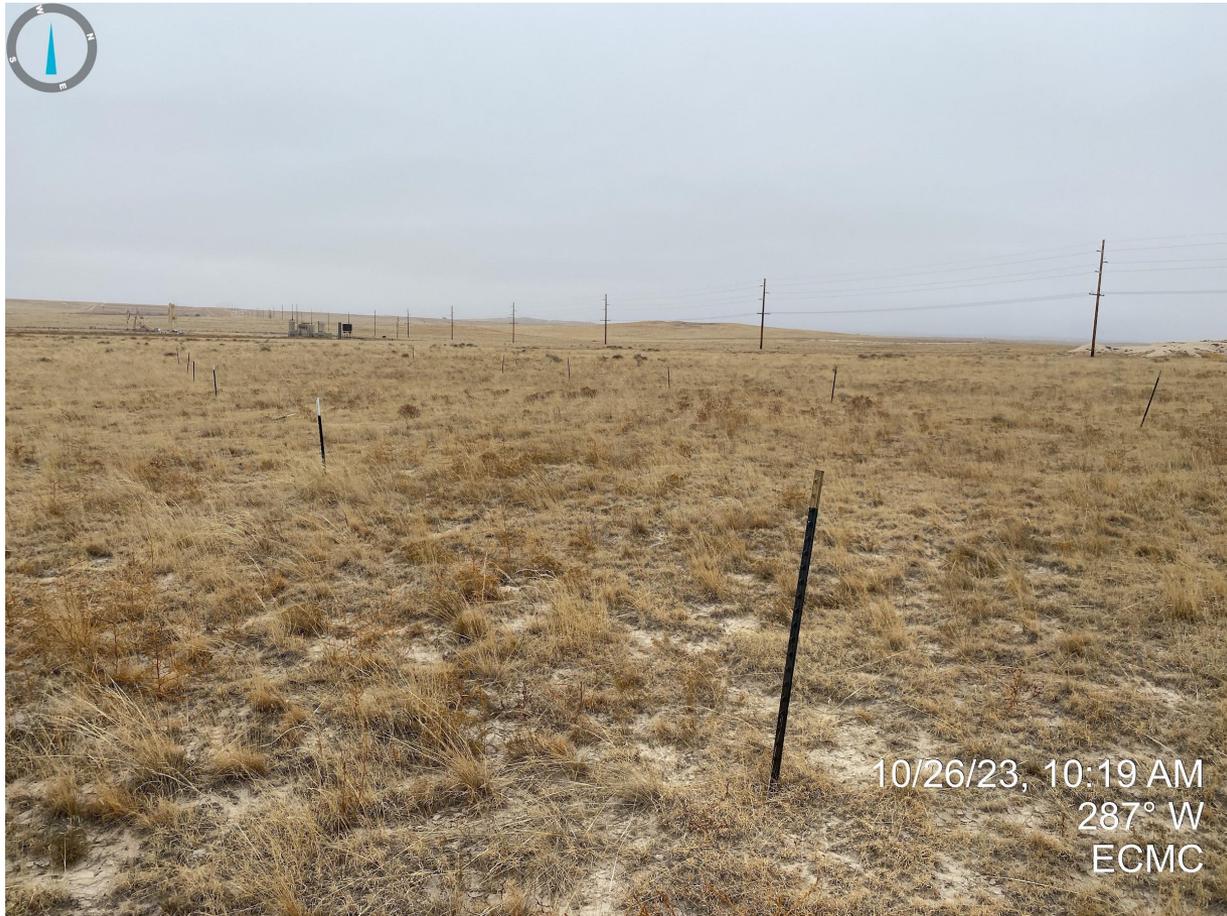
Photo 1. This location does not comply with Rule 1004. Operator submitted Form 4 Sundry Notices stating the above wells were not drilled. Location was not constructed at the proposed well location based off field observations. However, during this inspection, Staff observed that t-posts and wooden stakes remain on location, which is now considered debris, and will need to be removed in order to meet Rule 1004 standards.

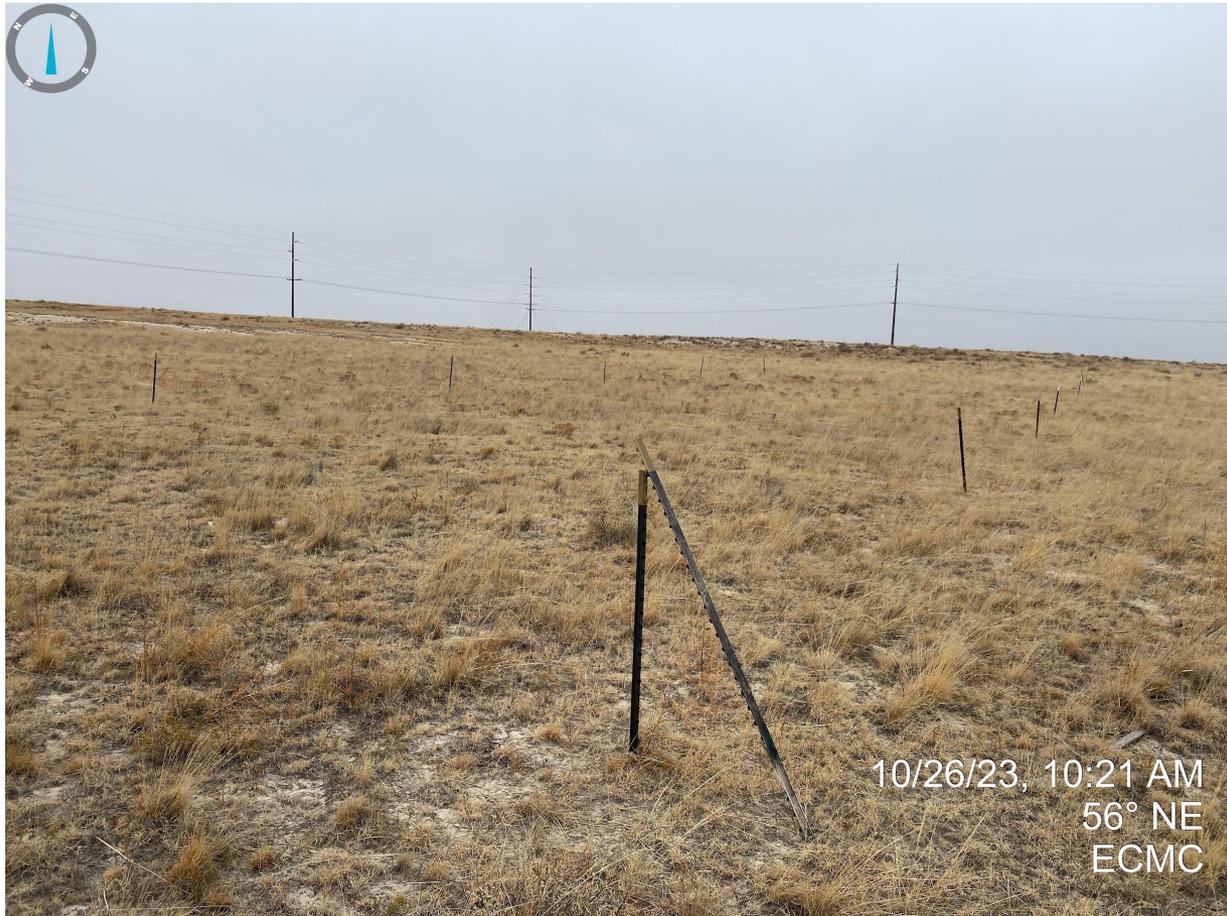
Photo 2. See comments in Photo 1.
