Final Reclamation and Stormwater Inspection

Operator: WHITING OIL & GAS CORPORATION - 96155

Location ID: 435866

Inspection Photos
Location Name: Horsetail 29F Pad
Location ID: 435866

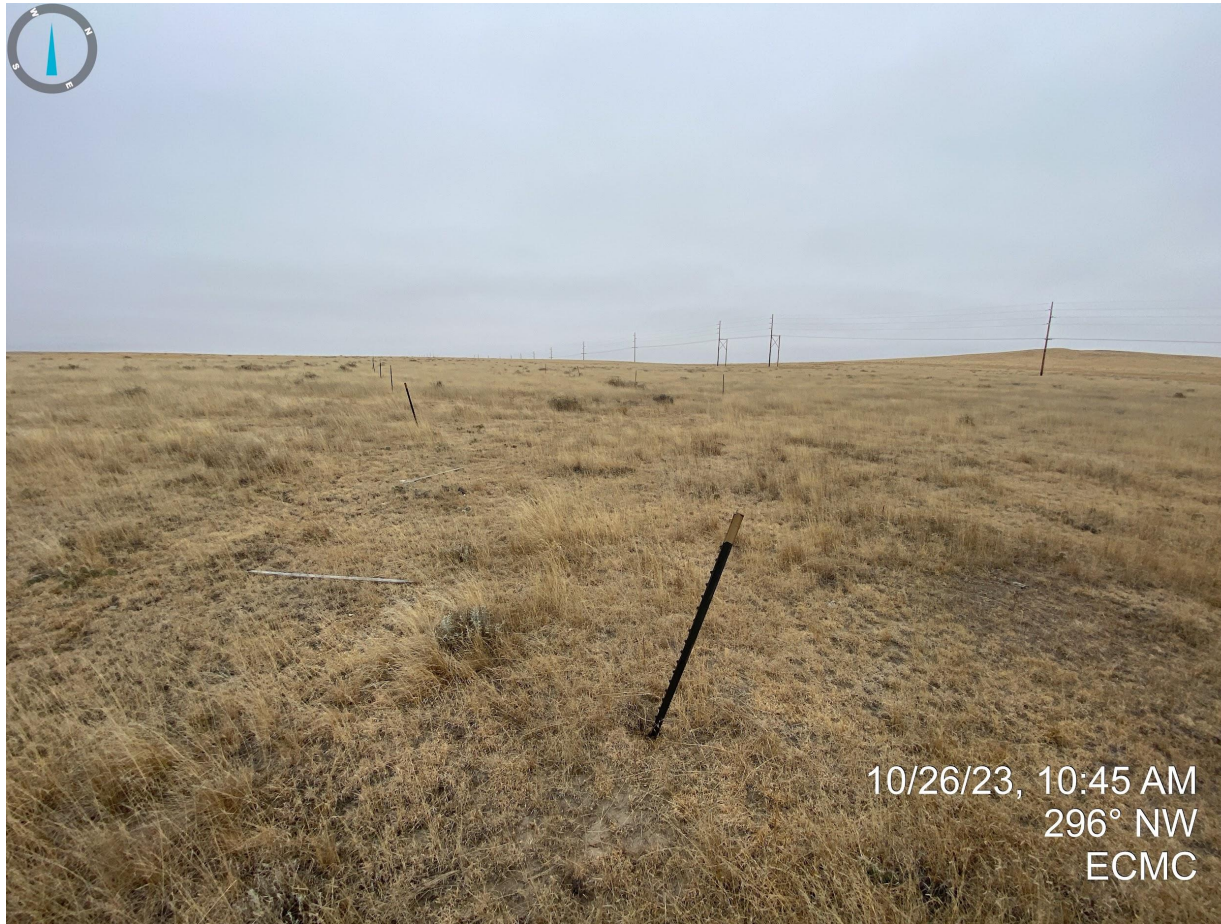
Photo 1. This location does not comply with Rule 1004. Operator submitted Form 4 Sundry Notices stating the above wells were not drilled. Location was not constructed at the proposed well location based off field observations. However, during this inspection, Staff observed that t-posts and wooden stakes remain on location, which is now considered debris, and will need to be removed in order to meet Rule 1004 standards.

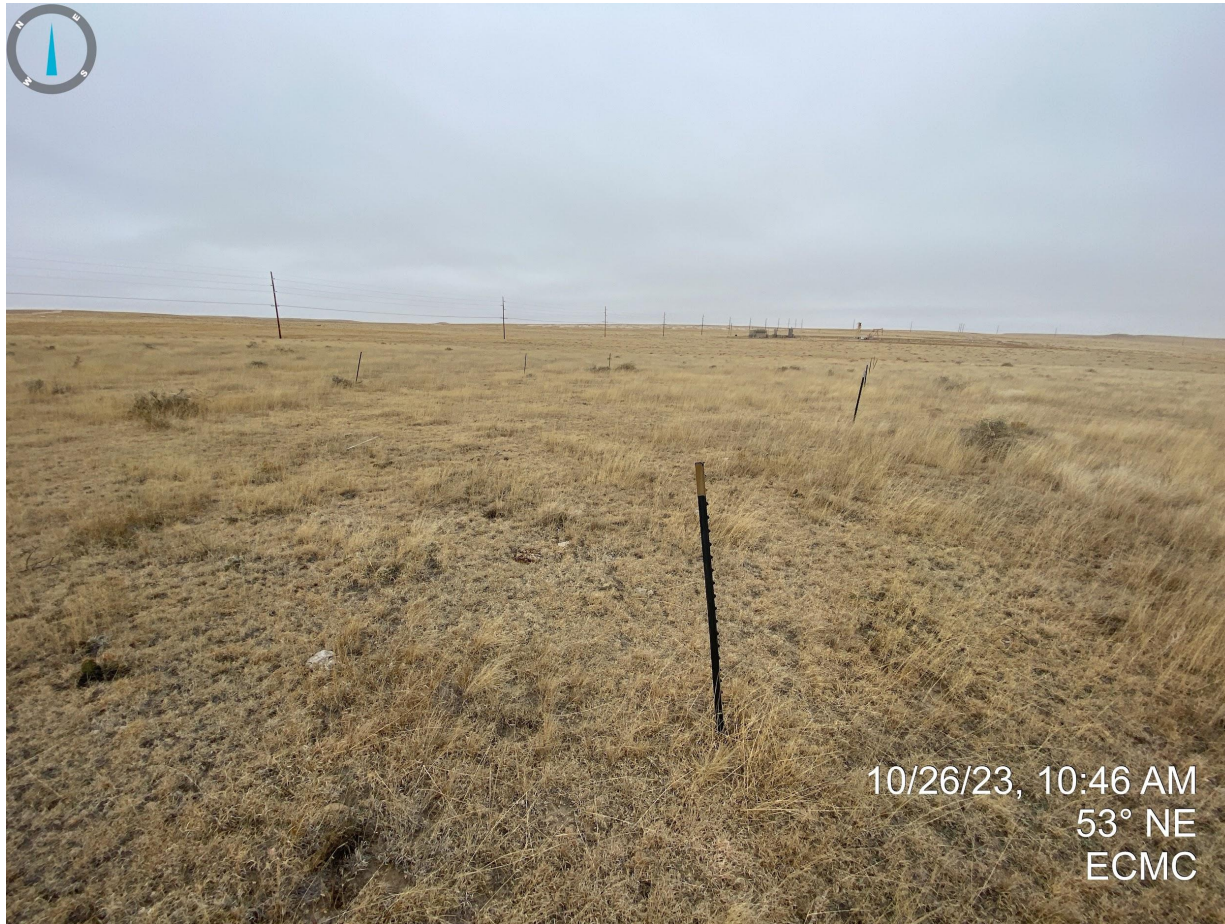
Photo 2. See comments in Photo 1.
