Final Reclamation and Stormwater Inspection

Operator: WHITING OIL & GAS CORPORATION - 96155

Location ID: 435875

Inspection Photos
Location Name: Horsetail 29E Pad
Location ID: 435875

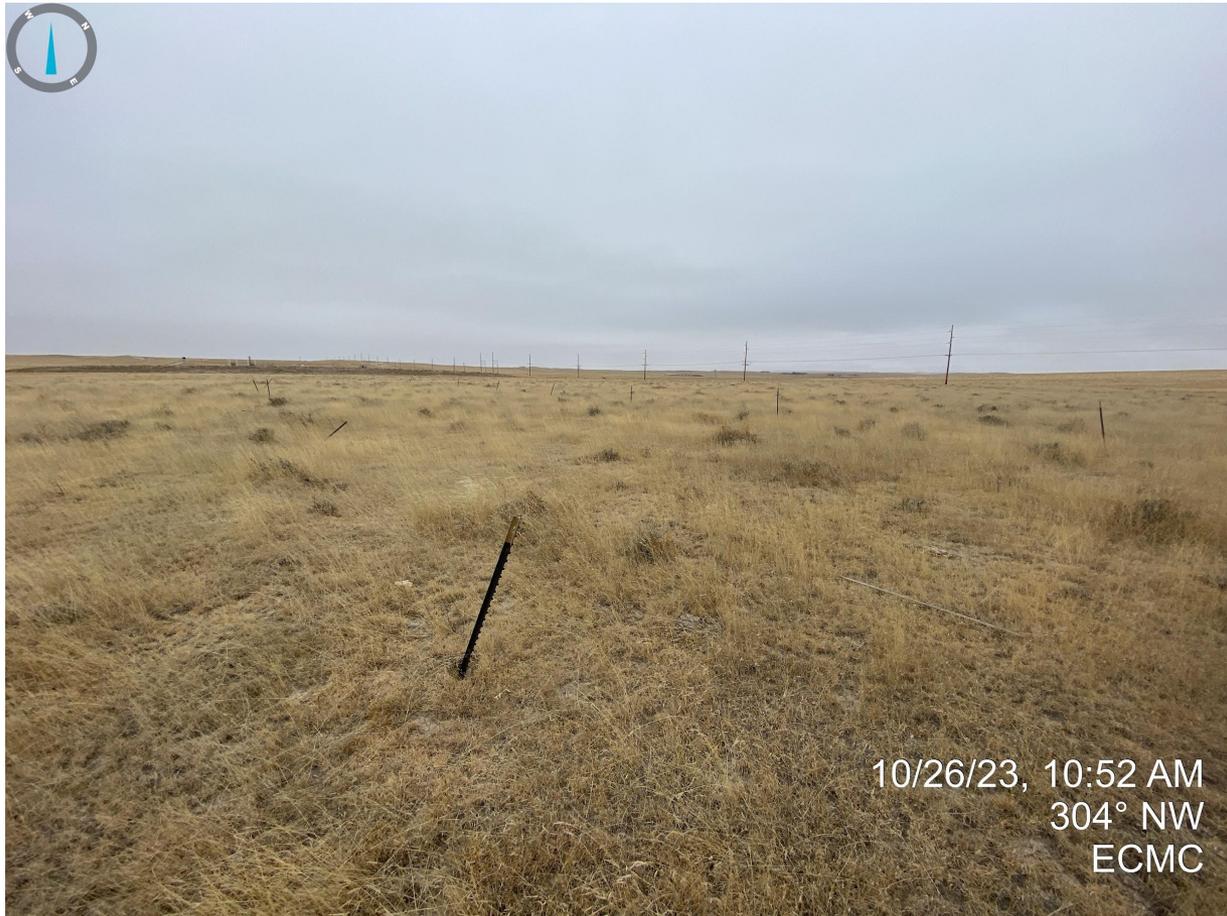
Photo 1. This location does not comply with Rule 1004. Operator submitted Form 4 Sundry Notices stating the above wells were not drilled. Location was not constructed at the proposed well location based off field observations. However, during this inspection, Staff observed that t-posts and wooden stakes remain on location, which is now considered debris, and will need to be removed in order to meet Rule 1004 standards.

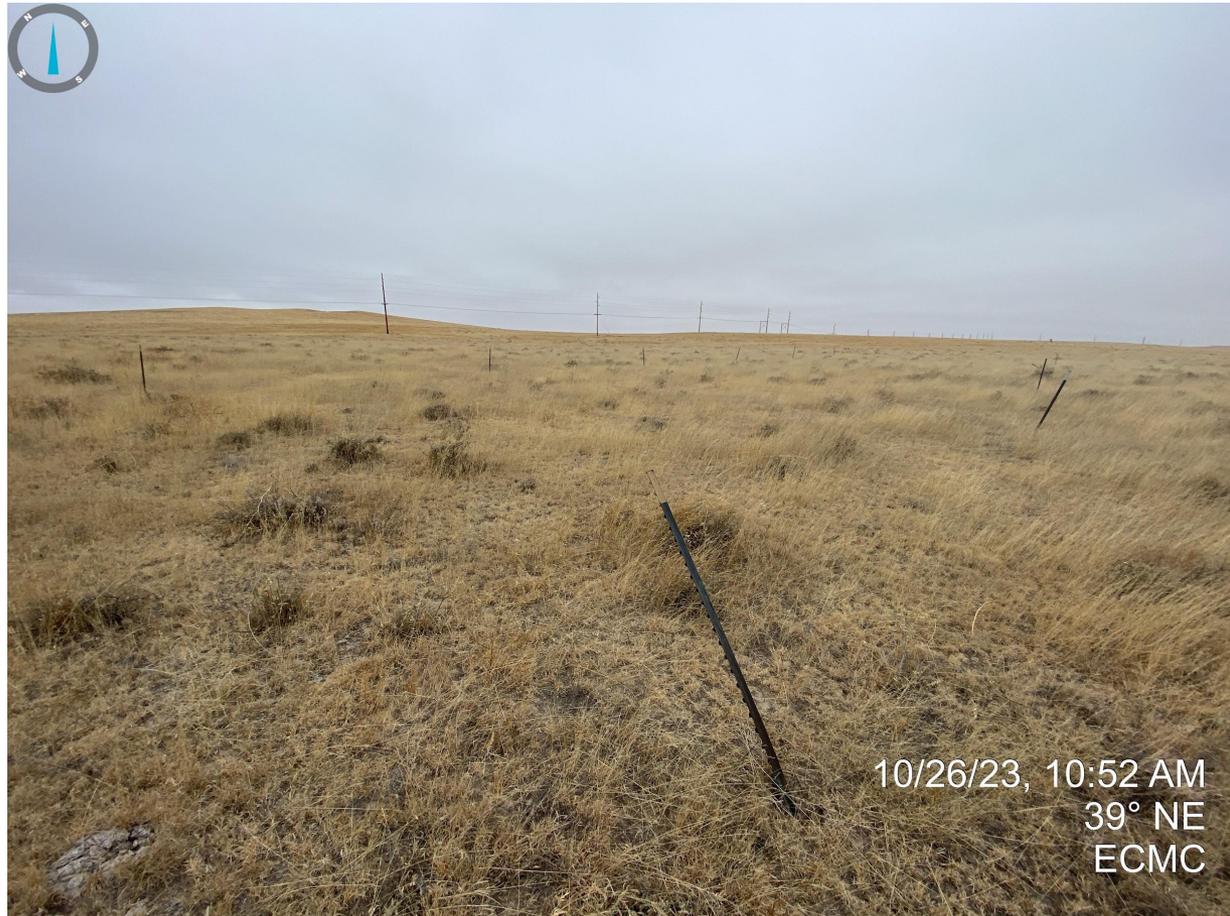
Photo 2. See comments in Photo 1.
