APACHE CANYON 20-11 API# 05-071-09868 – OGRIS OPERATING
COGCC OPERATOR NUMBER 10758 - DATE: NOVEMBER 17, 2023
CORRECTIVE ACTIONS COMPLETED REGARDING COGCC FIR DOCUMENT #695108681

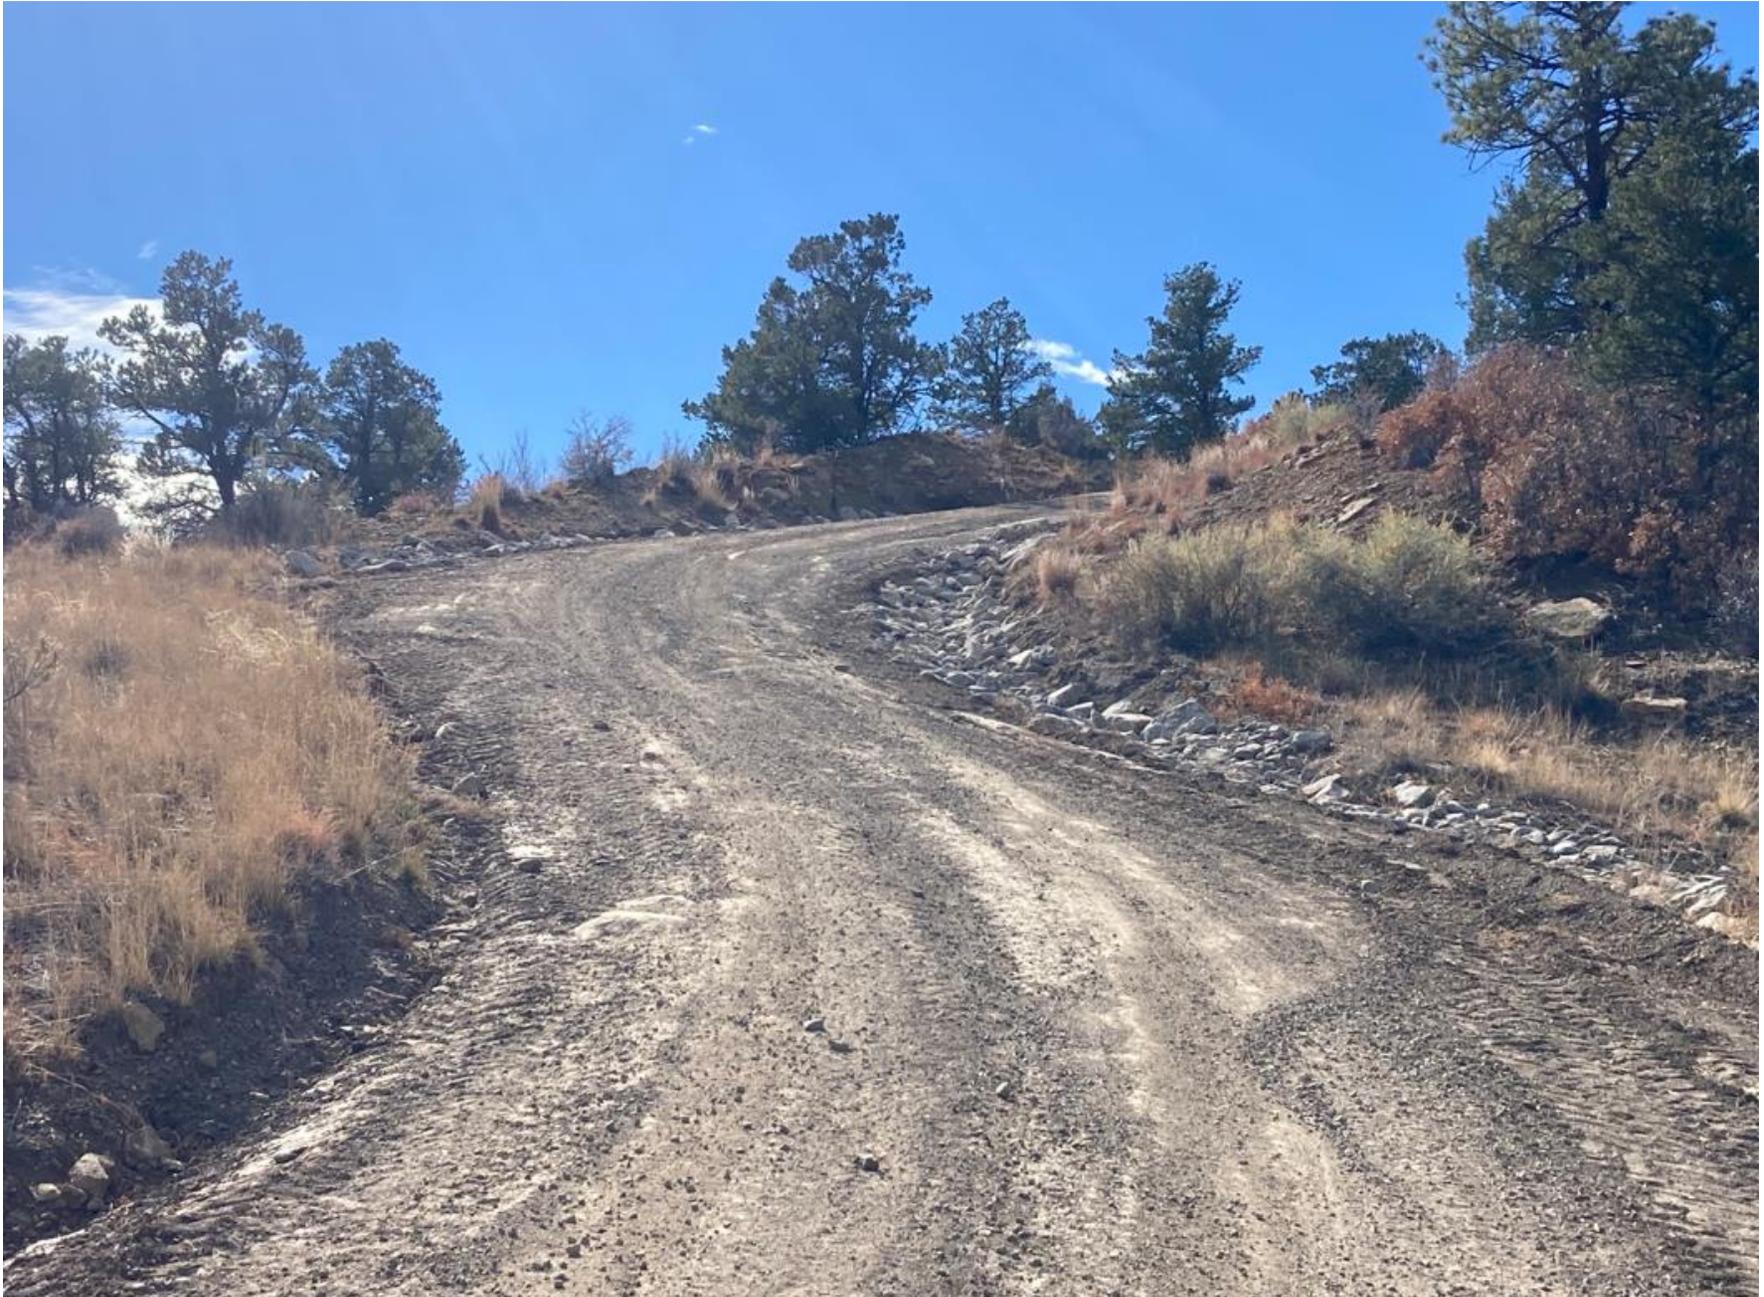
PHOTO 1: THE MAIN ACCESS ROAD LEADING TO LOCATION HAS BEEN BLADED AND CROWNED TO DIRECT STORMWATER TO THE ROCKED DIVERSION DITCHES. TURN OUTS WERE ALSO ESTABLISHED.

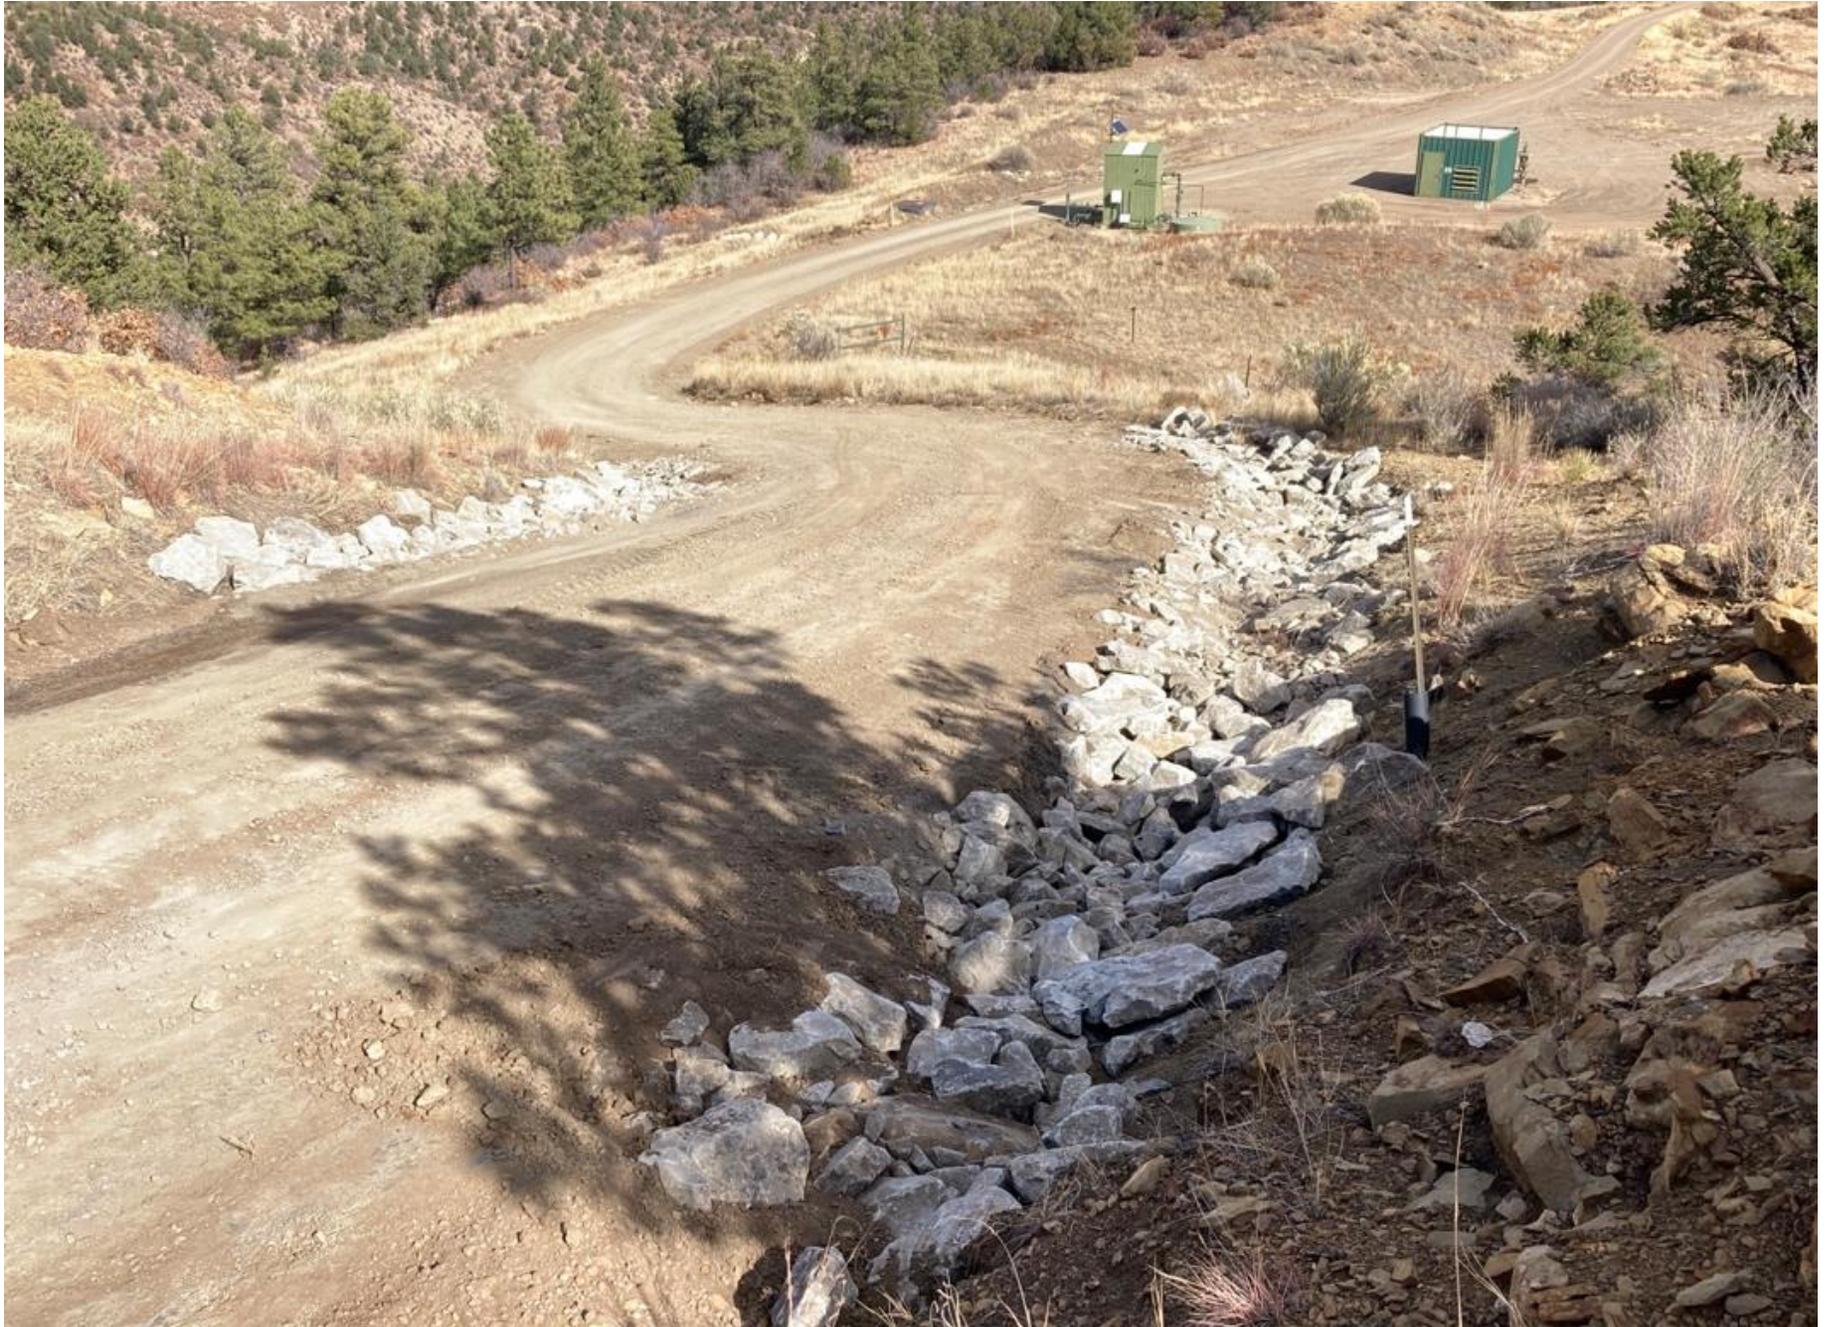
PHOTO 2: THE ROCKED DIVERSION DITCHES ALONG SIDE THE MAIN ACCESS ROAD LEADING TO LOCATION.

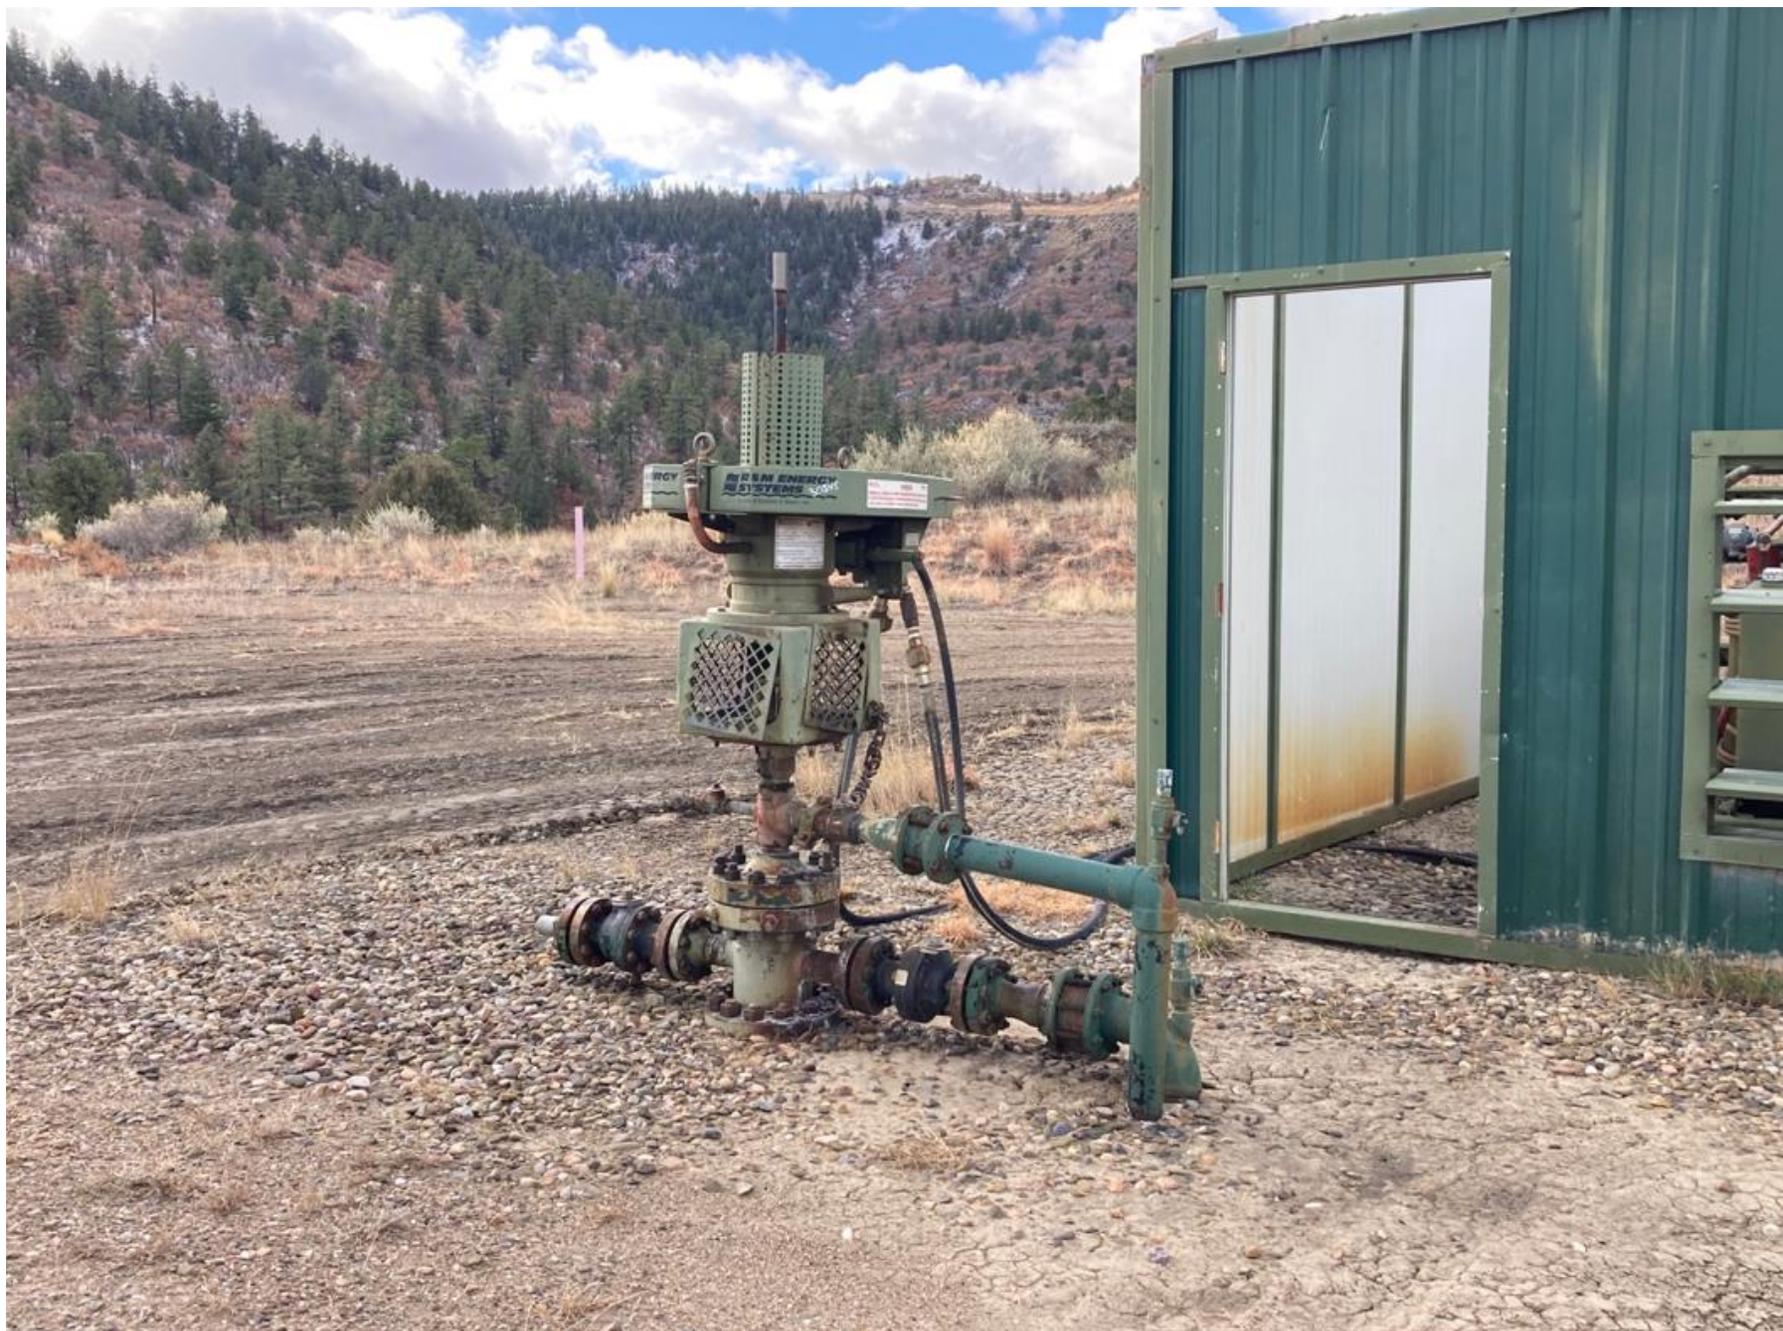
PHOTO 3: THE WATER LEAK AT THE WELL HEAD WAS STOPPED IMMEDIATELY AND MECHANICAL MAINTENANCE WAS PERFORMED. THE STAINED SOIL WAS REMOVED FROM LOCATION AND FRESH GRAVEL ADDED TO THE WELL PAD. THE SELF INSPECTION PROCESS HAS BEEN REVIEWED.
