Sam Burch 30 Figure 1 Site Map

ENDURING
RESOURCES, LLC

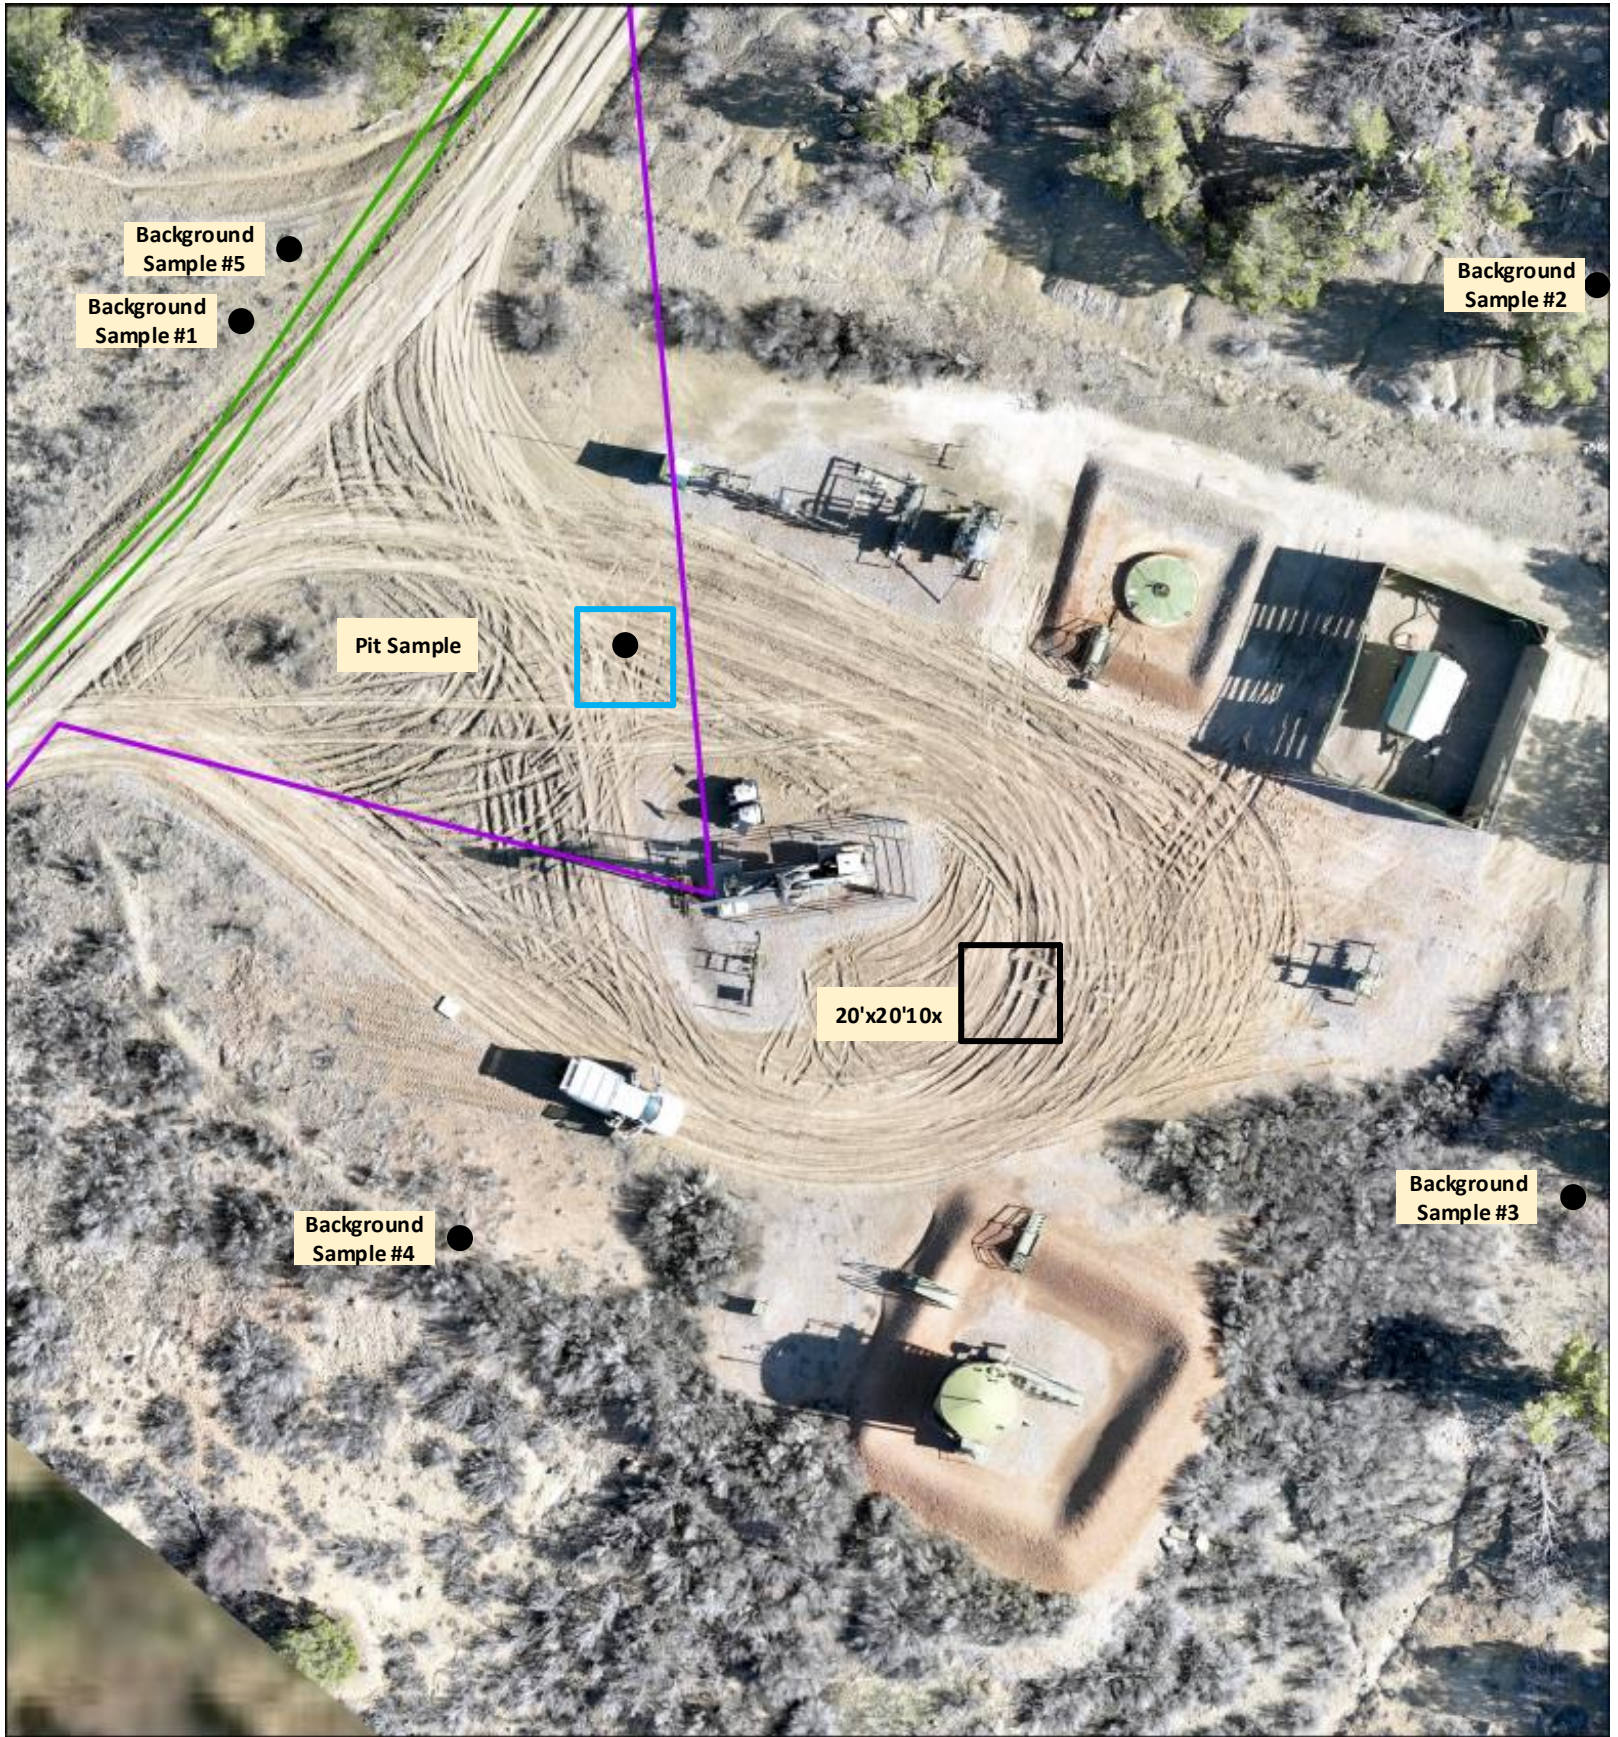
Please Note:
Based on site topography and field evidence, the pit was determined to have existed at coordinates that differ from the COGIS database coordinates. A Form 15 fill will be submitted to rectify the discrepancy between the database and field conditions
