Final Reclamation and Stormwater Inspection

Operator: Noble Energy Inc. - 100322

Location ID: 328396

Inspection Photos
Location Name: Duncan D 11-13
Location ID: 328396

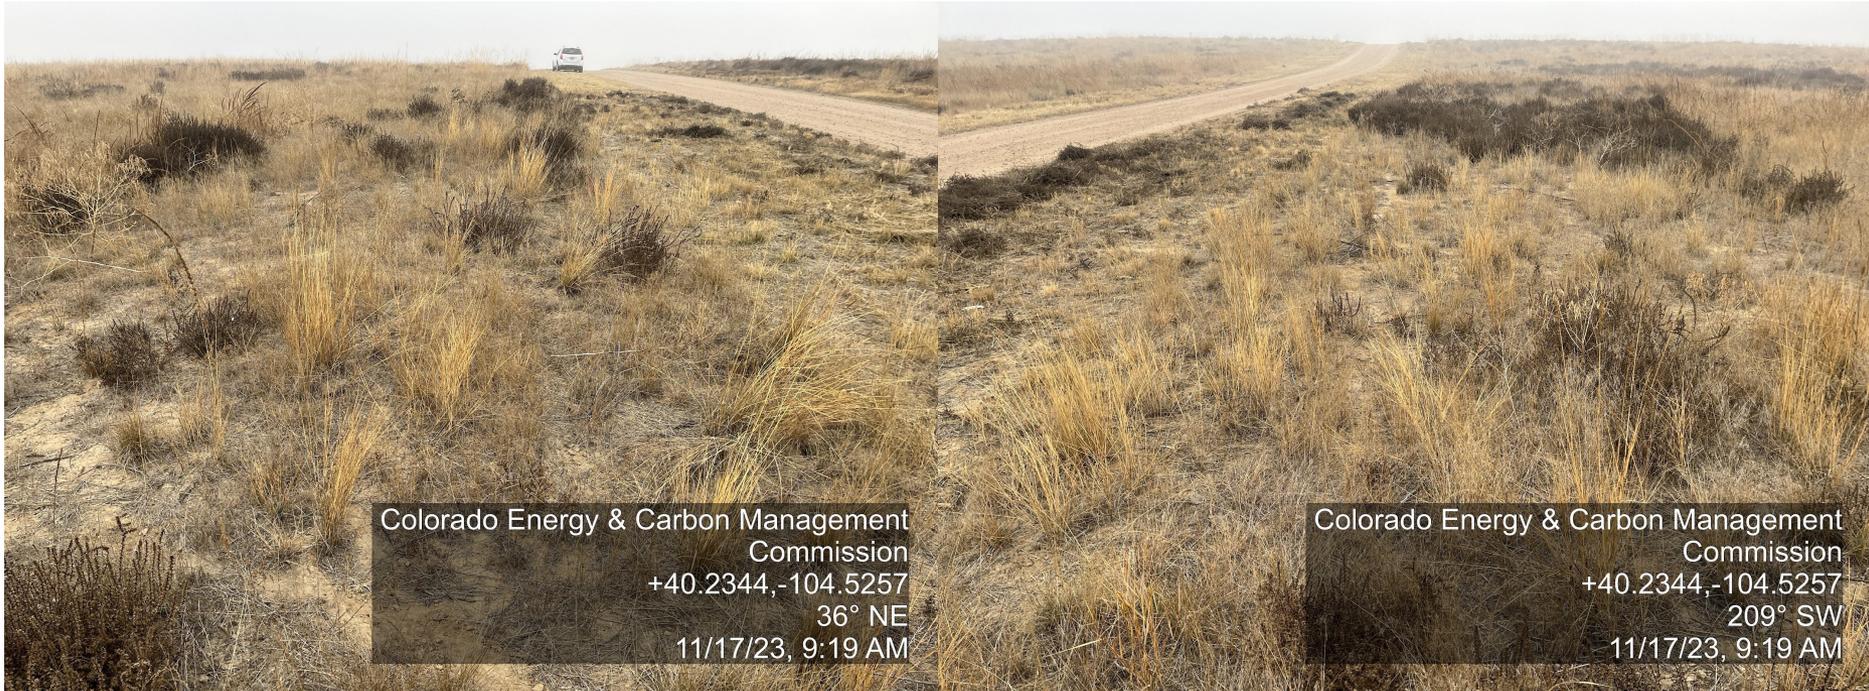
Photo 1. The photo was taken at the well location facing Northeast. The photo illustrates the well location is dominated by cheatgrass and russian thistle.

Photo 2. The photo was taken at the well location facing Southwest. Refer to the comment for photo 1.

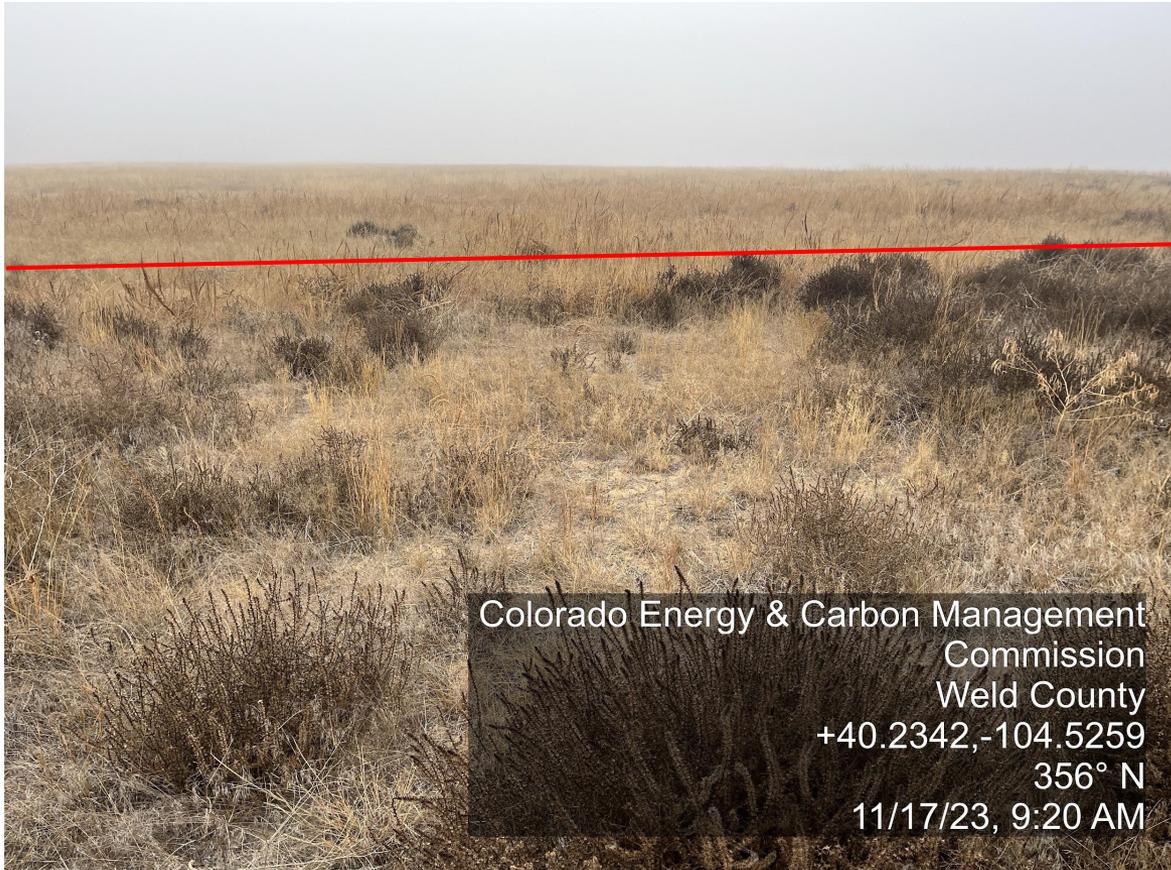
Photo 3. The photo was taken at the well location facing North. The photo illustrates russian thistle and cheatgrass dominate to the edge of the disturbance where blue grama is more dominant.
