Operator: BONANZA CREEK ENERGY OPERATING COMPANY LLC

Location Name: PRONGHORN-65N61W 4NWNE

Loc ID: 306061

Inspection: 713900047

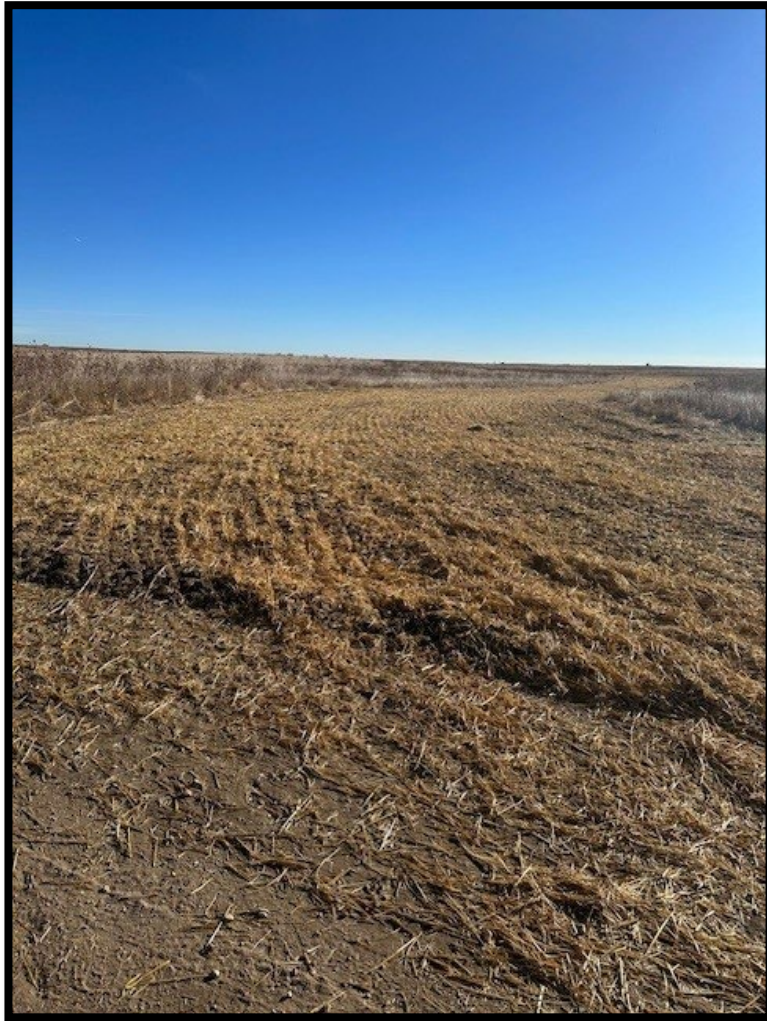
Exhibit A

CA: This location does not comply with Rule 1004. Reclamation rules require reclamation activities to be conducted within twelve months of plugging on non-cropland. Well was plugged 12/05/2018. It does not appear reclamation work has been successful; gravel remains throughout the location; weedy, annual vegetation was observed which includes but not limited to cereal rye, Russian thistle and lovegrass. Comply with Rule 1004. Reseed disturbance areas using a seed mixture requested by the surface owner, or a mixture prescribed by the local county NRCS. Establish vegetation with total perennial, non-invasive uniform plant cover of at least eighty (80) percent of reference area levels. Ensure erosion controls are implemented to stabilize the seeded soil. Operator shall continue to monitor and manage this site until the location meets Rule 1004 standards, including stormwater and weed management.

CA Resolution: Operator has reported that the location has been mowed, recontoured, and reseeded to comply with Rule 1004 regarding reclamation.
