Operator: BONANZA CREEK ENERGY OPERATING COMPANY LLC

Location Name: ANTELOPE C-33

Inspection: 713900099

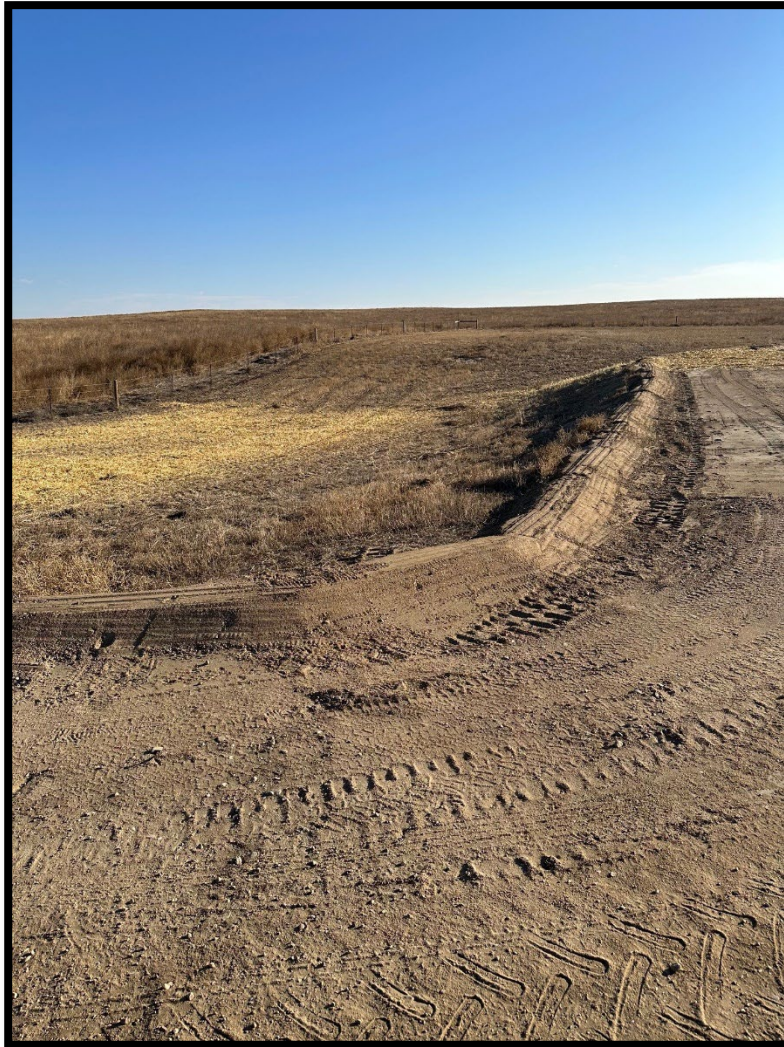
Exhibit A

CA: Weed debris in the form of tumbleweeds were observed in each perimeter fence corner and in other areas around the location. Tumbleweeds are a troublesome annual nonnative weed that easily breaks off at the stem. Operator failed to control and manage weeds to prevent weed waste and prevent the spread of seeds onto adjacent lands. Comply with Rule 606 to remove weed debris.

CA Resolution: Operator has addressed and cleared weed debris and mowed location to comply with Rule 606.

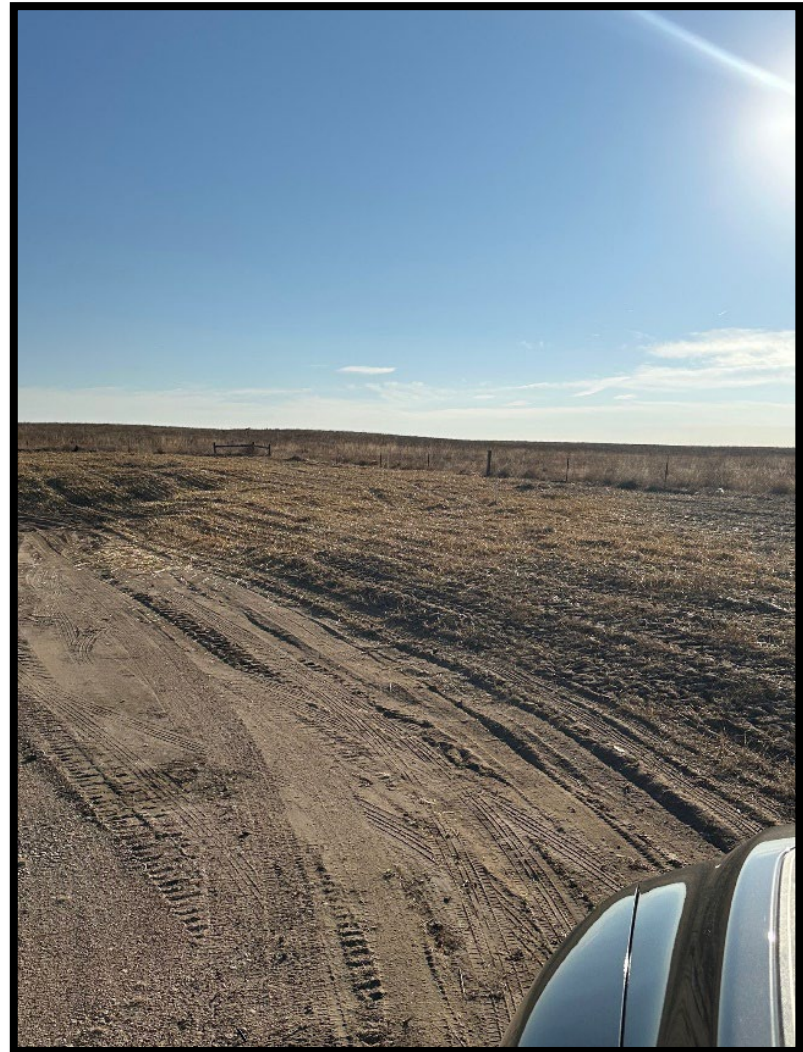
Exhibit B

CA: Interim reclamation activities have been performed to reduce disturbance areas only needed for production operations. Vegetation throughout the interim areas was mowed and had accumulation of tumbleweeds across the location so it has not met Rule 1003 standards.

CA Resolution: Operator has reported that identified areas have been crimped to help prevent regrowth of undesirable vegetation and bare areas have been reseeded.
