Final Reclamation and Stormwater Inspection

Operator: Noble Energy Inc. - 100322

Location ID: 328233

Inspection Photos
Location Name: Jurgens B8-16
Location ID: 328233

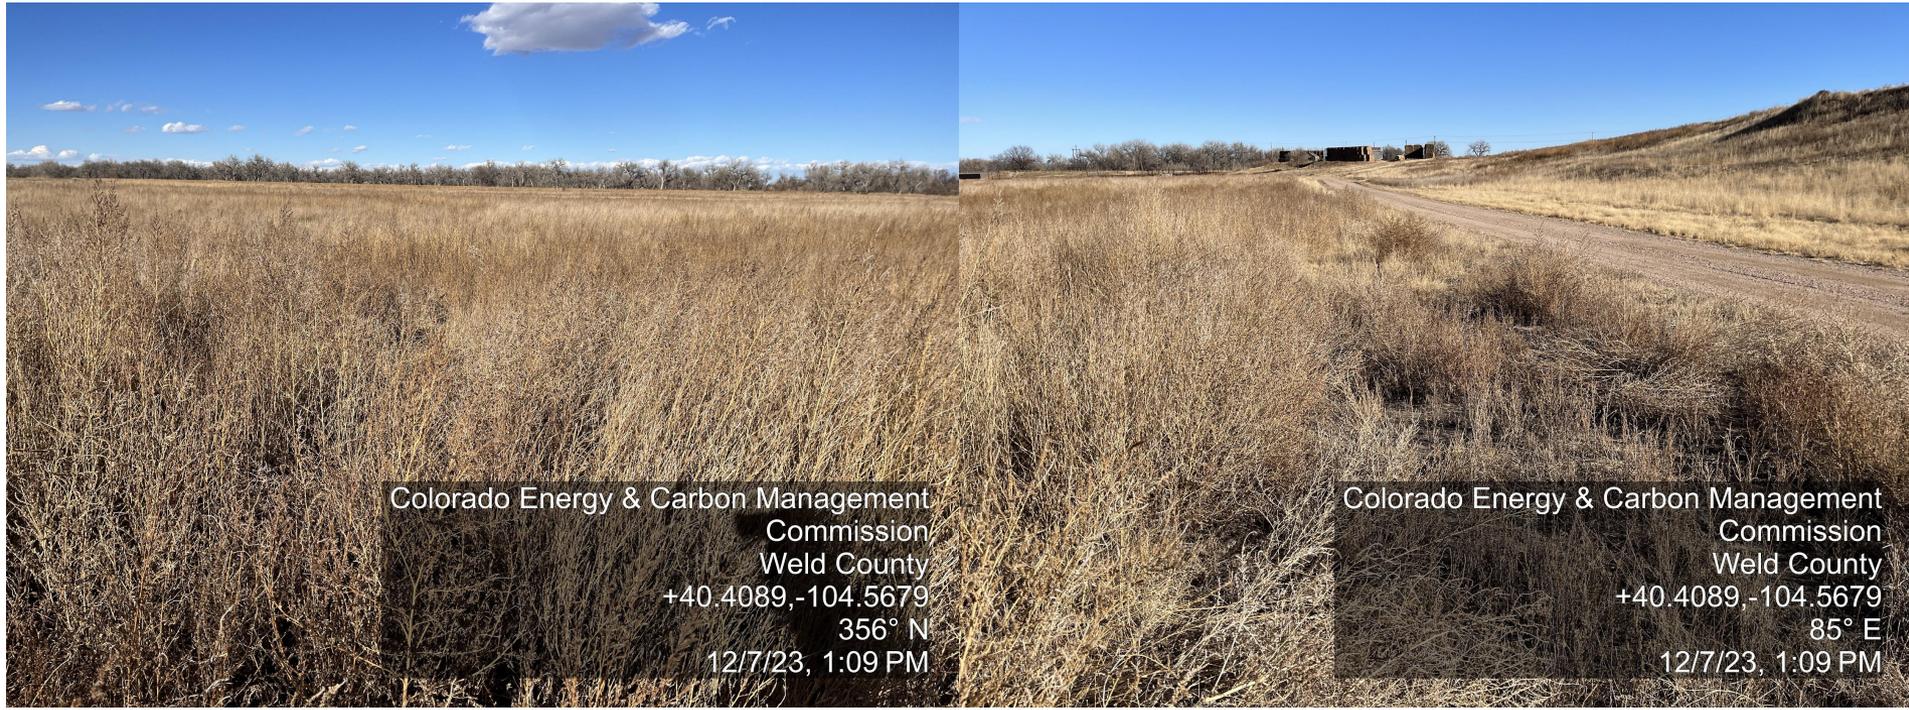
Photo 1. The photo was taken at the well location facing North. The photo illustrates the entire location is dominated by kochia.

Photo 2. The photo was taken at the well location facing East. Refer to the comment for photo 1.

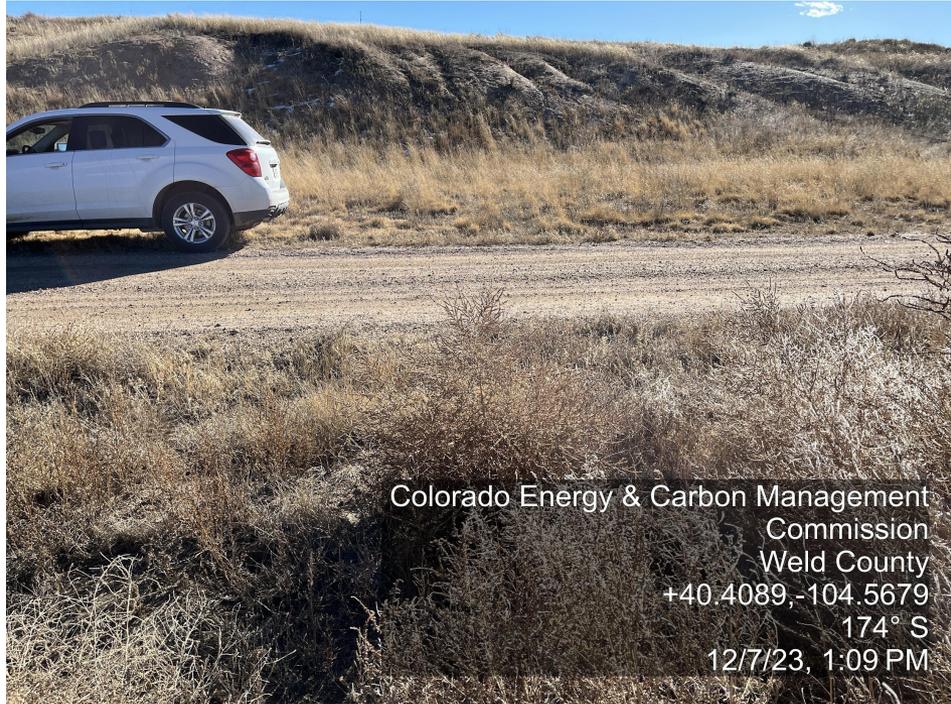
Photo 3. The photo was taken at the well location facing South. Refer to the comment for photo 1.

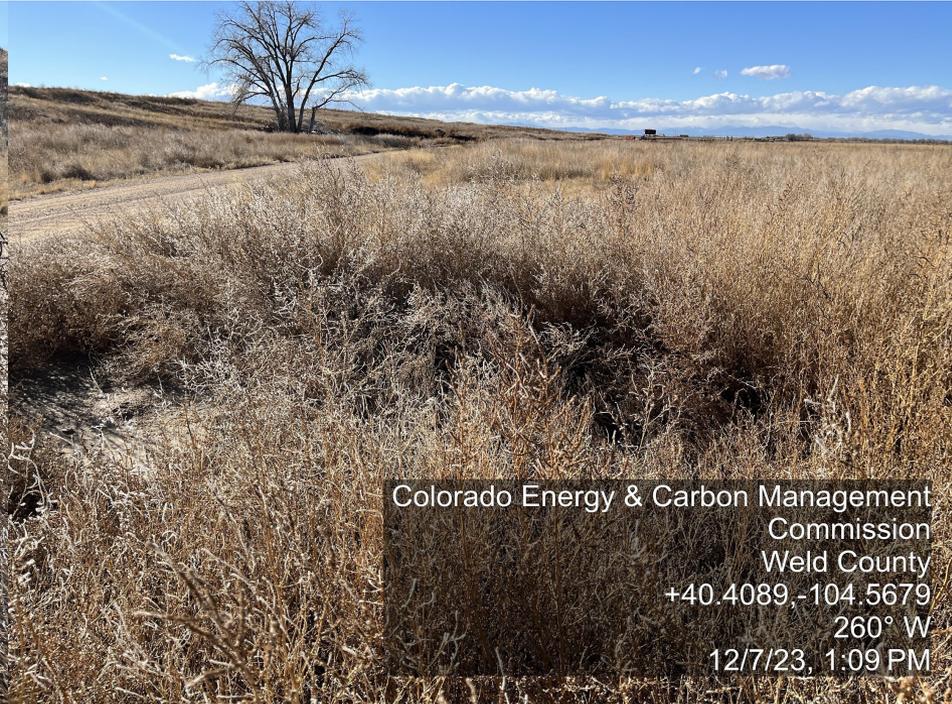
Photo 4. The photo was taken at the well location facing West. Refer to the comment for photo 1.

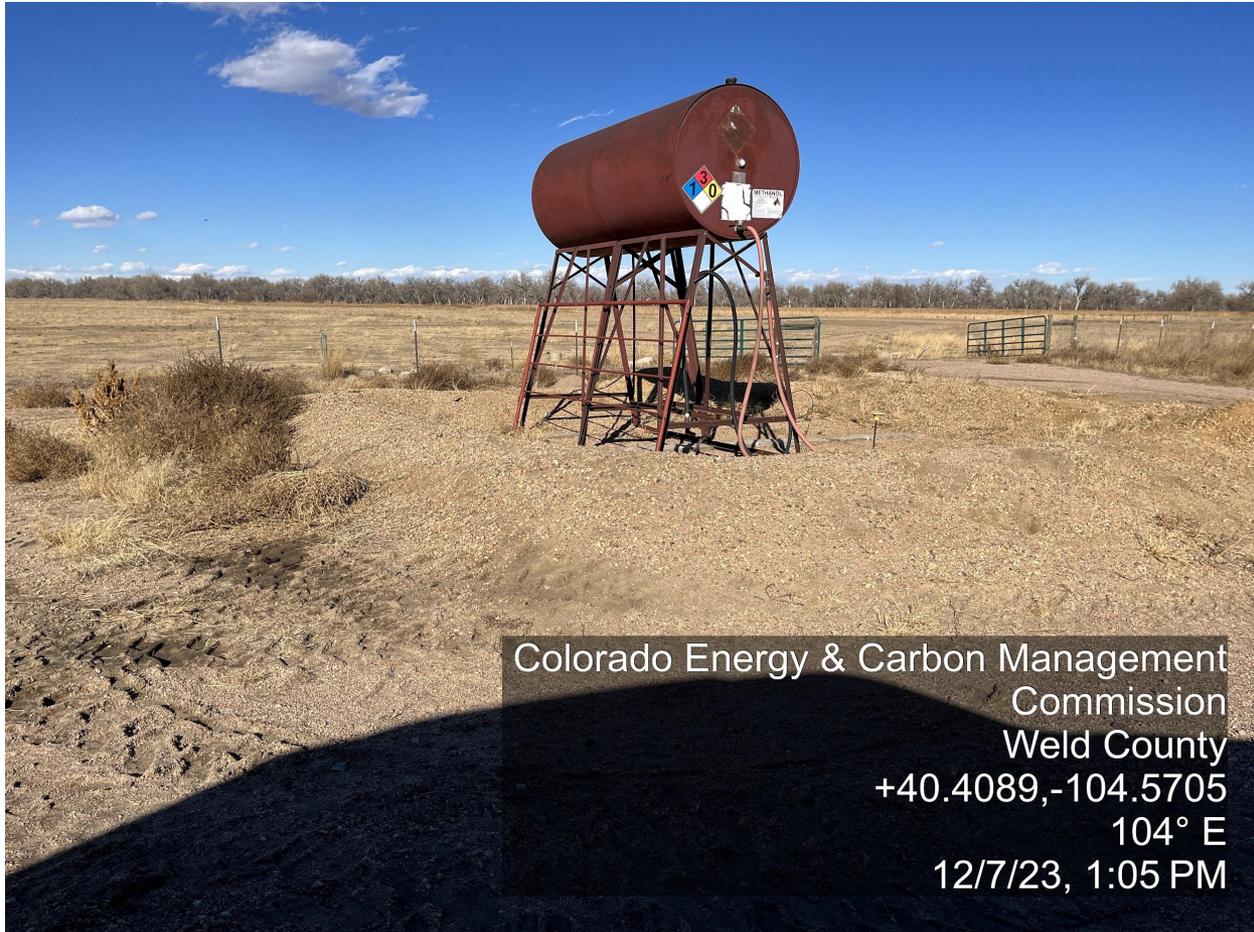
Photo 5. The photo was taken at the tank battery location facing East. It appears the one methanol tank is the surface owners and berm still remain and bare soil dominates.
