Final Reclamation and Stormwater Inspection

Operator: Kerr McGee Oil & Gas Onshore LP - 47120

Location ID: 329147

Location Name: Fort Saint Vrain 30

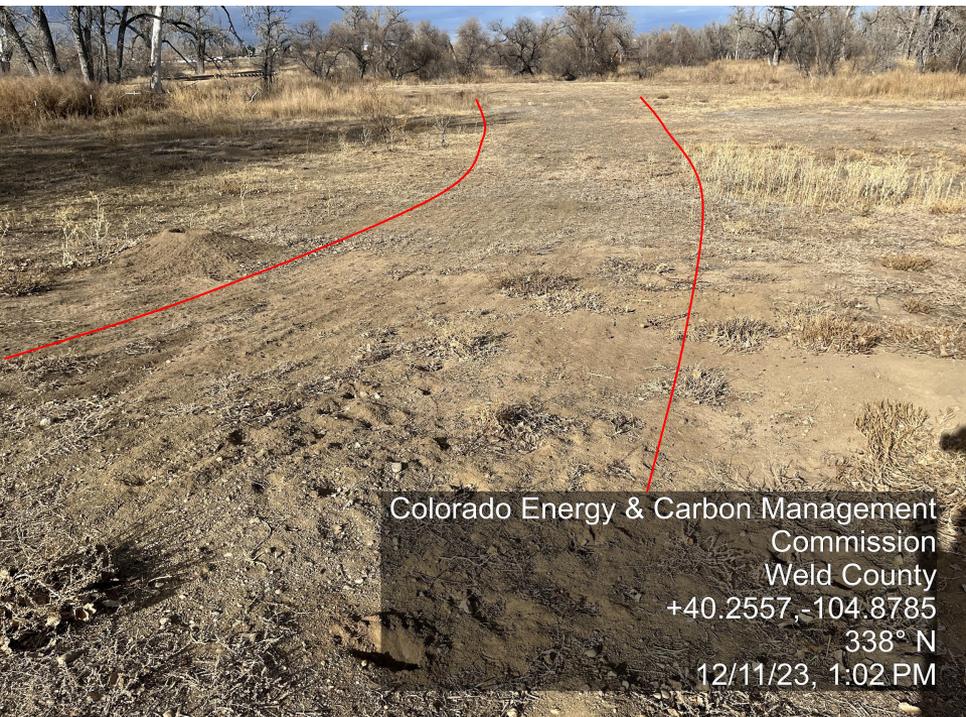
Photo 1. The photo was taken from the well location entrance facing North. The photo illustrates the access road appears to have been seeded with evidence of seeding rows.

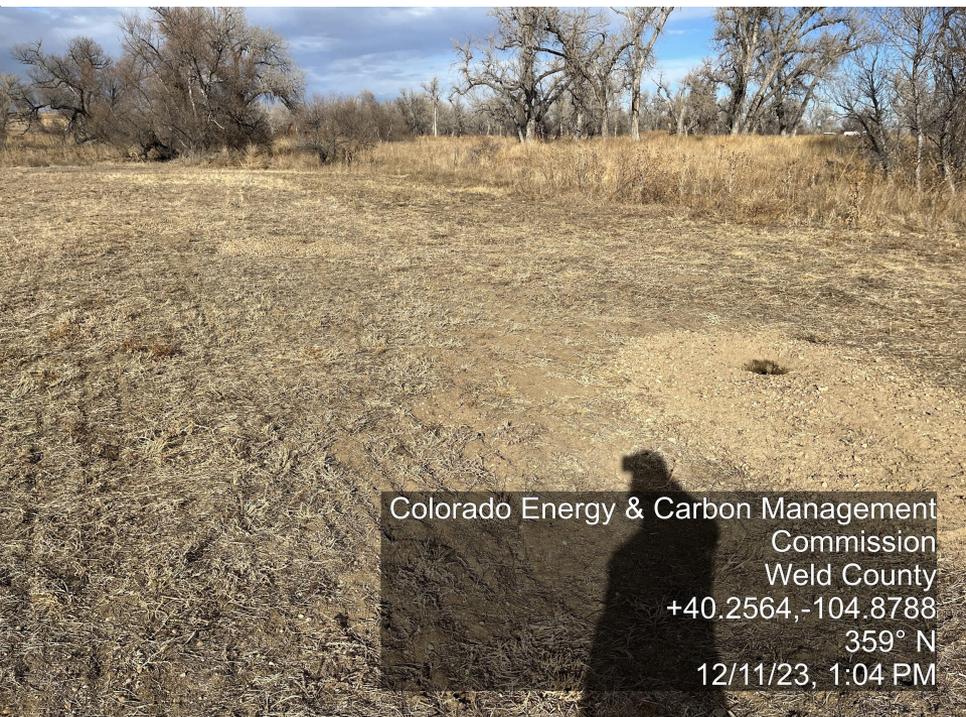
Photo 2. The photo was taken from the well location facing North. The photo illustrates the former pad has been mowed and appears to have been seeded although is still growing undesirables. The photo also illustrates that a prairie dog town is located on site and has pulled up road mix.

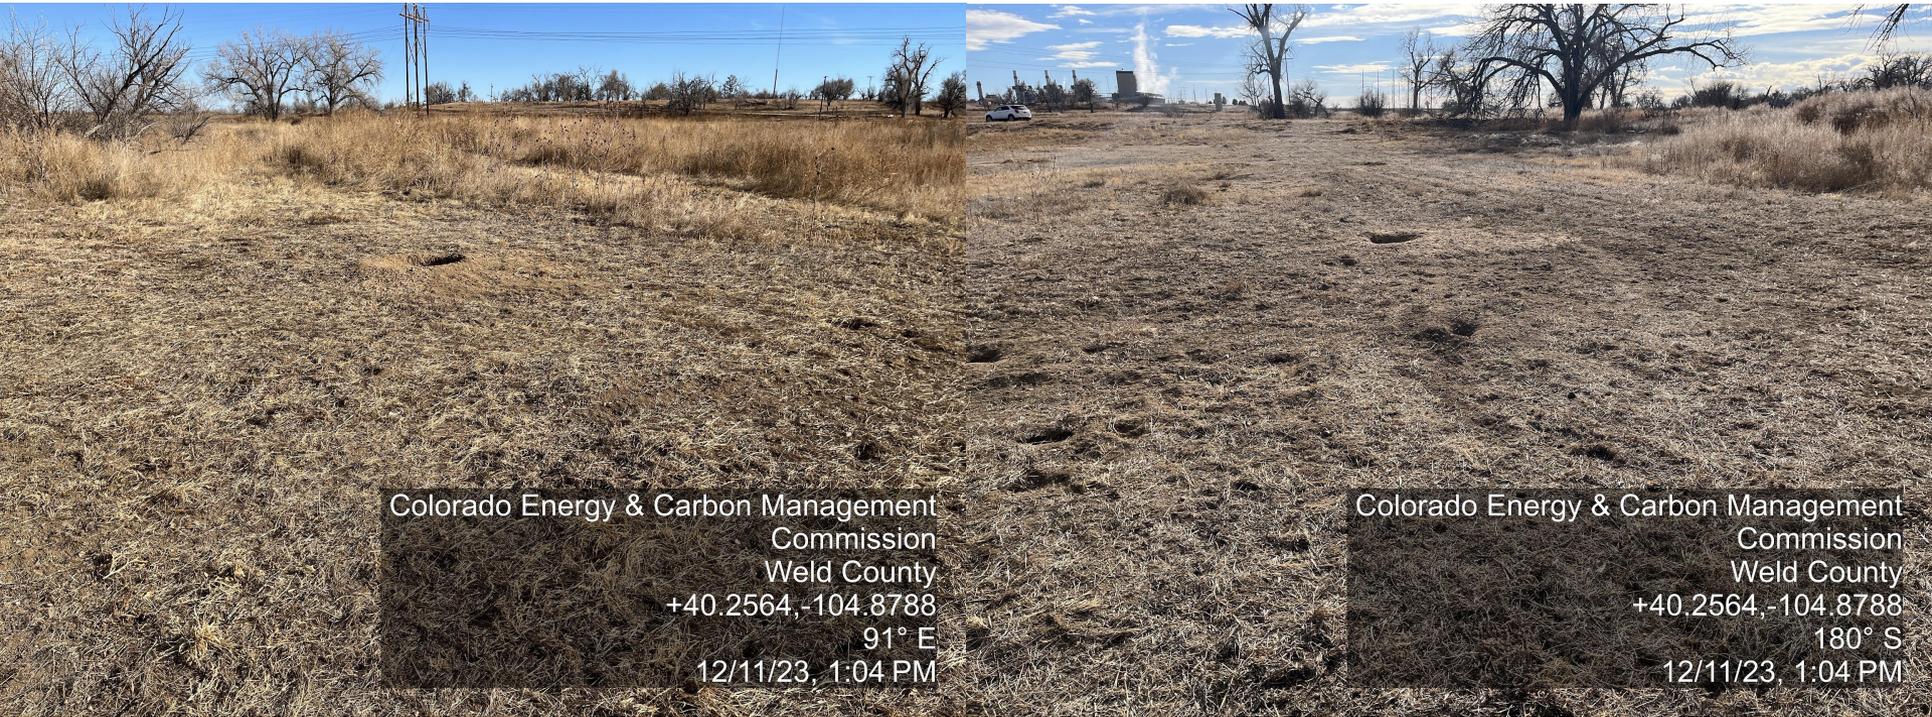
Colorado Energy & Carbon Management
Commission
Weld County
+40.2564, -104.8788
91° E
12/11/23, 1:04 PM

Photo 3. The photo was taken from the well location facing East. Refer to the comment for photo 2.

Photo 4. The photo was taken from the well location facing South. Refer to the comment for photo 2.

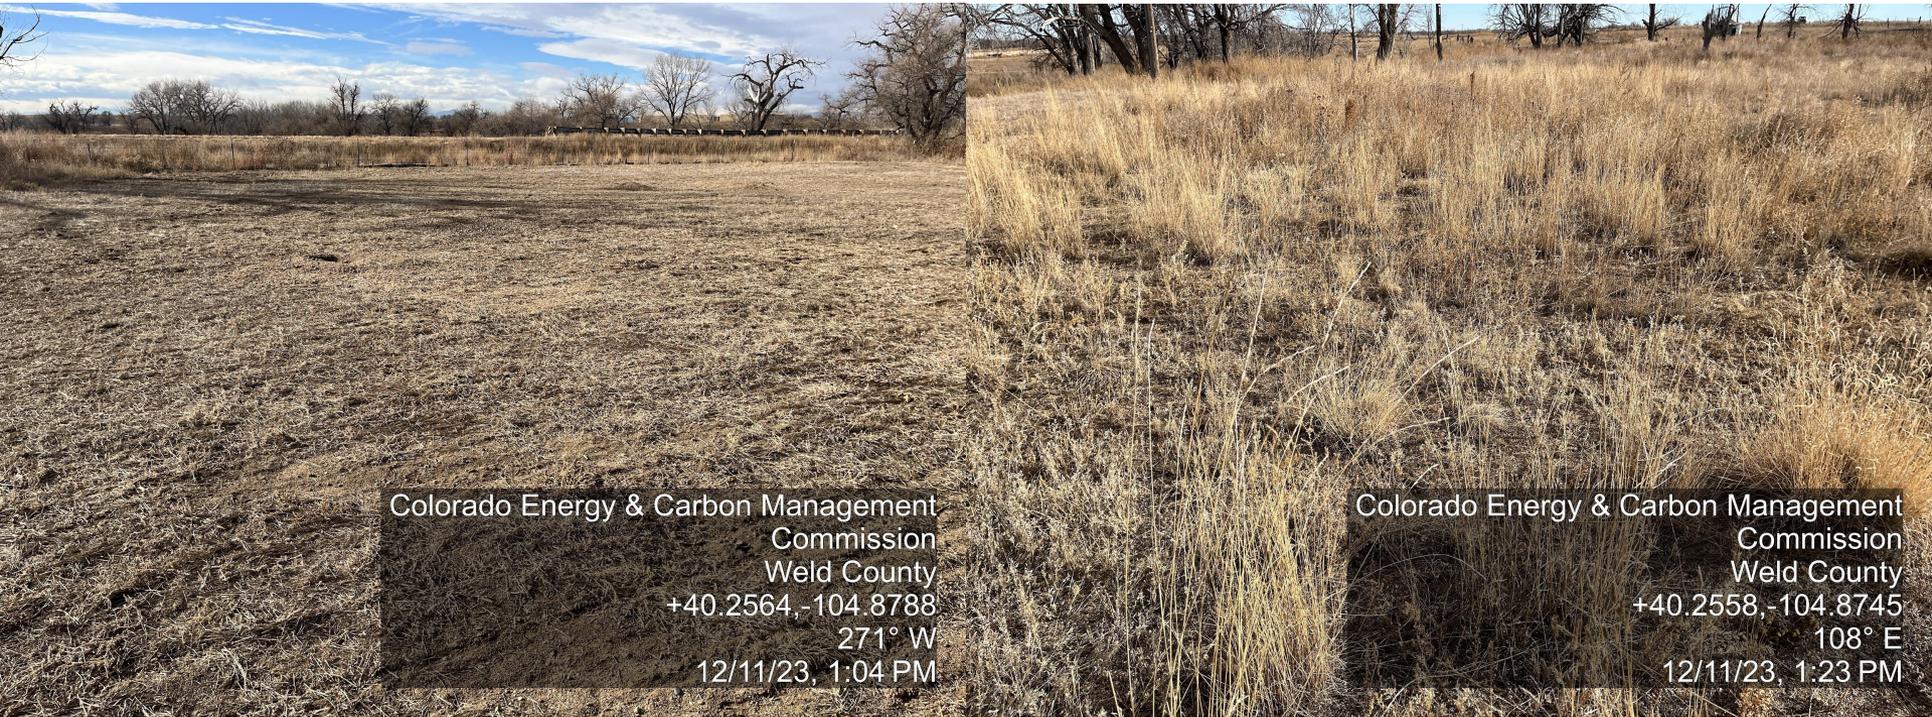
Photo 5. The photo was taken from the well location facing West. Refer to the comment for photo 2.

Photo 6. The reference photo was taken from near the well location facing East.

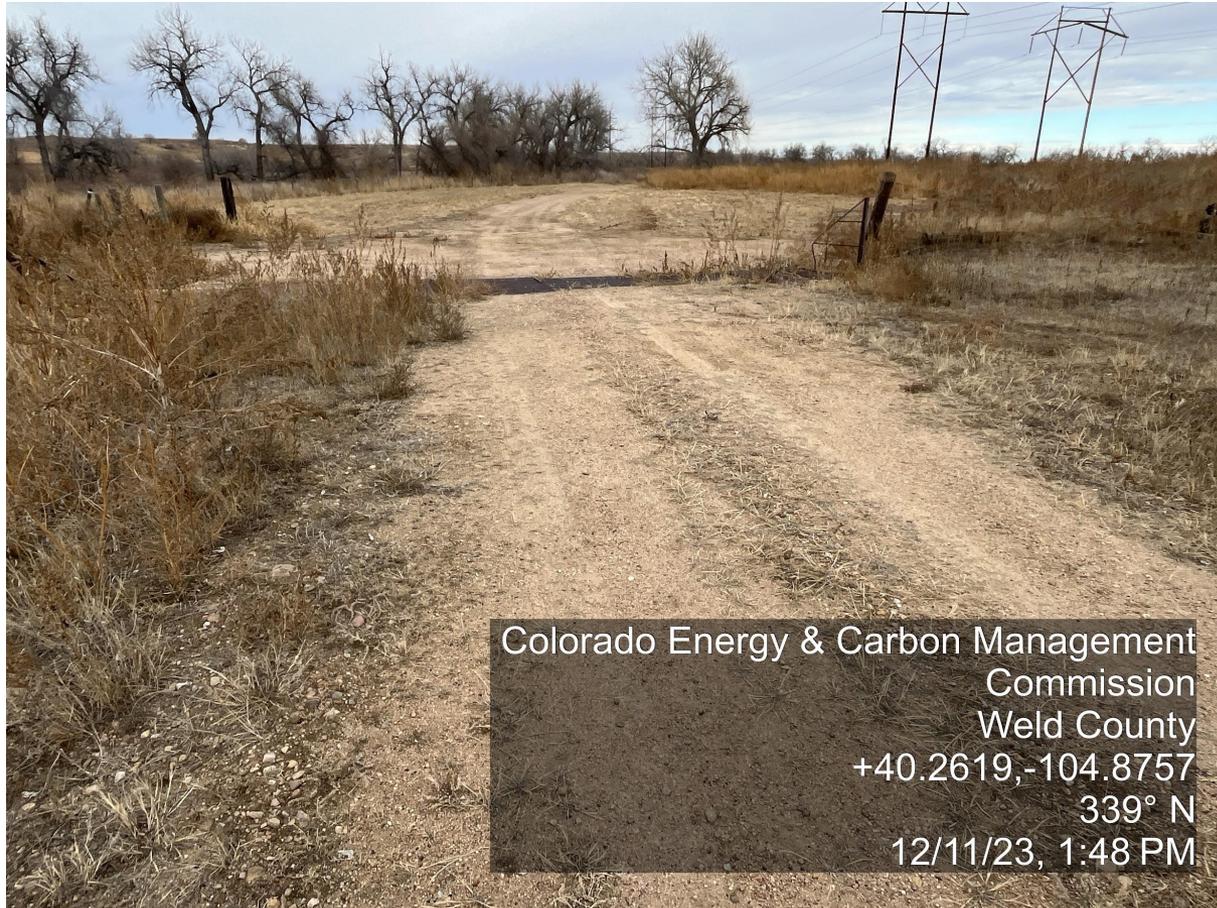
Photo 6. The photo was taken from the tank battery location entrance facing North. The photo illustrates the tank battery location road is still intact and the area has been mowed and dominated by undesirables.
