VESSELS 12-30 (05-123-23987): Wellhead Cut/Cap

Crestone Peak Resources (10633)

VESSELS 12-30 (12323987_FL): Off-Location Flowline Decommission

VESSELS 12-30 (05-123-23987): ¼ Mile Buffer - Wildlife and Hydrology Map

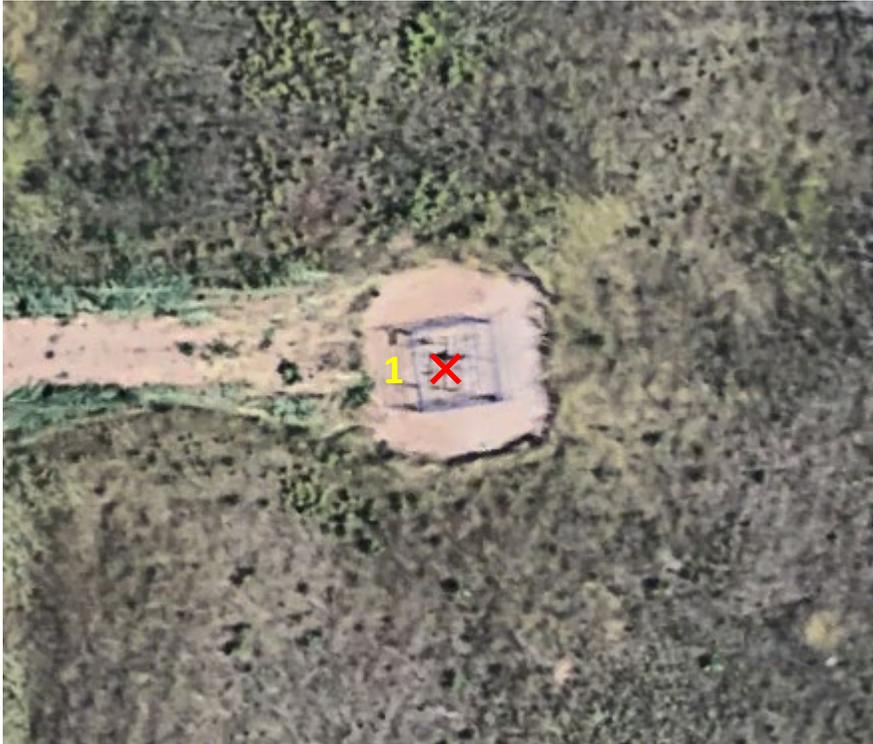
Equipment to be Removed		
Legend	Equipment On-Site	# Pieces of Equipment
1	VESSELS 12-30 (05-123-23987) 40.023780, -105.052373	1

Legend
Site Investigation Points

X Visual Inspection and Soil Sample

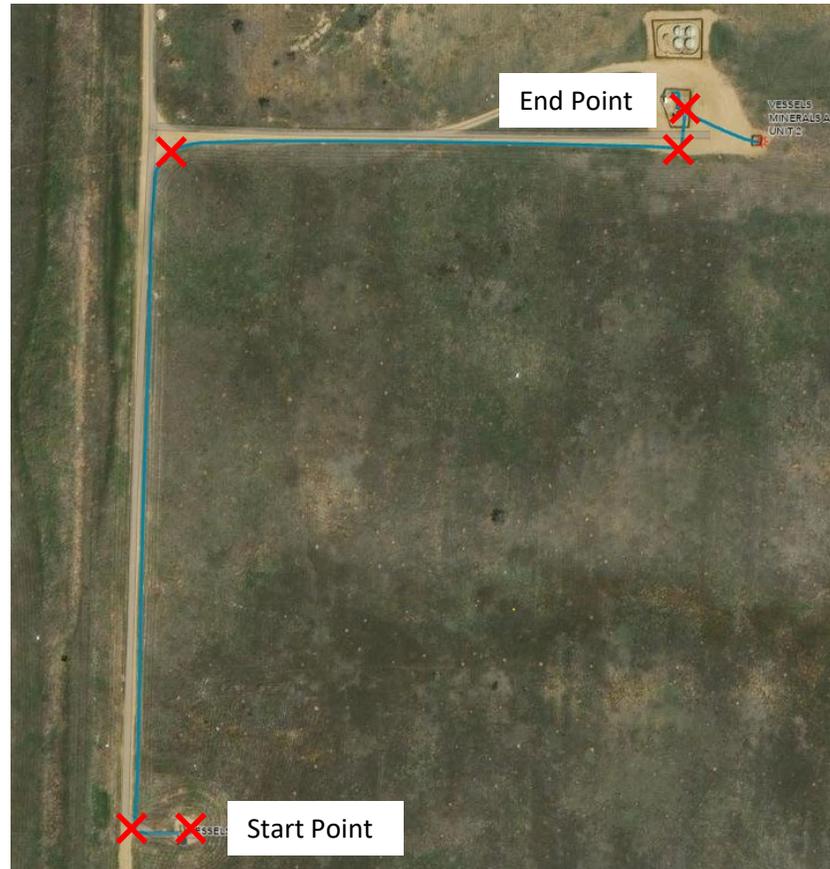
Flowline Unique OperFeatID	Line Type	Start Location	Start Location Latitude	Start Location Longitude	End Location	End Location Latitude (Cut Point)	End Location Longitude (Cut Point)	Approx. Length to Abandon (ft)
12323987_FL	Multiphase	Wellhead	40.023780	-105.052373	Separator	40.026373	-105.050046	1670

Site Investigation Points

✘ Visual Inspection and Soil Sample

Potholes will be dug every 250 feet along the flowline path. These observation points will be photographed and field screened. Additional soil samples will be collected when flowline repairs are observed, changes in flow direction, or when there is a change in the flowline material type.
