**Operator: BONANZA CREEK ENERGY OPERATING COMPANY LLC**

**Location Name: North Platte 23-24**

**Loc ID: 310067**

**Inspection: 713900197**

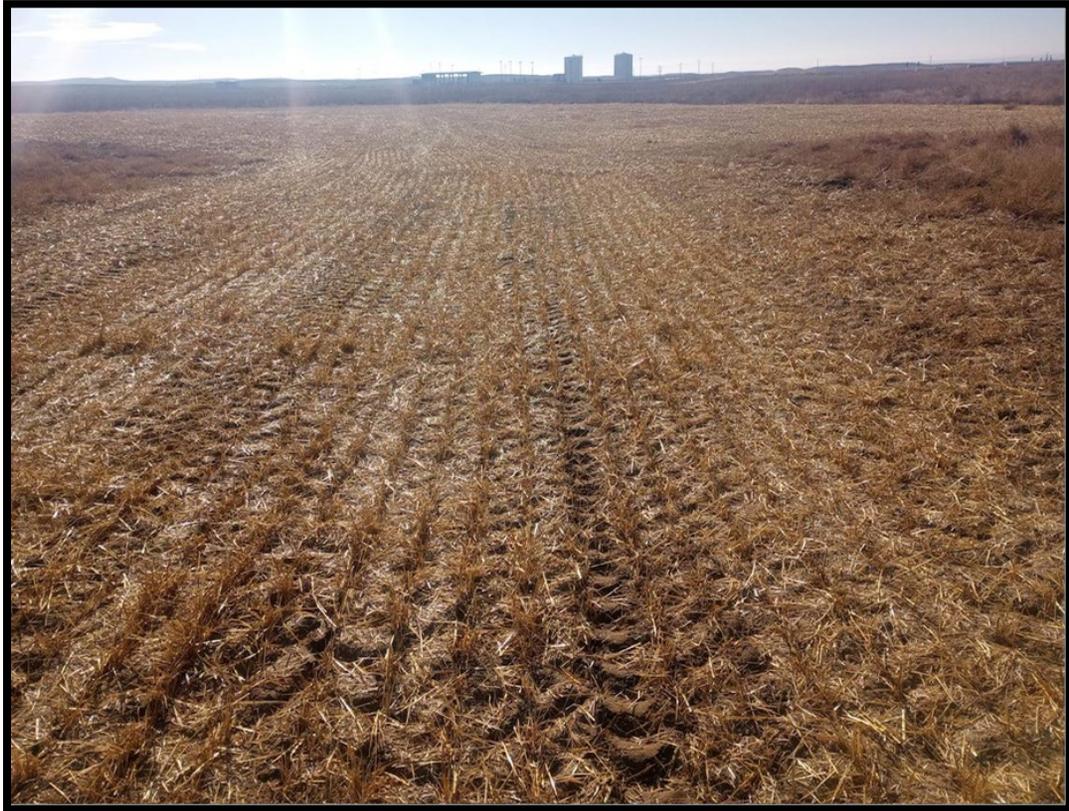
Exhibit A

**CA:** This location does not comply with Rule 1004. Reclamation rules require reclamation activities to be conducted within twelve months of plugging on non-cropland. Well was plugged 06/08/2021. The well location has some evidence of reclamation activities with evidence of few perennial grasses germinating on location. Operator has failed to reclaim the access road and the well location area is dominated by Russian thistle, kochia and bare soil patches. Comply with Rule 1004. Reseed disturbance areas using a seed mixture requested by the surface owner, or a mixture prescribed by the local county NRCS. Establish vegetation with total perennial, non-invasive uniform plant cover of at least eighty (80) percent of reference area levels. Ensure erosion controls are implemented to stabilize the seeded soil. Operator shall continue to monitor and manage this site until the location meets Rule 1004 standards, including stormwater and weed management.

**CA Resolution:** Operator has reported that reclamation activity, including clearing of weeds, reseeding location, and stabilizing with crimped straw to promote vegetation growth, has been completed as of 1/23/2024. Operator has also noted that a small fence has been installed to prevent vehicles from driving on location and disturbing recent work completed. Location is currently in compliance with Rule 1004.
