Operator: CRESTONE PEAK RESOURCES OPERATING LLC

Location Name: Tebo 3/1H

Loc ID: 430346

Inspection: 709400707

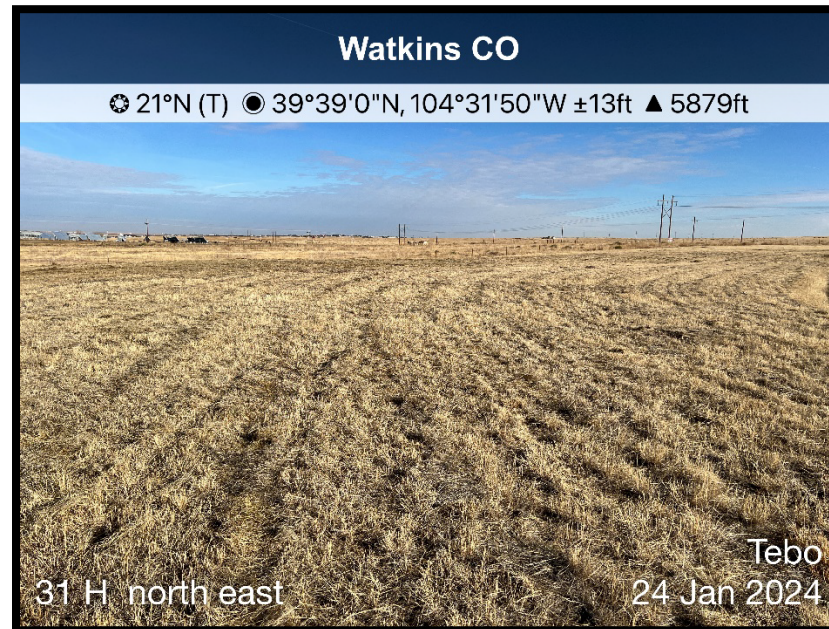
Exhibit A

CA: Failure to control and manage weeds to prevent weed waste and prevent the spread of seeds onto adjacent lands. Comply with Rule 606.c. The corrective date is not intended to be the date for which the Operator shall complete the corrective actions but rather the corrective date the location was observed out of compliance.

CA Resolution: Operator has reported that the identified weeds and weed debris on location has been appropriately addressed and cleared to comply with Rule 606.
