Inspection Photos

Loc: 418695

Operator: **JAVERNICK OIL**

Inspection Date: 1/23/2024

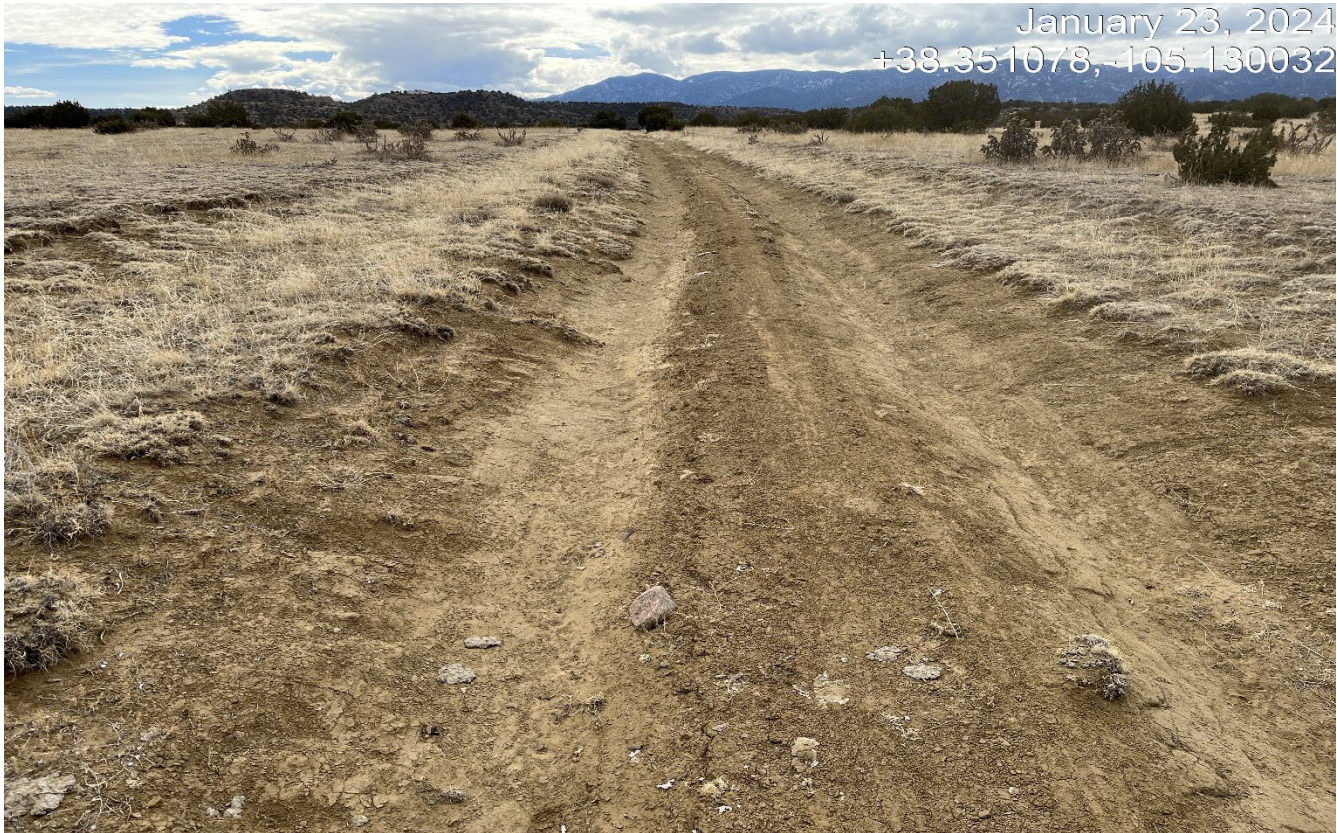
Photo 1. Facing south along the preexisting portion of the road. There is erosion and deep vehicle ruts along the road that have not been repaired and stabilized. Previous corrective action was not performed.

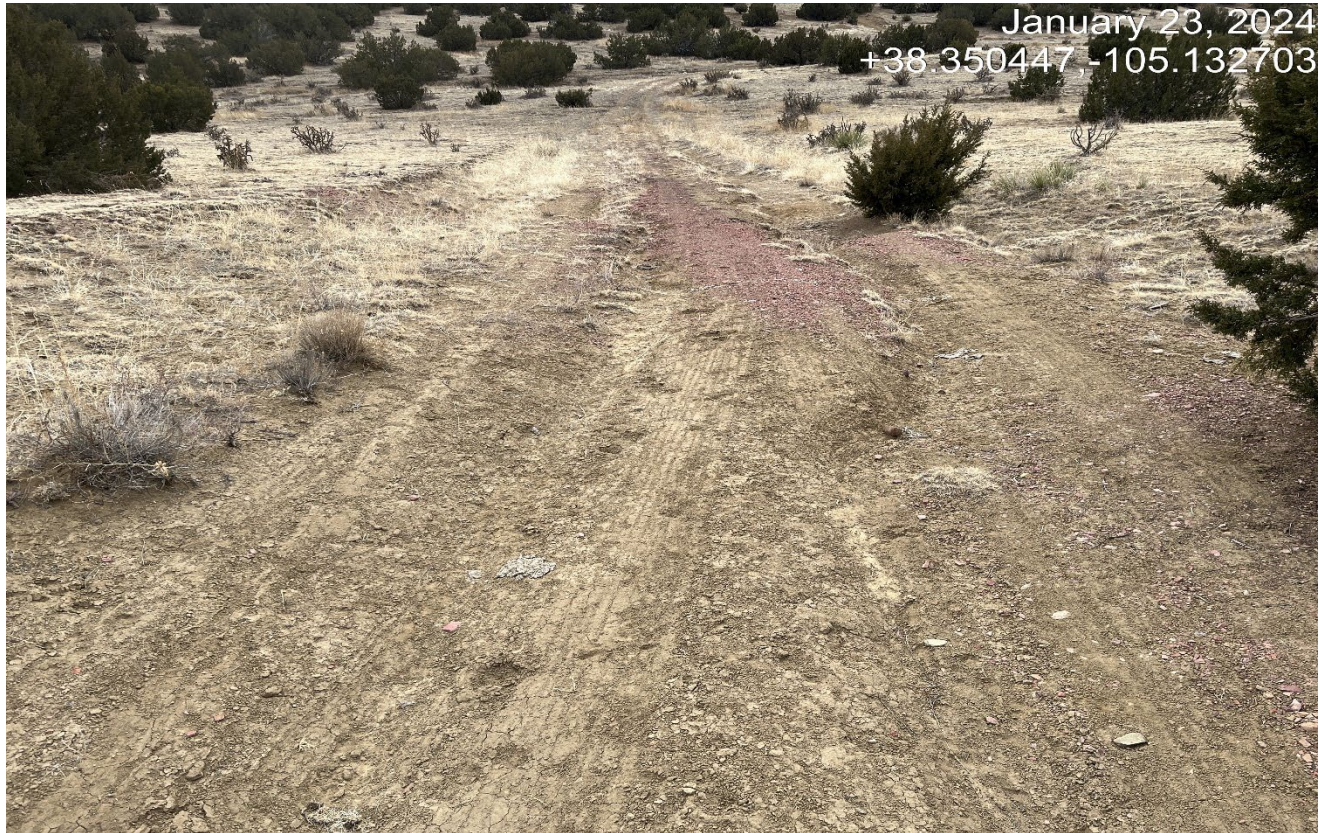
Photo 2. Facing southwest toward the former access road. There were temporary erosion controls installed which have washed out. This area of the access road needs to be reclaimed and stabilized for long term stabilization.

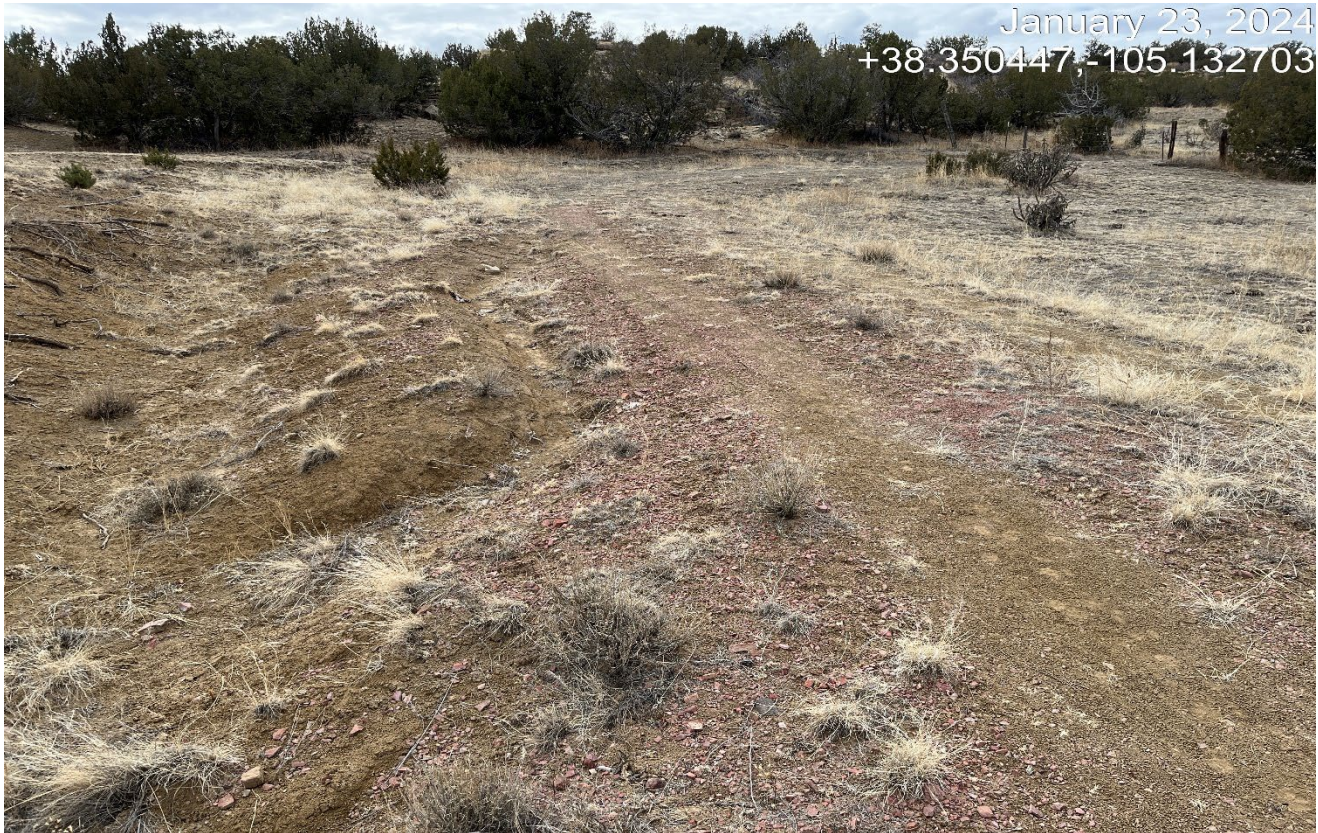
Photo 3. Facing southwest along the access road. This portion of the access road has not been reclaimed and there is erosion shown at red arrow.

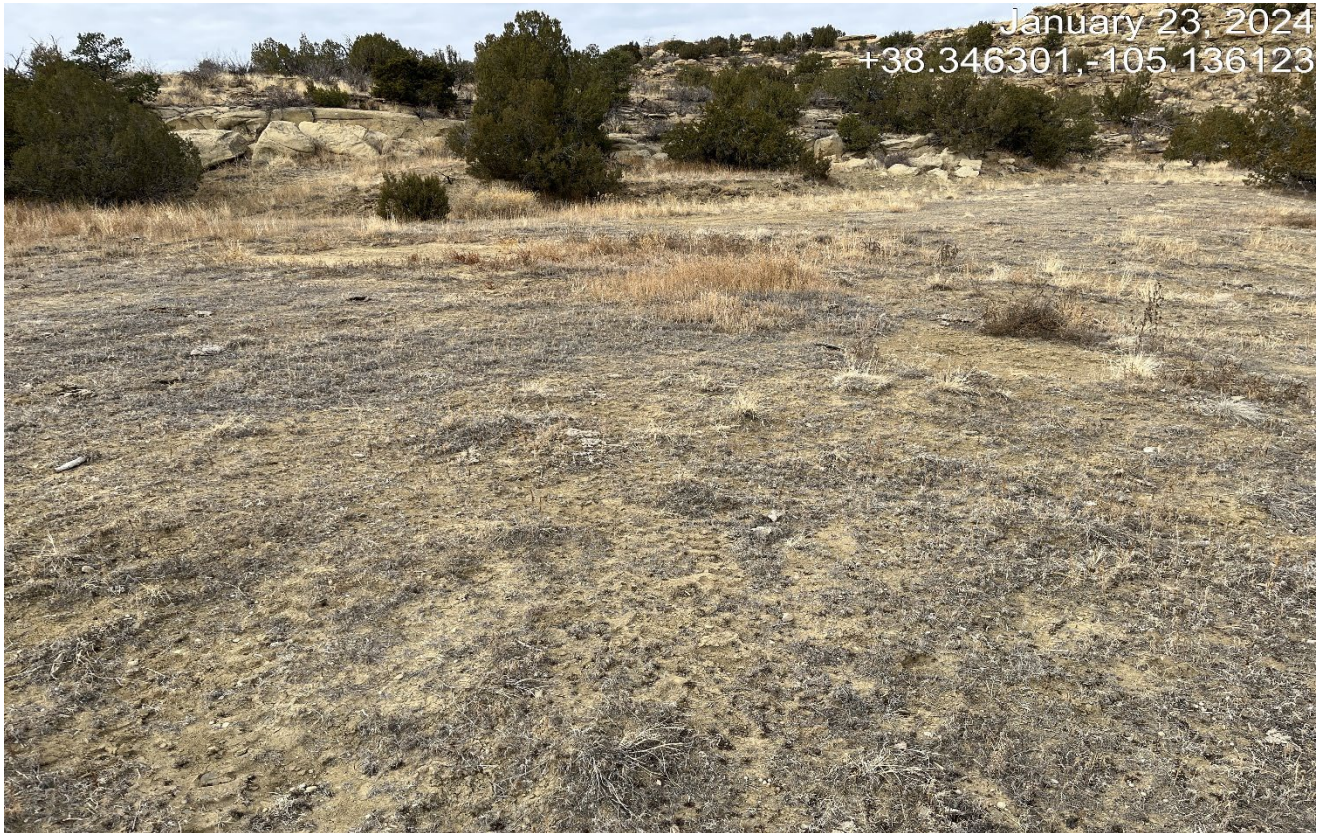
Photo 4. Facing northwest toward the location. The location has not been reclaimed.

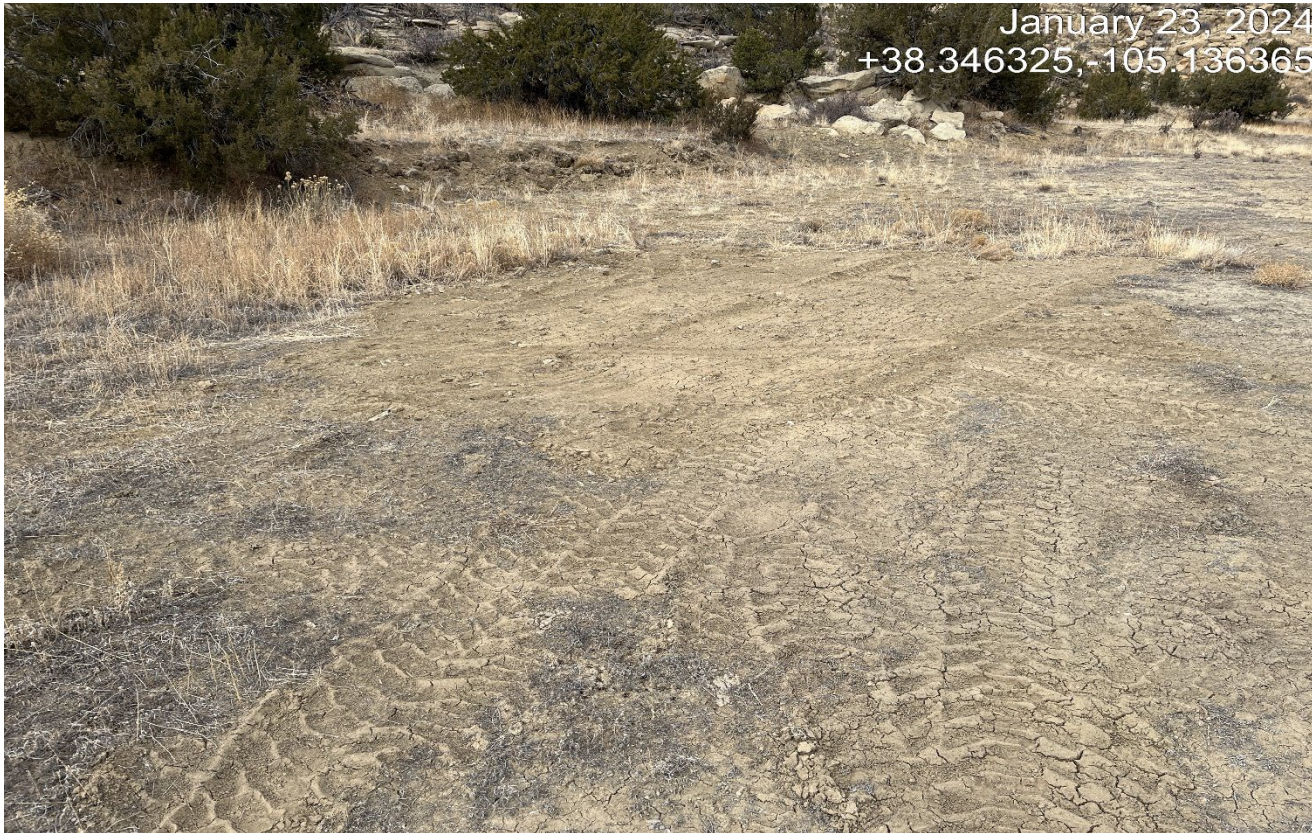
Photo 5. The open hole previously observed has been backfilled. The location will need to be reclaimed.

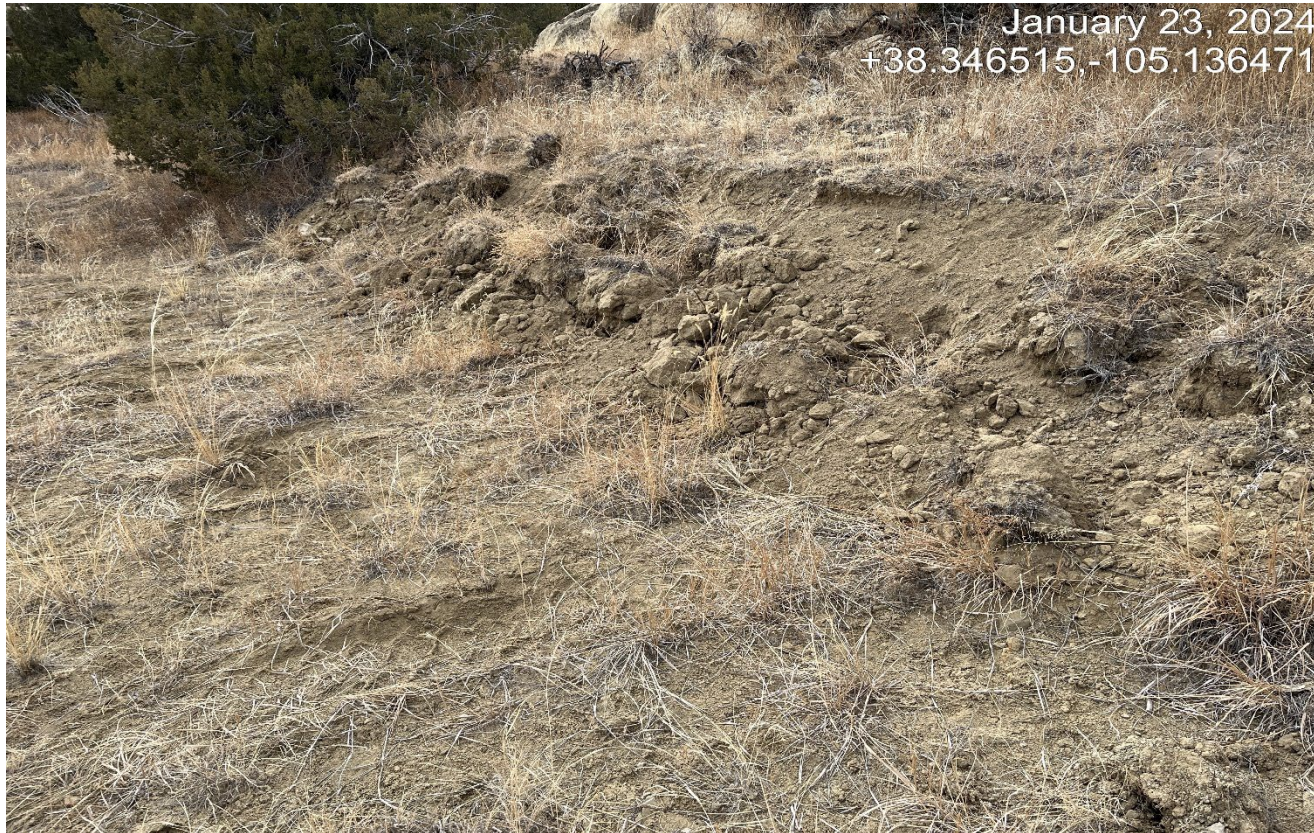
Photo 6. Facing toward the cut slope. There was recent soil put along the slope however additional recontouring is needed along this cut slope to match the topography. All disturbed soils will need to be seeded and stabilized.

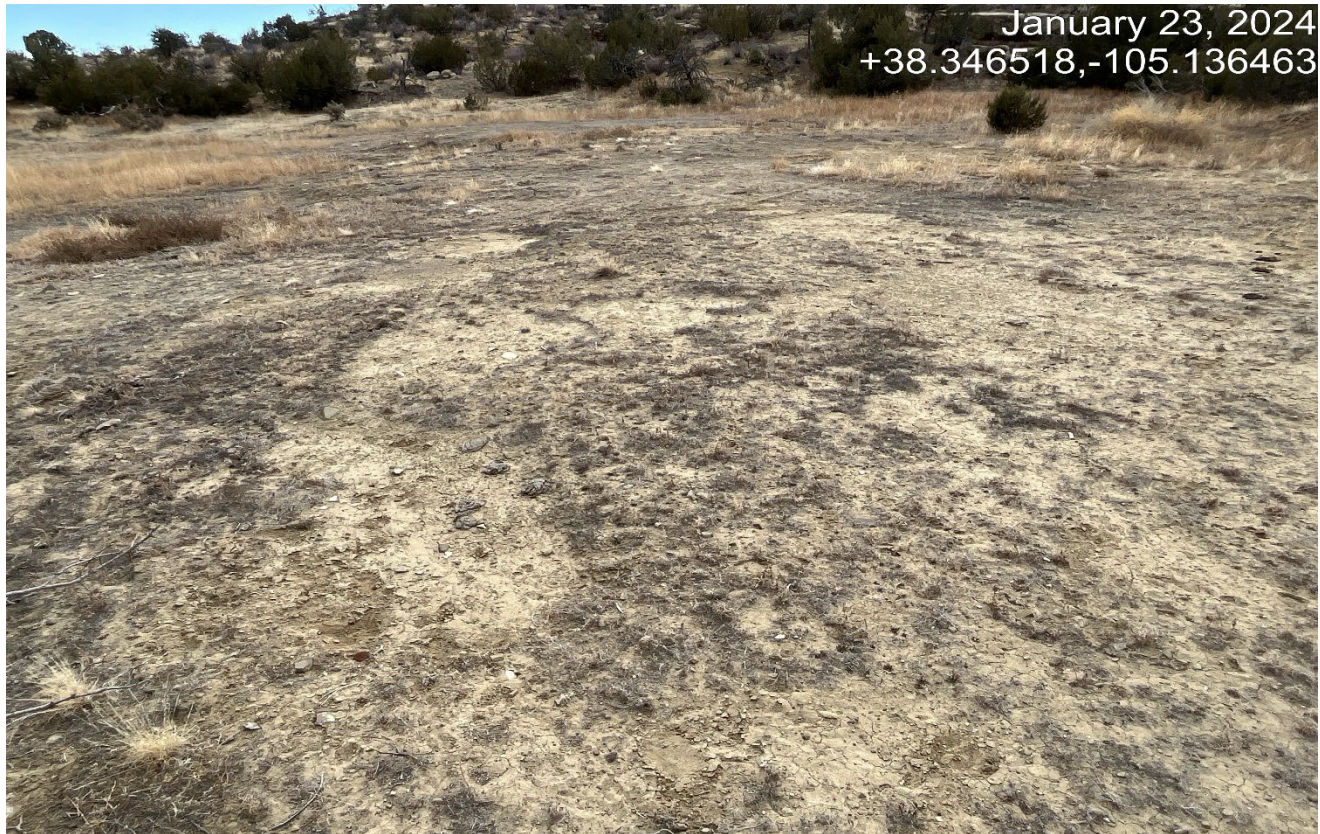
Photo 7. Facing southwest toward the location. The location has not established a uniform perennial vegetation cover.

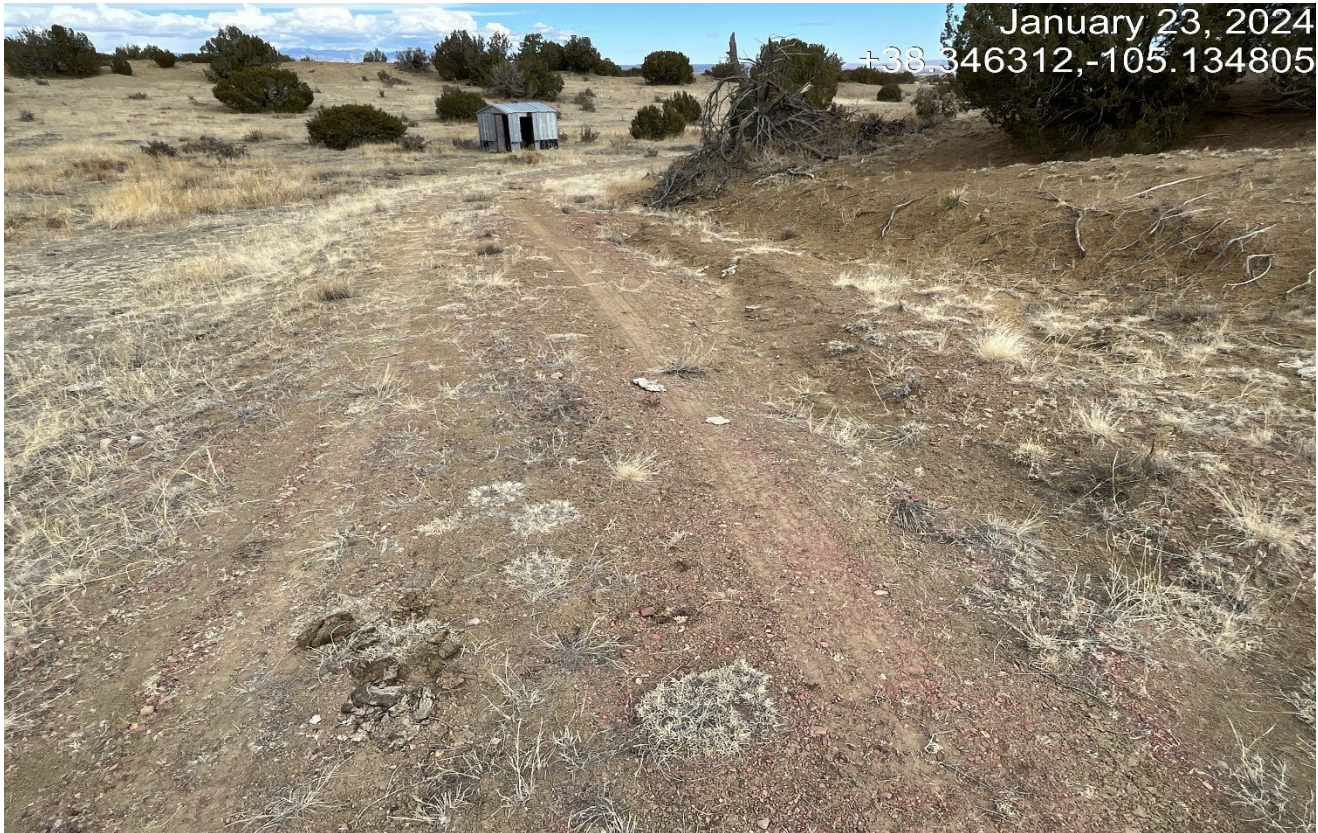
Photo 8. Facing northeast toward the access road. This area needs to be recontoured and reclaimed.
