Operator: BONANZA CREEK ENERGY OPERATING COMPANY LLC

Location Name: North Platte I-24 Pad

Inspection: 713900195

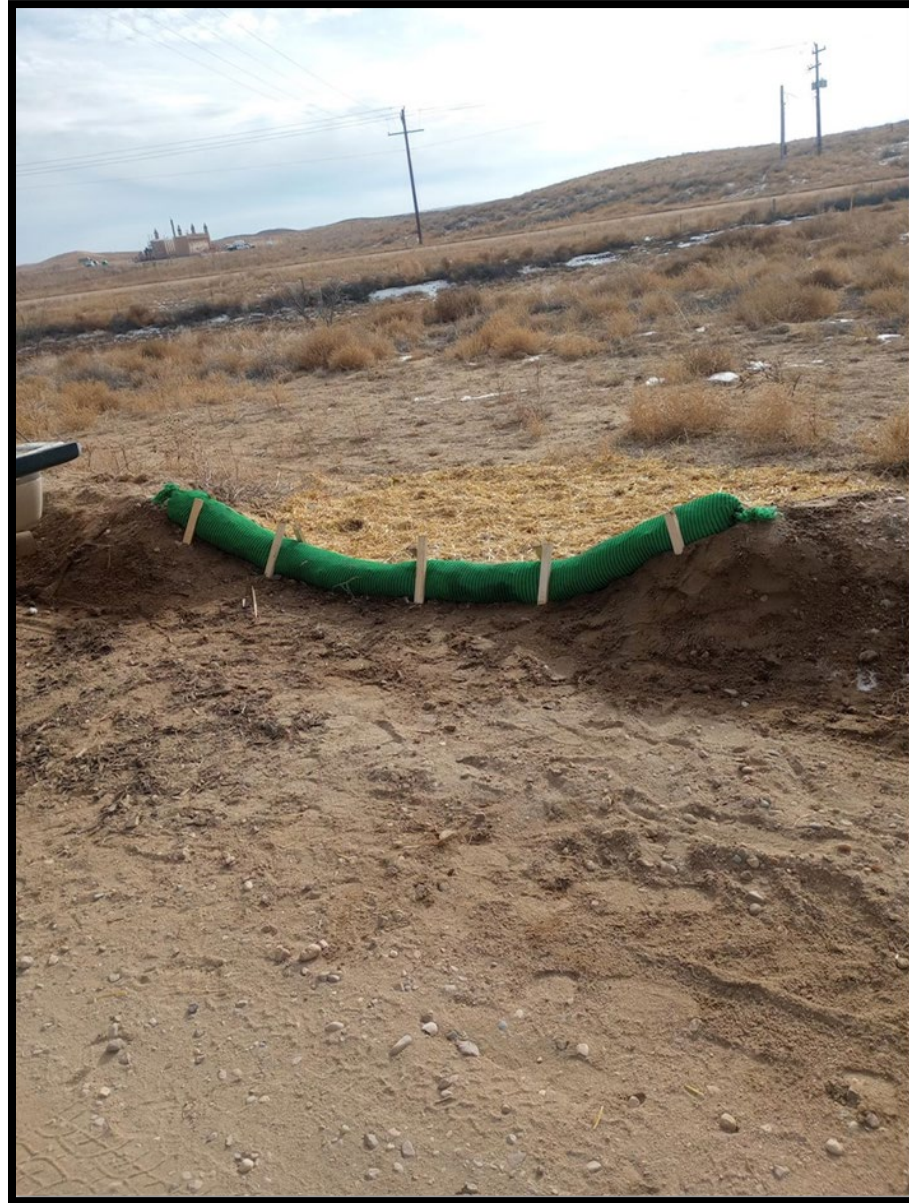
Exhibit A

CA: This location does not comply with Rule 1002.f. Sediment traps around the perimeter of the well location are overgrown with tumbleweeds and unconsolidated with straw wattles being degraded and rendered ineffective. The operator shall repair installed BMP's per Rule 1002.f.

CA Resolution: Operator has addressed weeds and tumbleweeds and repaired identified sediment traps to comply with Rule 1002.f.
