**Operator: Crestone Peak Resources**

**Location Name: McPeck SESW Multi Well Pad 0-6-10**

**Loc ID: 422467**

**Inspection: 702402754**

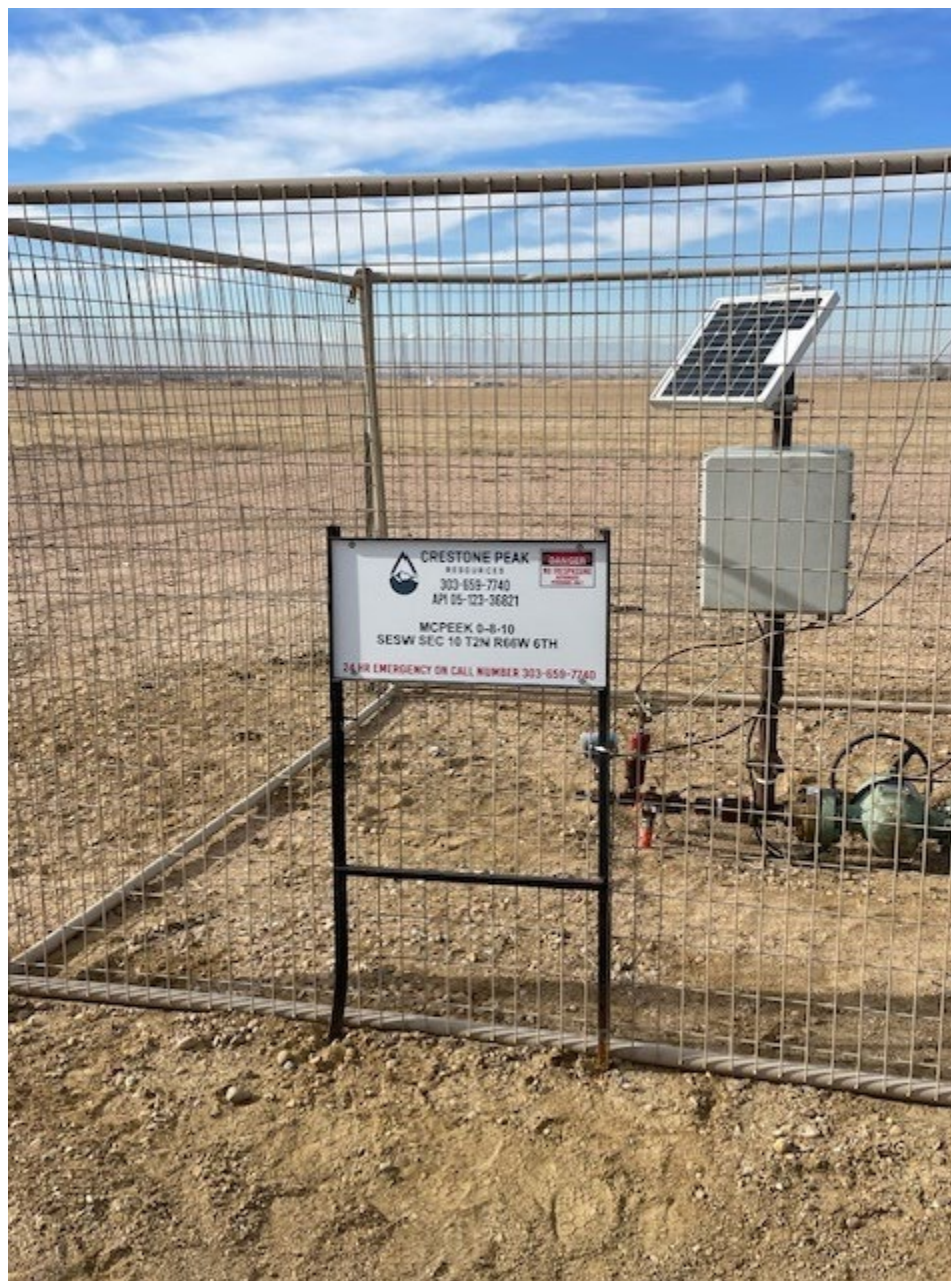
Exhibit A

**CA:** Sign not posted or information inaccurate at well(s). Install sign to comply with Rule 605.a.

**CA Resolution:** Sign has been installed to comply with Rule 605.a.

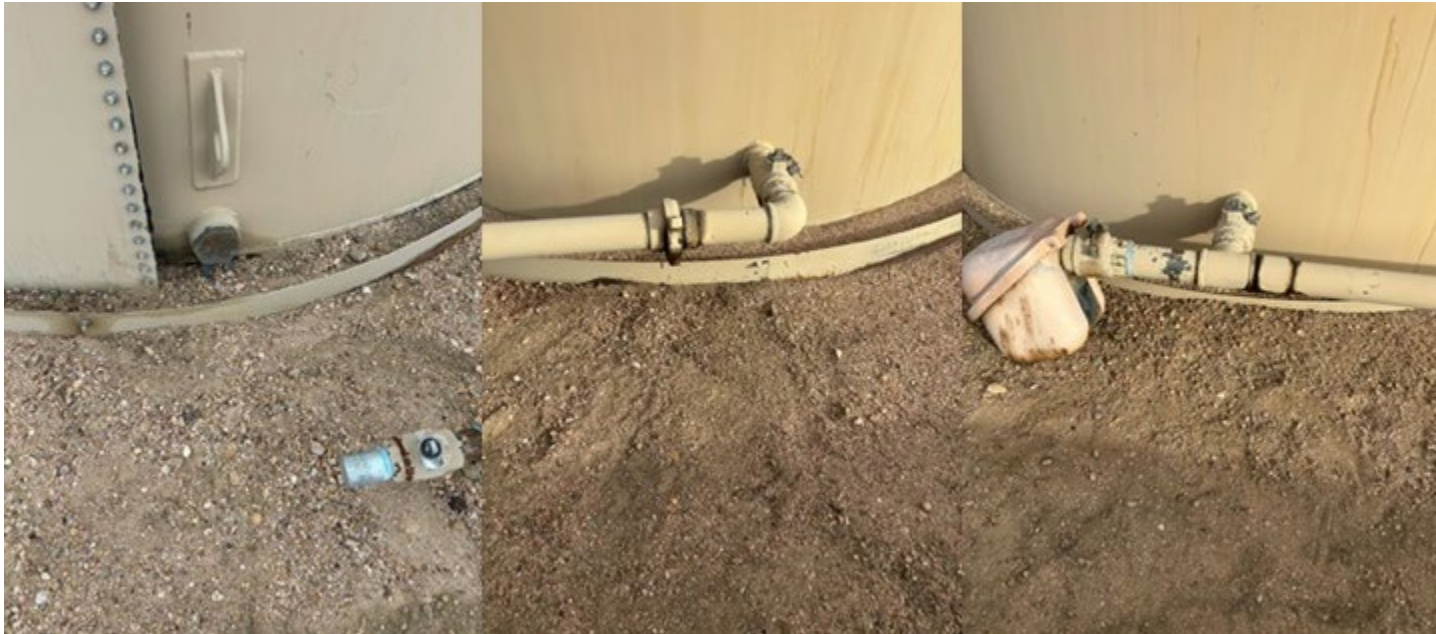
**Exhibit B**

**CA:** Stained soils on the west side of the condensate tanks load line. Properly dispose of oily waste in accordance with Rule 905.e.

**CA Resolution:** Oily waste has been disposed of to comply with Rule 905.e.

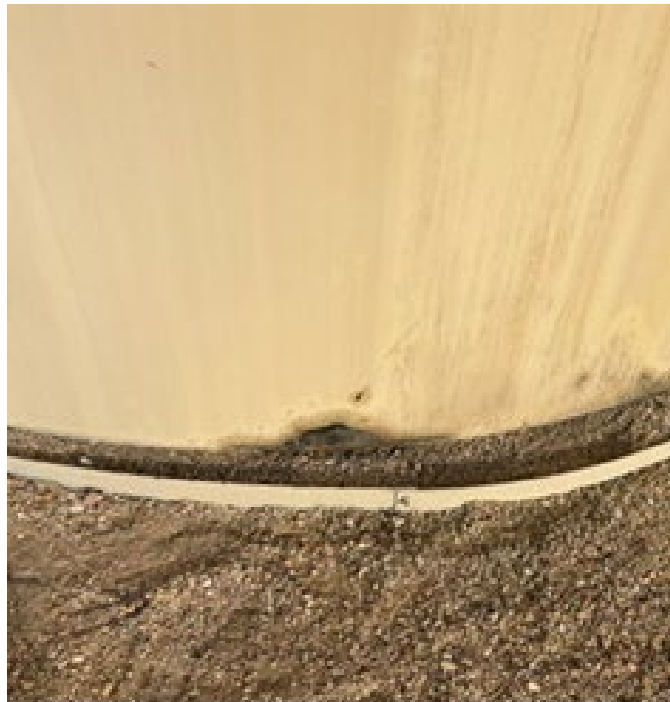
**Exhibit C**

**CA:** North Tank is rusted, pitted, or show evidence of inadequate repair. Stained soil under pitted hole in tank. Inspect, maintain, and repair tanks to comply with rule 609.b.

**CA Resolution:** Tanks has been repaired to comply with Rule 609.b.
