**Operator: HIGHPOINT OPERATING CORPORATION**

**Location Name: Pappenheim SW 6-62-23**

**Inspection: 696305501**

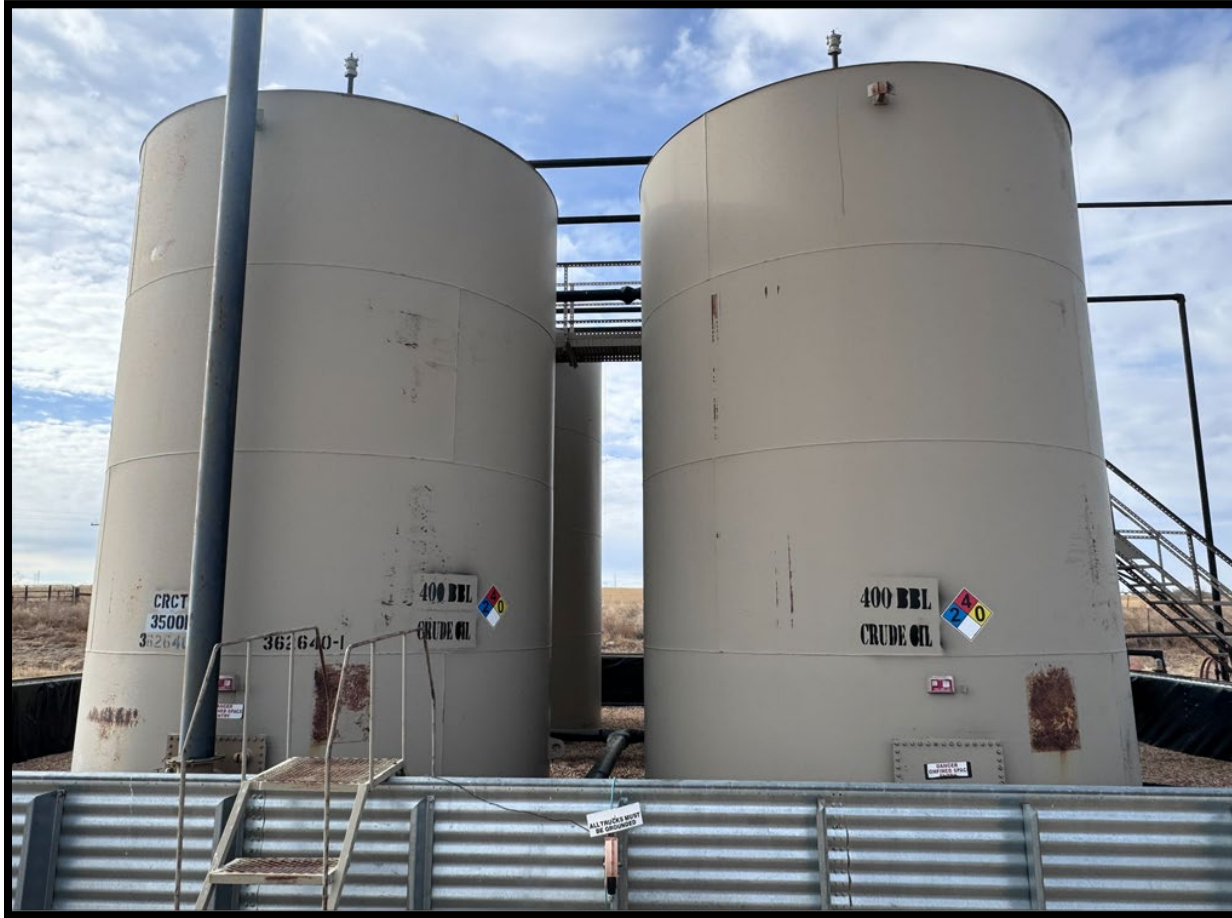
Exhibit A

**CA:** All 4 Tanks missing Labels - Content, Capacity and NFPA. Install sign to comply with Rule 605.h.

**CA Resolution:** Operator has installed appropriate signage on the identified tanks to comply with Rule 605.h.

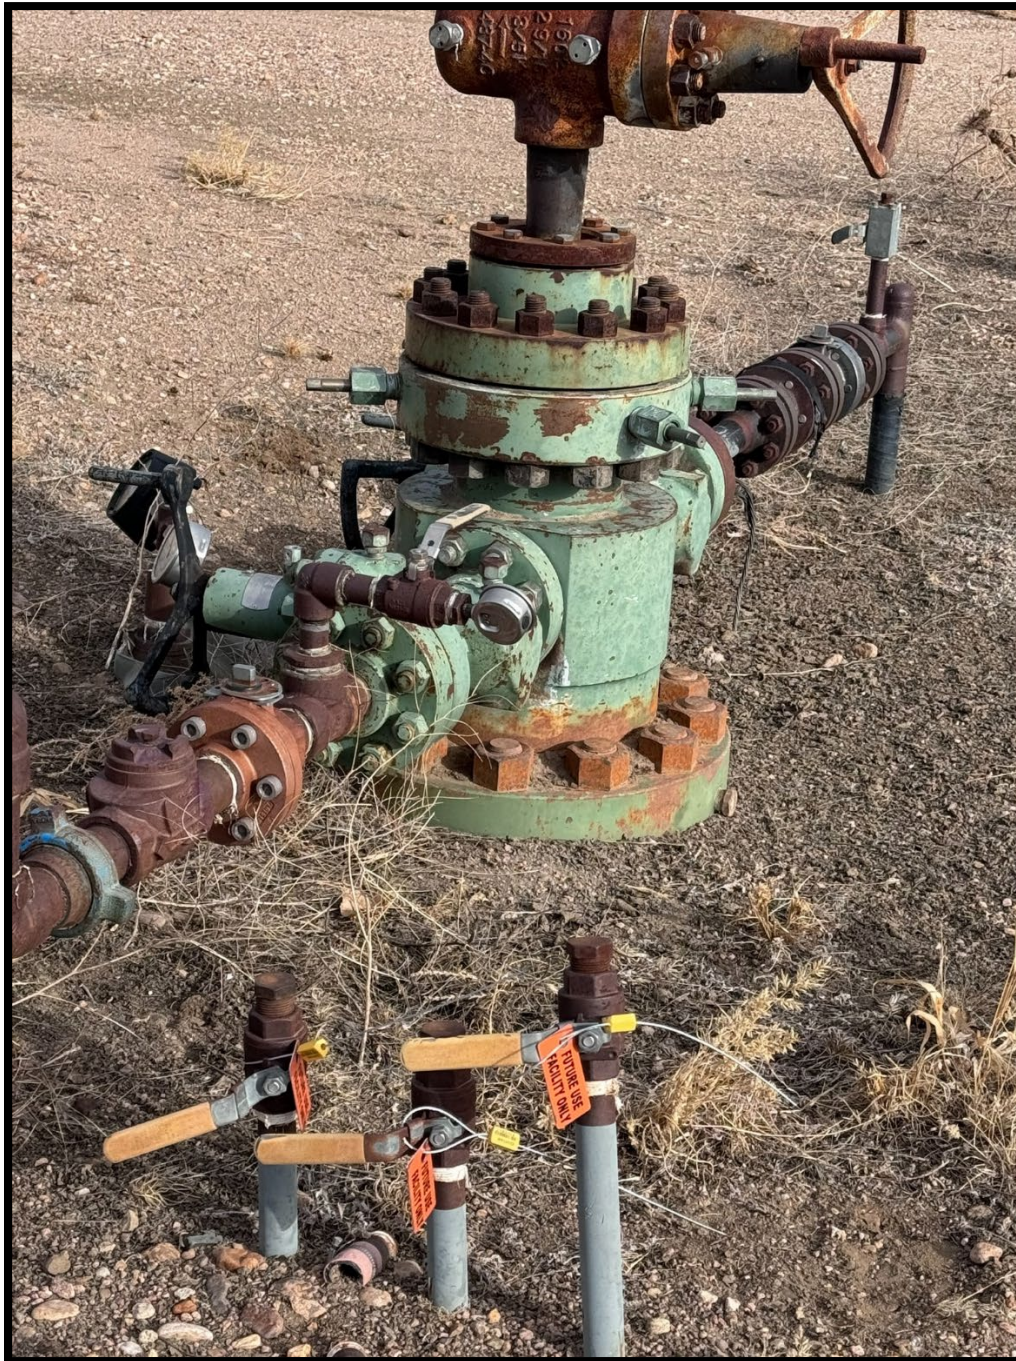
Exhibit A

**CA:** Unmarked OOSLAT Risers at Tanks, Separator, ECD and Wellhead. See photos. Complete flowline and crude oil transfer line abandonments to comply with Rule 1105.

**CA Resolution:** Operator has added tags to all identified Risers to comply with Rule 1105.
