**Operator: Civitas North**  
**Location Name: Rothe 12-14-8-61**  
**Loc ID: 424216**  
**Inspection: 709100217**

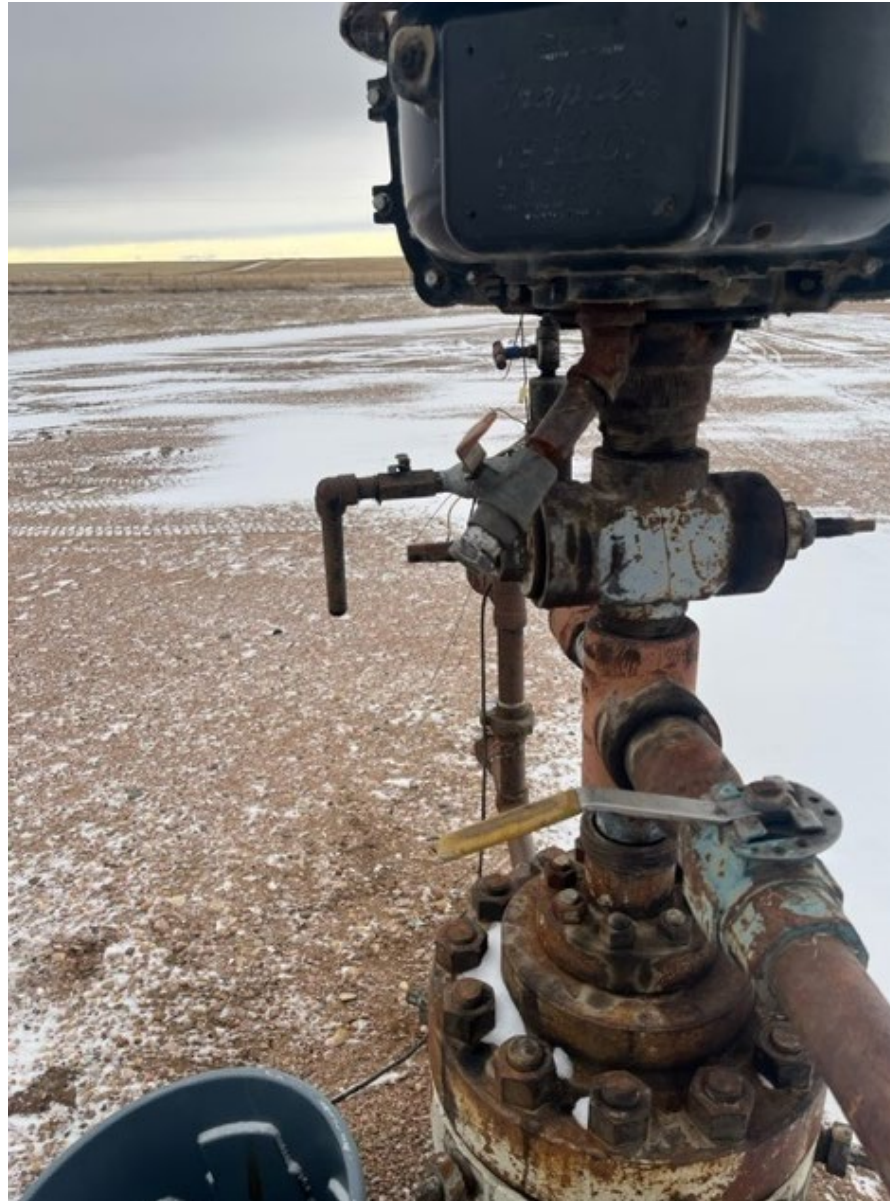
Exhibit A

**CA:** Pipe located on site not securely fastened to prevent leaks. Securely fasten all valves, pipes, fittings, and Production Facilities to ensure good mechanical condition, inspect at regular intervals and maintain in good mechanical condition, per Rule 608.e.

**CA Resolution:** Pipes have been repaired to comply with Rule 608.e.
