Operator: CRESTONE PEAK RESOURCES OPERATING LLC

Location Name: ANDERSON TRUST C 62N68W 32NENE

Inspection: 714300041

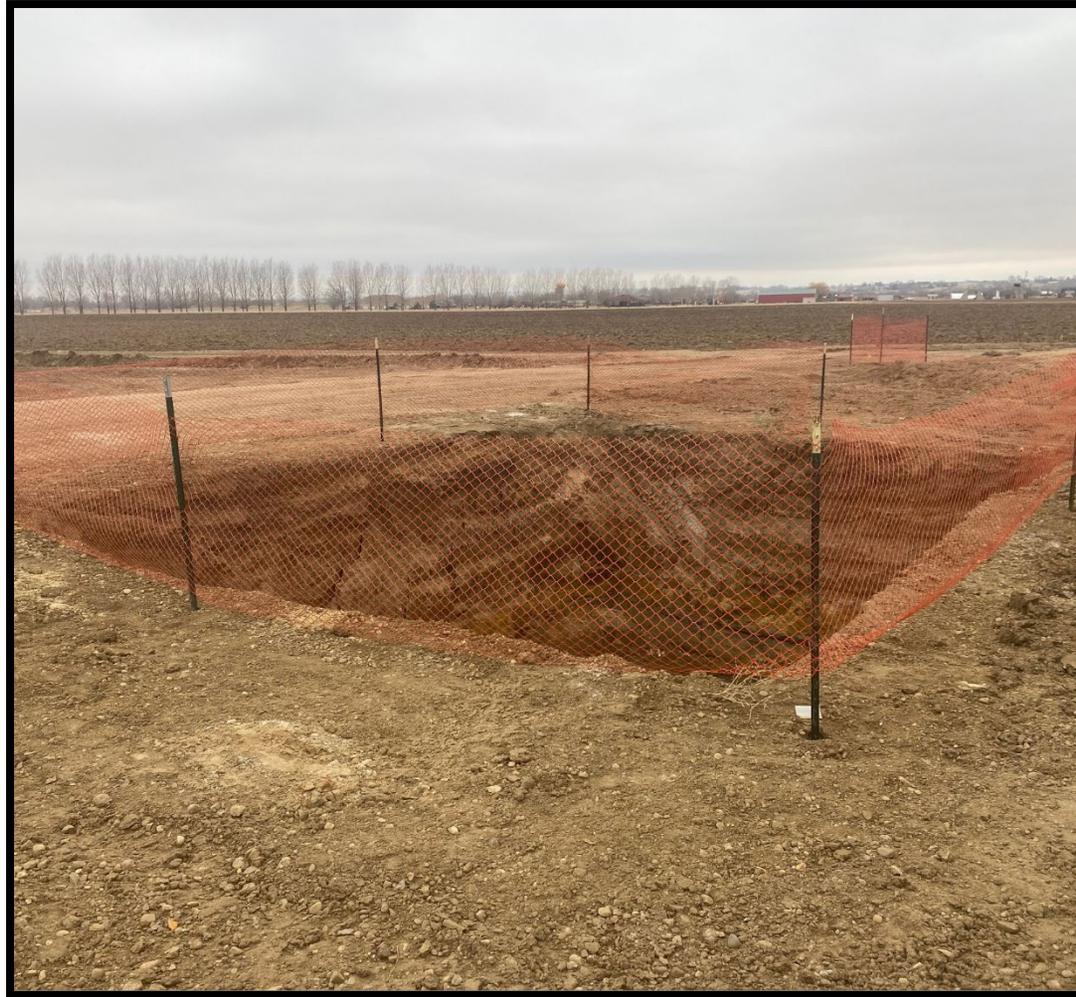
Exhibit A

CA: Fencing surrounding the excavation is beginning to sag and requires maintenance. Secure access to excavation in compliance with Rule 913.b.(5).B.i and ECMC Guidance 913.b.(5)B i-v.

CA Resolution: Operator has appropriately repaired the fencing around the excavation to comply with Rule 913.b.(5).B.i.
