Operator: 8 North

Location Name: Silverback 36-A Pad

Loc ID: 443555

Inspection: 696306065

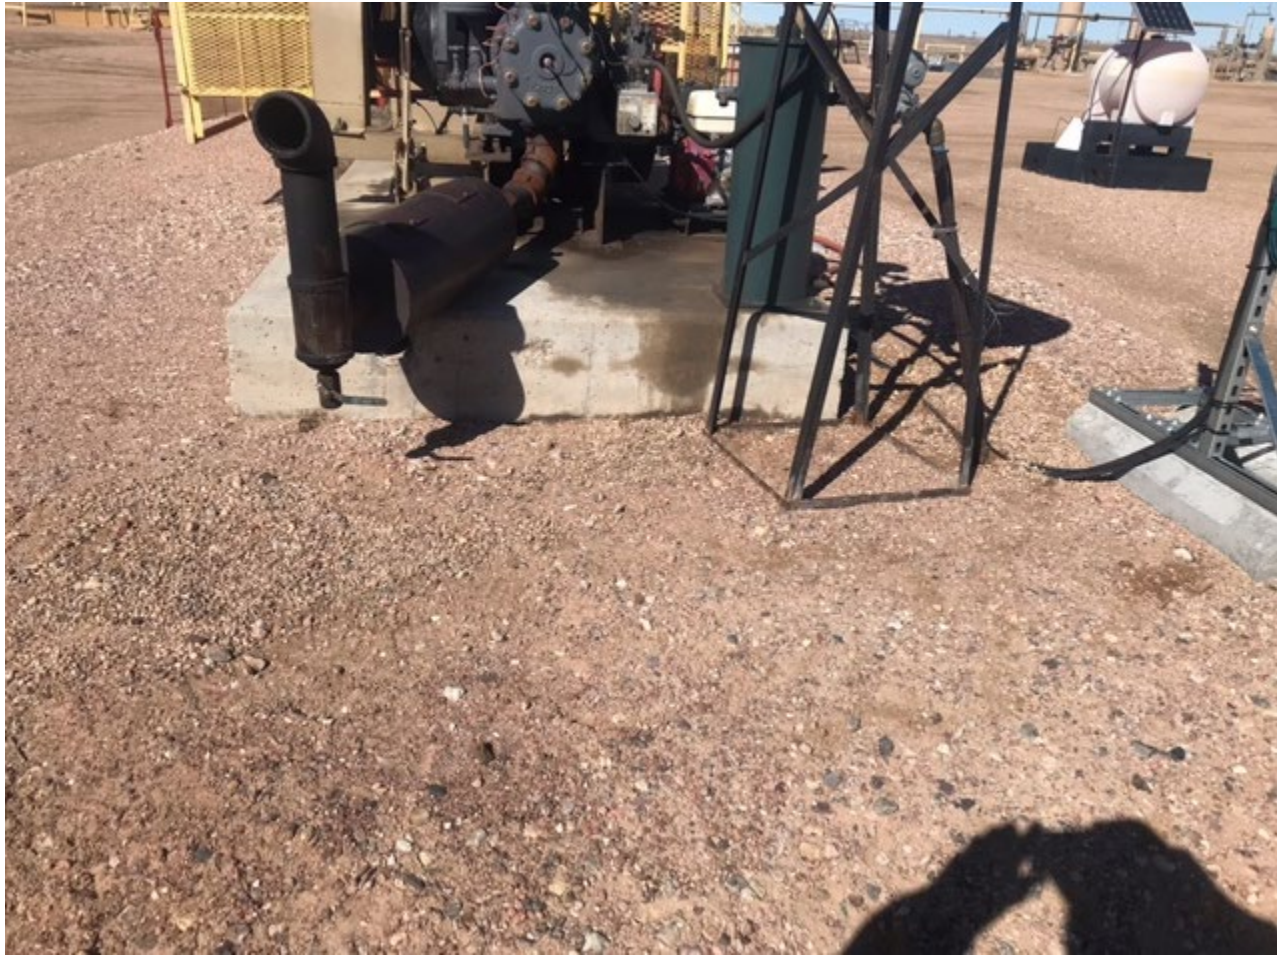
Exhibit A

CA: Stained Soil at both Gas Engines, see photos. For localized stained soils or oily waste - Properly dispose of oily waste in accordance with 905.e.

CA Resolution: Oily waste has been disposed of to comply with Rule 905.e.

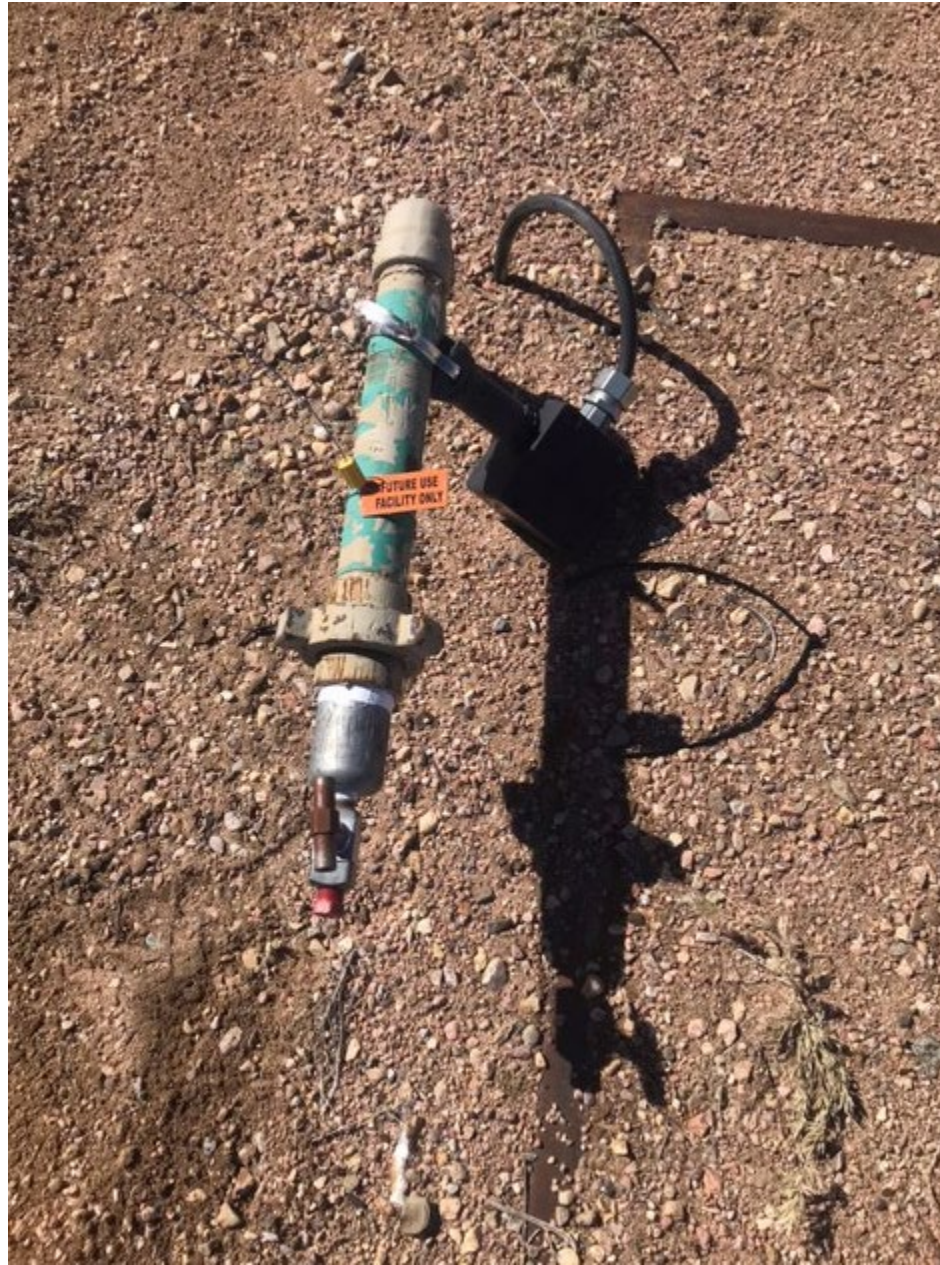
Exhibit C

CA: Unmarked Risers at Gas Meter House on East side of Location. Complete flowline and crude oil transfer line abandonments to comply with Rule 1105.

CA Resolution: Risers have marked to comply with Rule 1105.
