Final Reclamation and Stormwater Inspection

Operator: NOBLE ENERGY INC - 100322

Location ID: 336624

Inspection Document #: 708200999

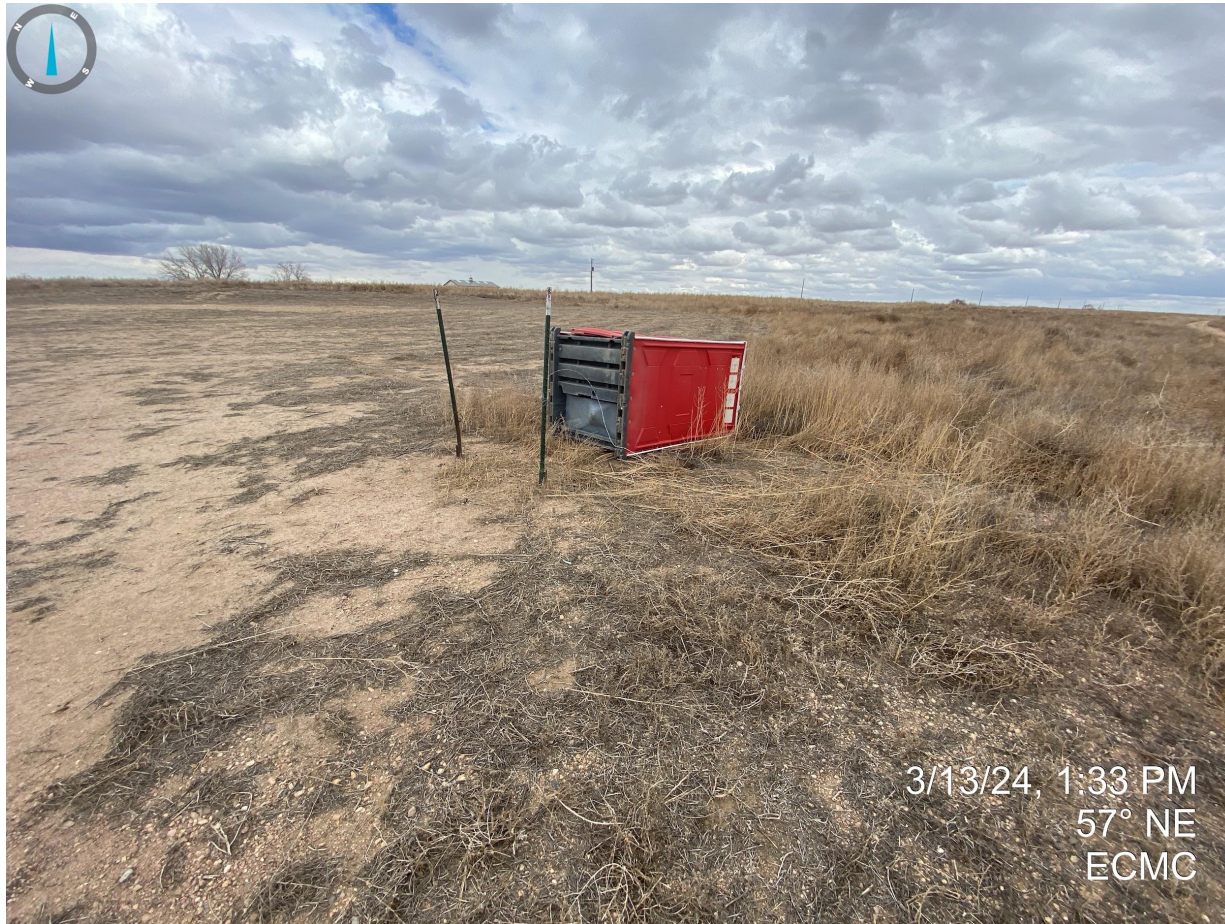
Photo 1. porta John on location is not adequately anchored.

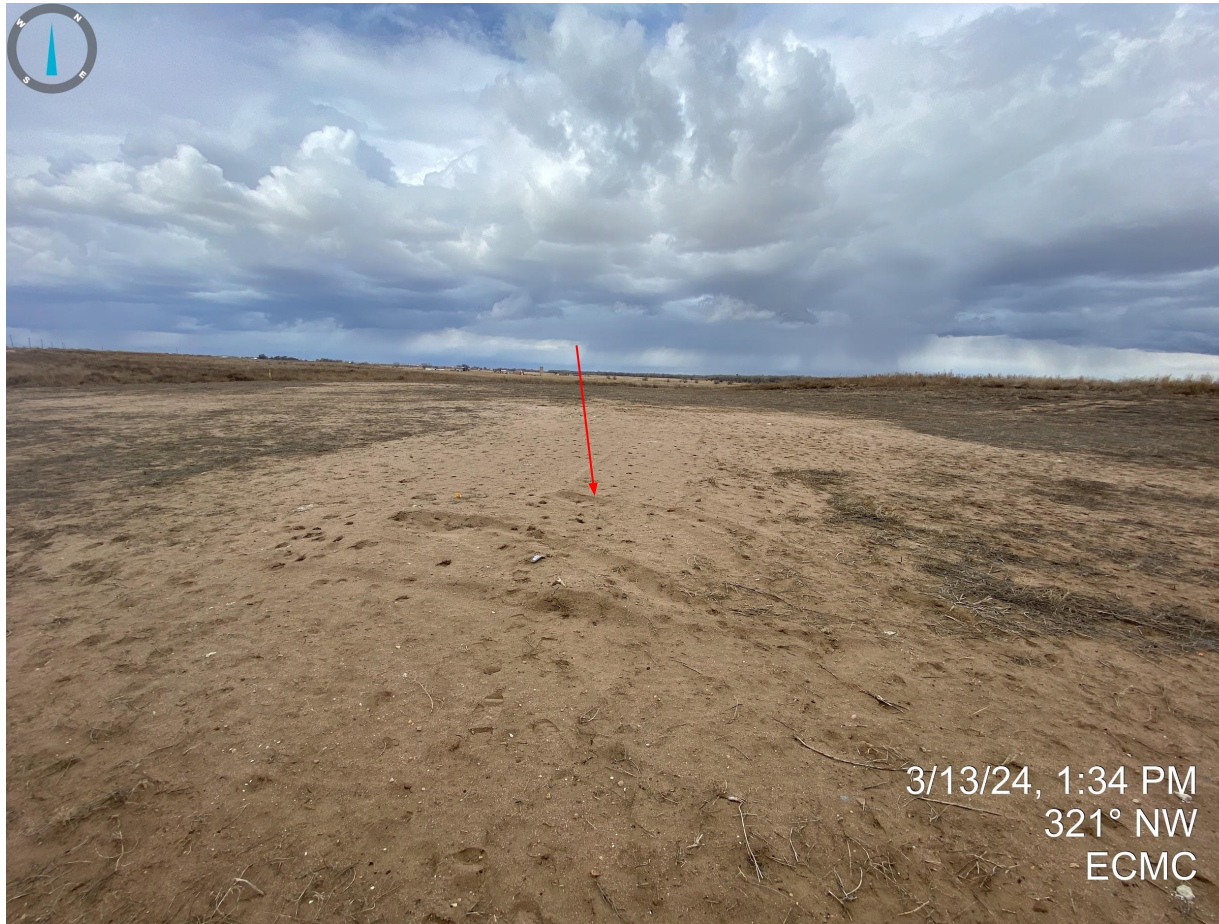
Photo 2. Well API #123-25036 was plugged and abandoned on 10/25/2023. Operator shall continue with reclamation activities in accordance with Rule 1004. A follow up inspection will be performed at a later date to verify compliance with Rule 1004.
