**Operator:** *Crestone Peak Resources*

**Location Name:** *ANDERSON TRUST C 62N68W 32NENE*

**Inspection:** *714300041*

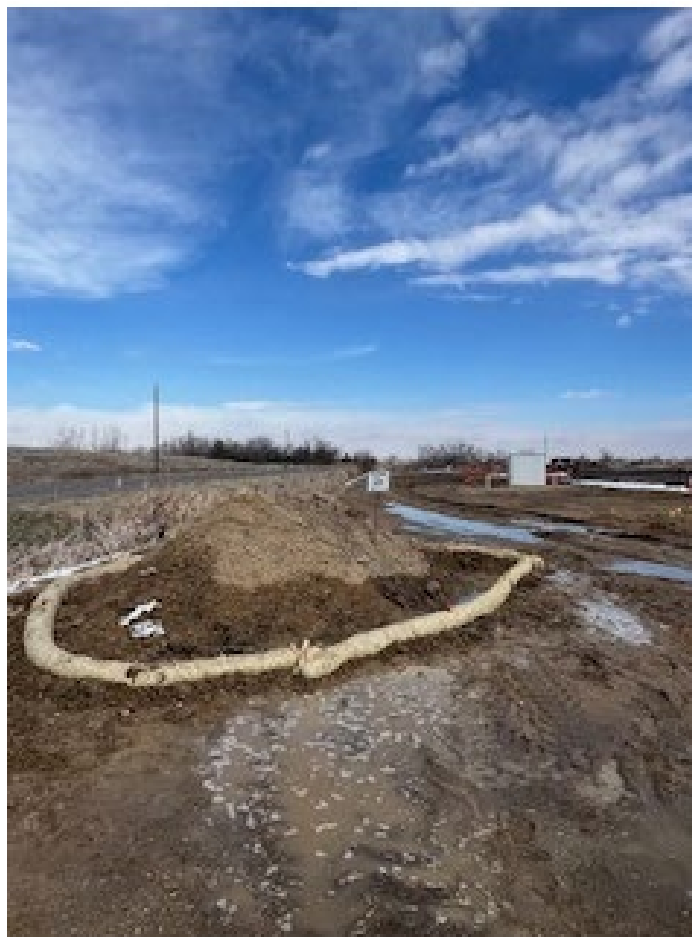
**Exhibit A**

**CA:** *A small excavation remains open at the location of the former tank battery. No groundwater was present in the excavation. No E&P waste stored on site. All tank battery equipment has been removed from the location. Form 27 Doc No 403678585 (In Process) lists the date of completion of remediation as 7/30/2024.v In accordance with 913.d.(1) Operator will investigate impacts to soil, Groundwater, and surface water as soon as the impacts are discovered. Operator will comply with the implementation schedule and Conditions of Approval for all remaining remediation of soil impacts, reclamation and reporting established in the ECMC Remediation Project No. 24140.*

**CA Resolution:** Waddle has been installed to comply with Rule 913.d.(1).
