#1 - DP406/Hullabaloo Facility

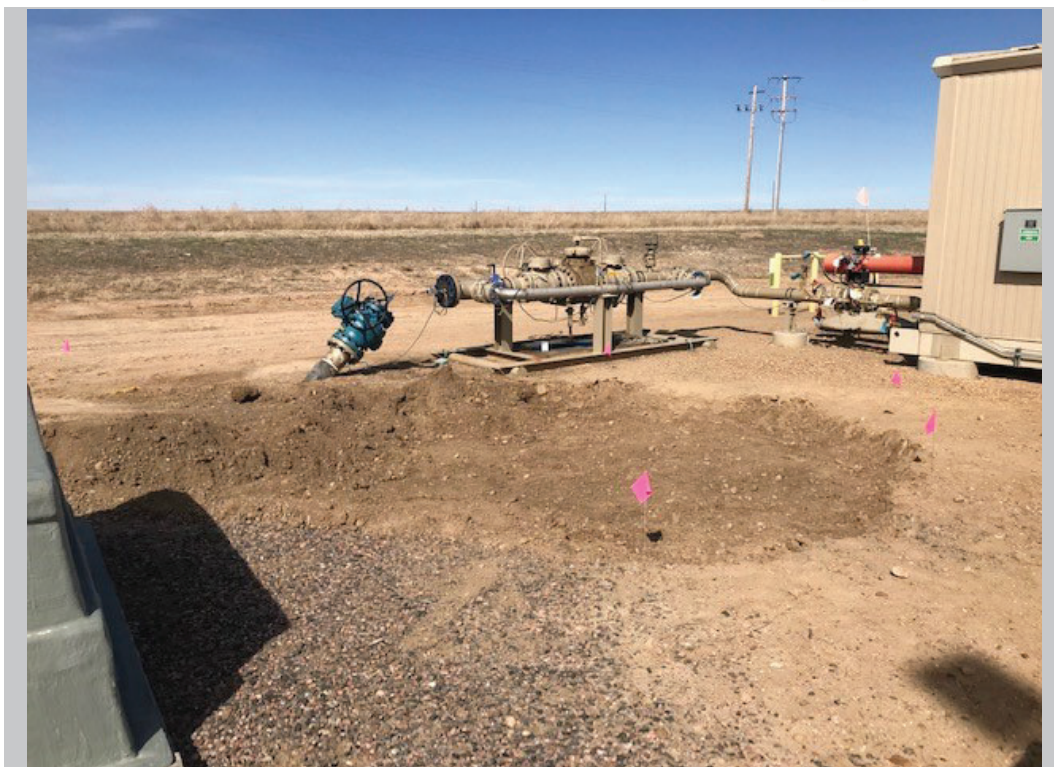
#2 - Looking northeast at pig launcher where release occurred

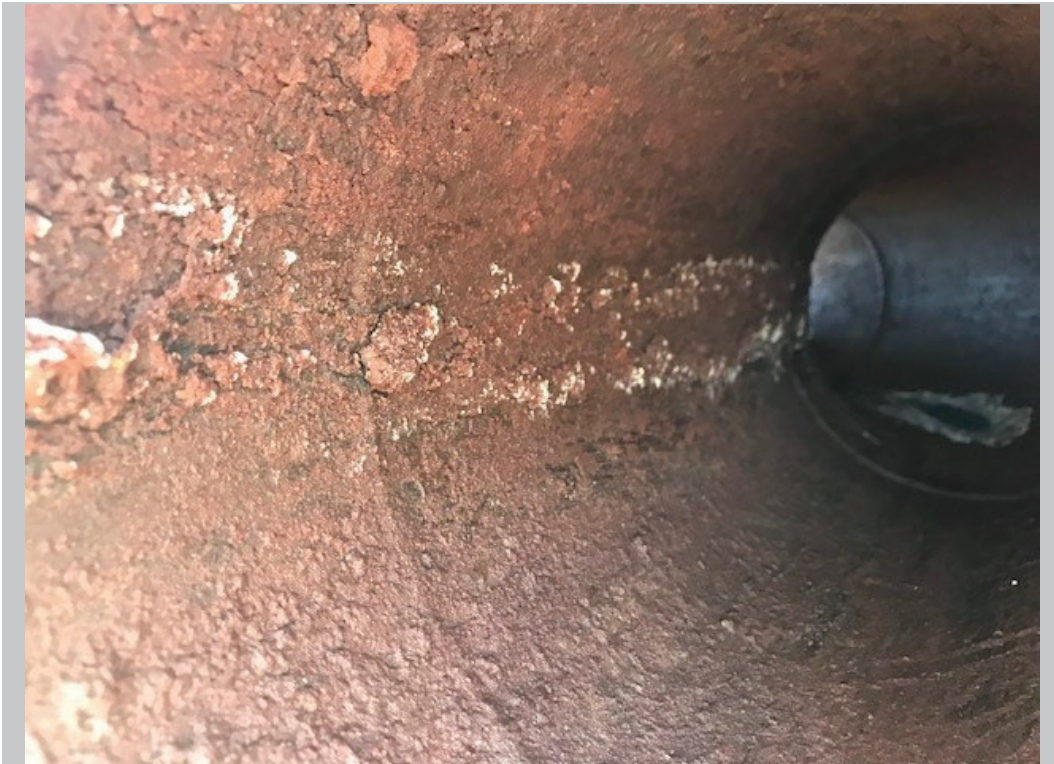
#6 - Inside of failed pipe section.
