Storm Water Management and Erosion control
Location Name: TEP Rocky Mountain LLC MAHAFFEY PA 24-32 Pad
Location # 323949

Section/Township/Range: 32 6S95W

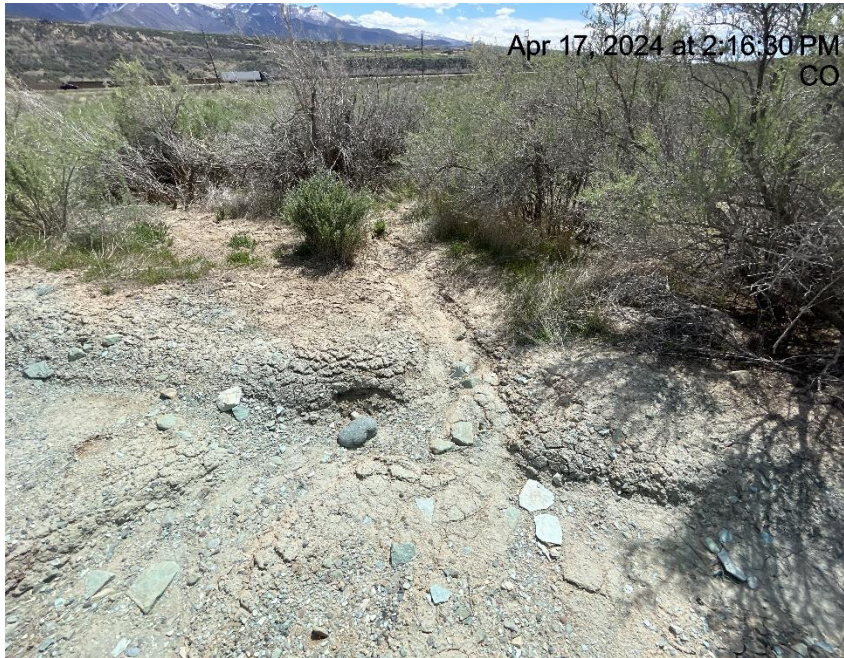
Photo # 4295 Berm needs maintenance/erosion & transport of sediment off location into a vegetated area (W/SW area of location)

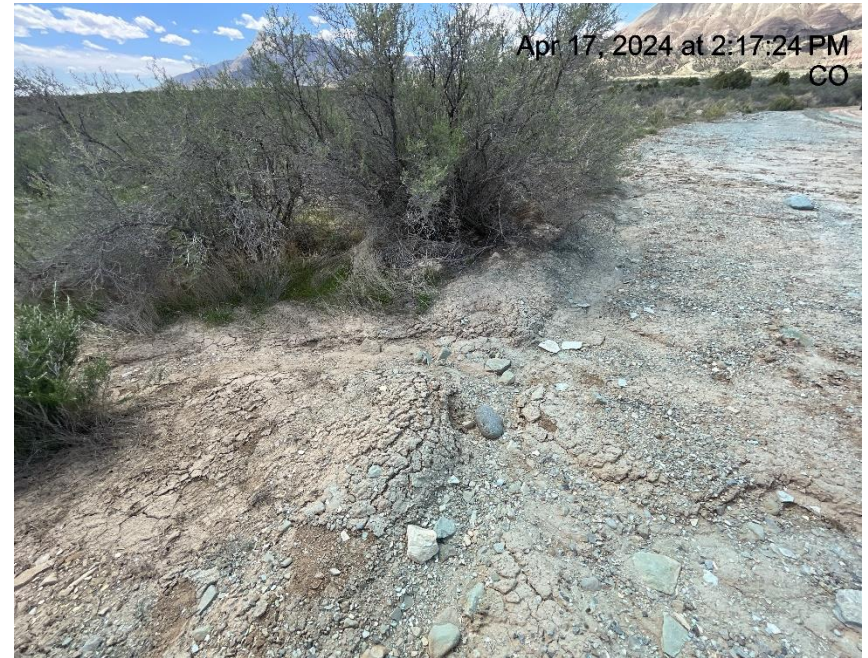
Photo # 4296 Berm needs maintenance/erosion & transport of sediment off location into a vegetated area (W/SW area of location)
