Operator: BONANZA CREEK ENERGY OPERATING COMPANY LLC

Location Name: Latham 14-12 Facility

Loc ID: 429893

Inspection: 713900513

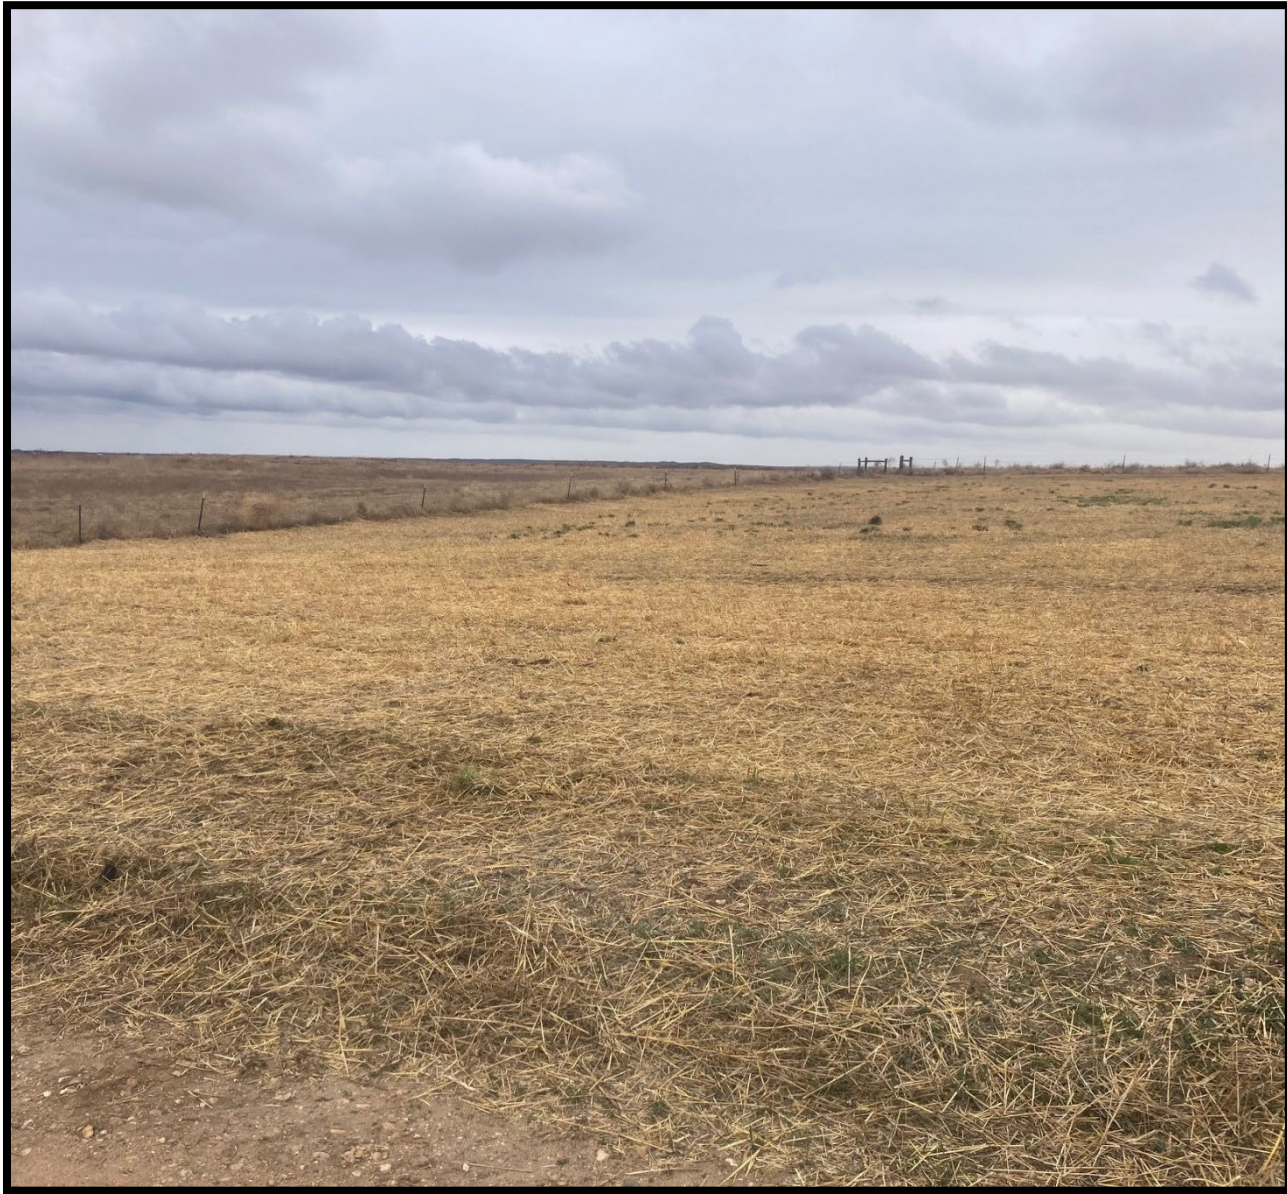
Exhibit A

CA: Weed debris in the form of tumbleweeds were observed throughout the location. Tumbleweeds are a troublesome annual non-native weed that easily breaks off at the stem. Operator failed to control and manage weeds to prevent weed waste and prevent the spread of seeds. Comply with Rule 606 to remove weed debris.

CA Resolution: Operator has reported that the location has been mowed to address undesirable vegetation and tumbleweeds have been cleared to comply with Rule 606. Operator has also noted that the location/flowline corridor has been inter-seeded, and straw crimped to promote vegetation.

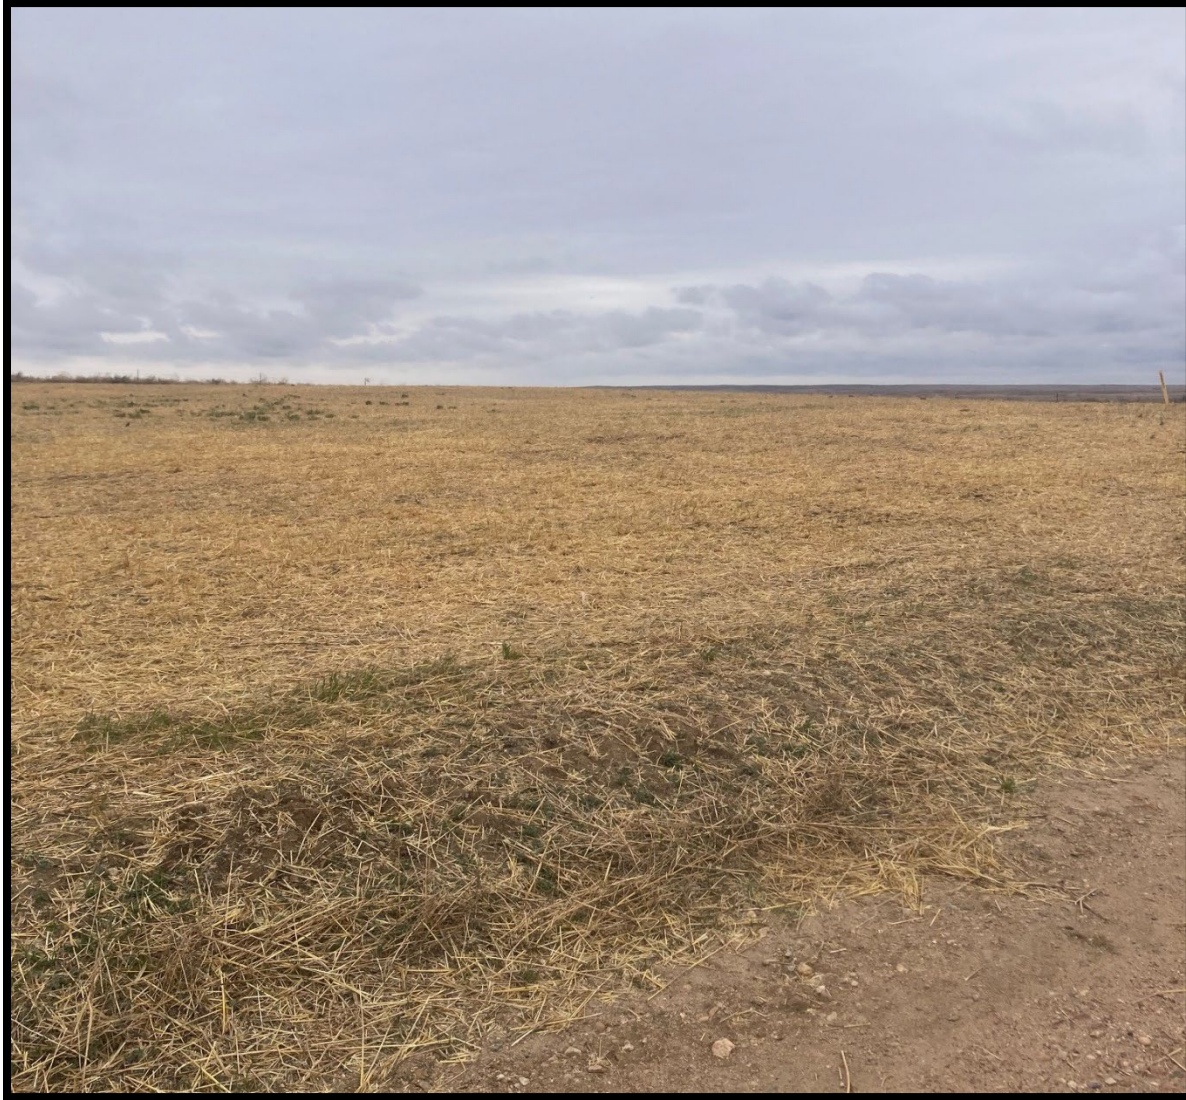
Exhibit D

CA: Barbed wire fencing remains around the tank battery facility and flowline corridor. It does not appear there is currently any cattle grazing in the area and so fencing should be removed. Remove fencing to comply with Rule 1004.

CA Resolution: Operator has reported that the barbed wire fencing has been removed around the flowline corridor and facility pad to comply with Rule 1004.
