**Operator:** *HIGHPOINT OPERATING CORPORATION*  
**Location Name:** *Anschutz Equus Farms 4-62-33 NWNW*  
**Loc ID:** *437854*  
**Inspection:** *713900536*

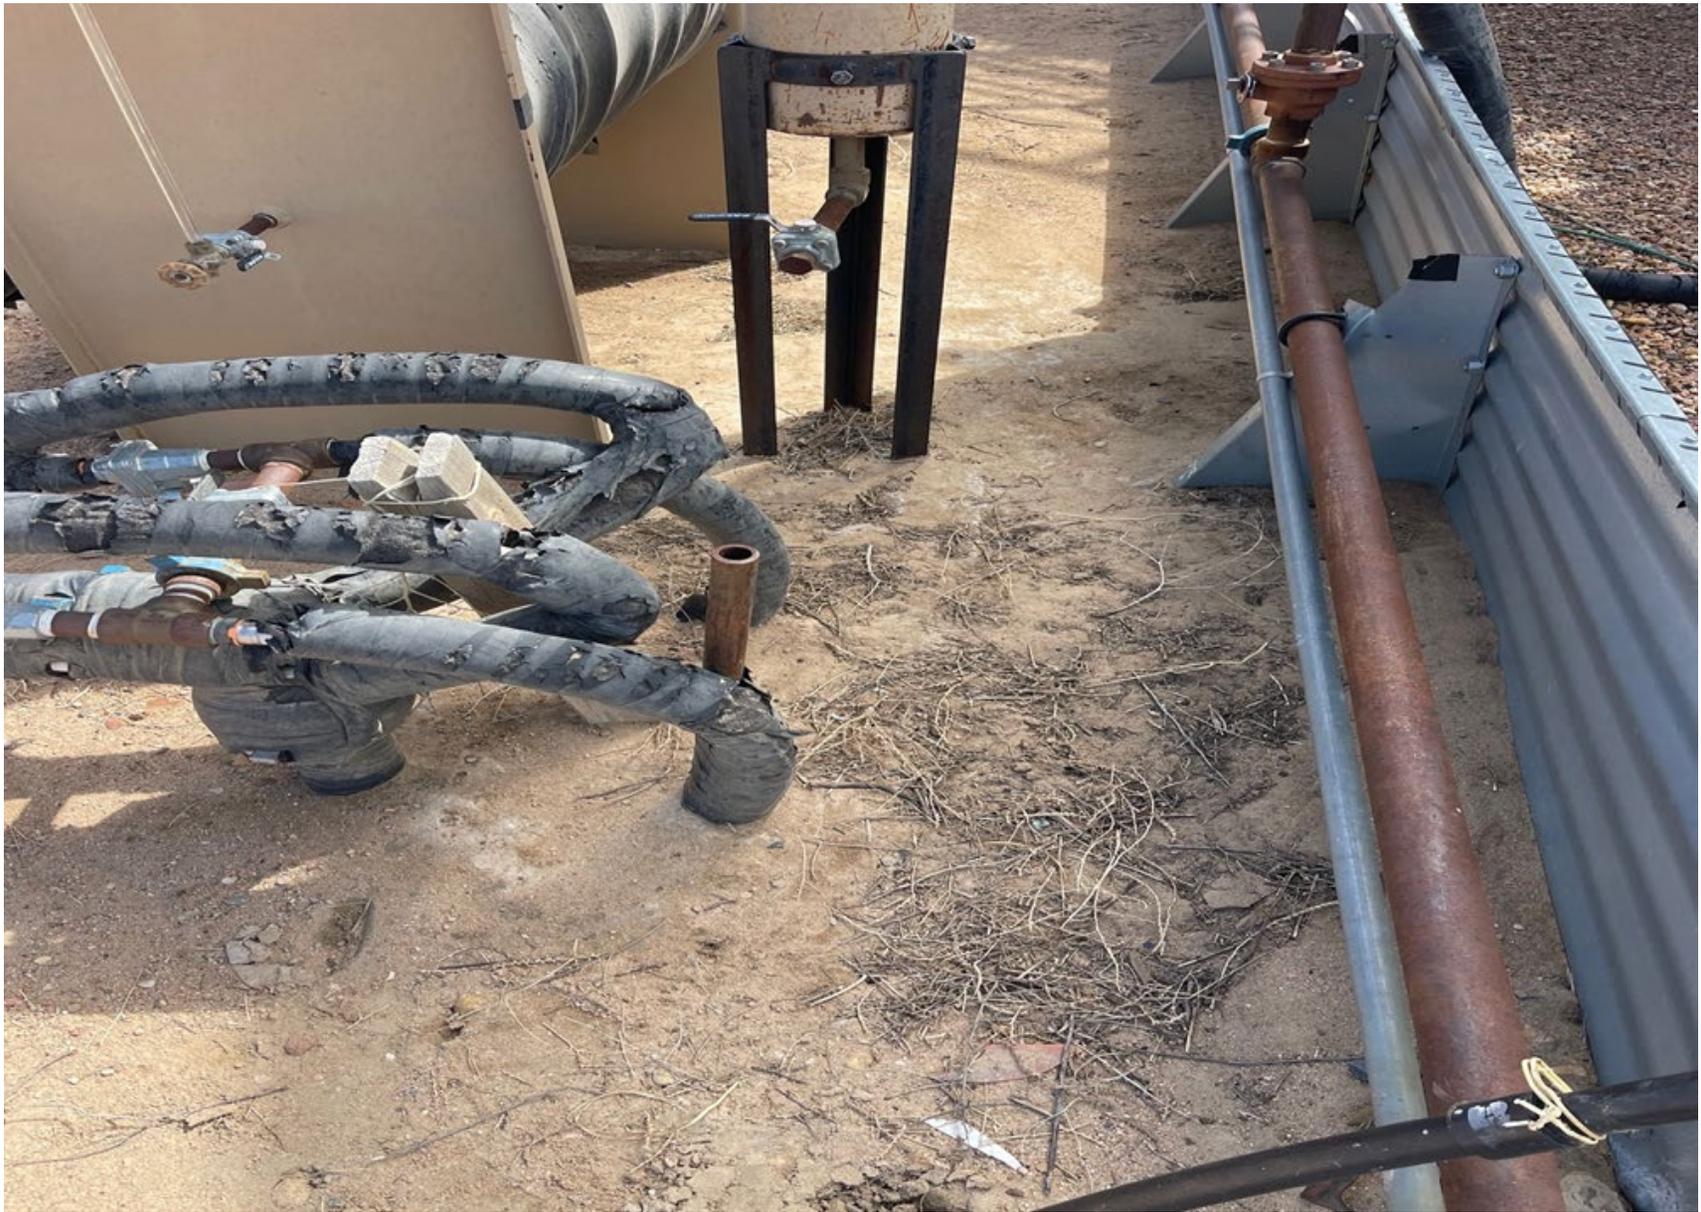
Exhibit A

**CA:** *Weed debris in the form of tumbleweeds were observed stuck within the location equipment. Tumbleweeds are a troublesome annual non-native weed that easily breaks off at the stem. Operator failed to control and manage weeds to prevent weed waste and prevent the spread of seeds onto adjacent lands. Comply with Rule 606 to remove weed debris.*

**CA Resolution:** *Weed debris has been removed to comply with Rule 606.*

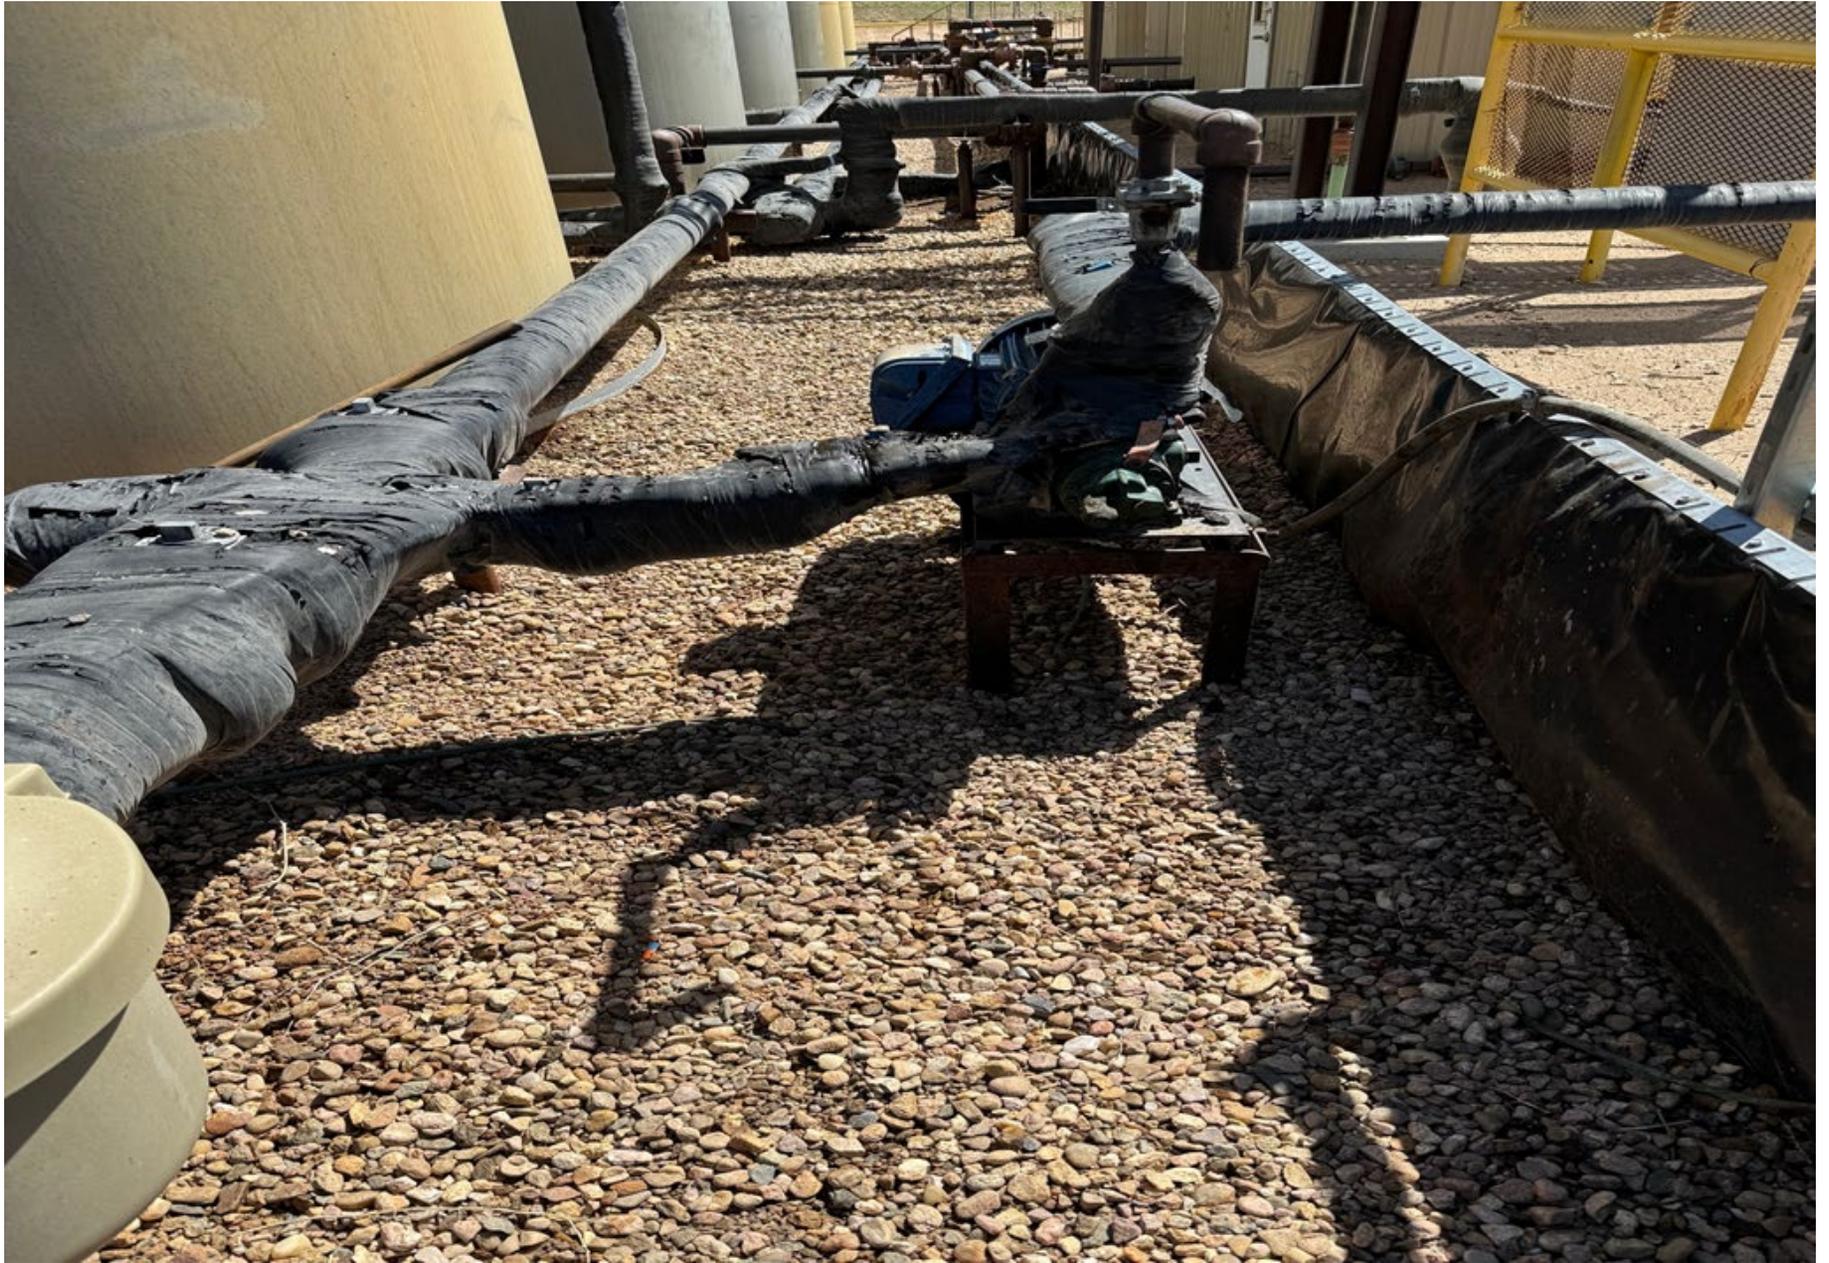
Exhibit B

**CA:** *Stained soil observed near unplugged hose, loadout lines, within secondary containment of tank batteries and buried tanks. Remove stained soil per Rule 912.a.*

**CA Resolution:** *Stained soil has been removed to comply with Rule 912.a.*
