WELL NAME: GOLDEN EAGLE 34-03, API #: 071-06182, INSP. # 695109520

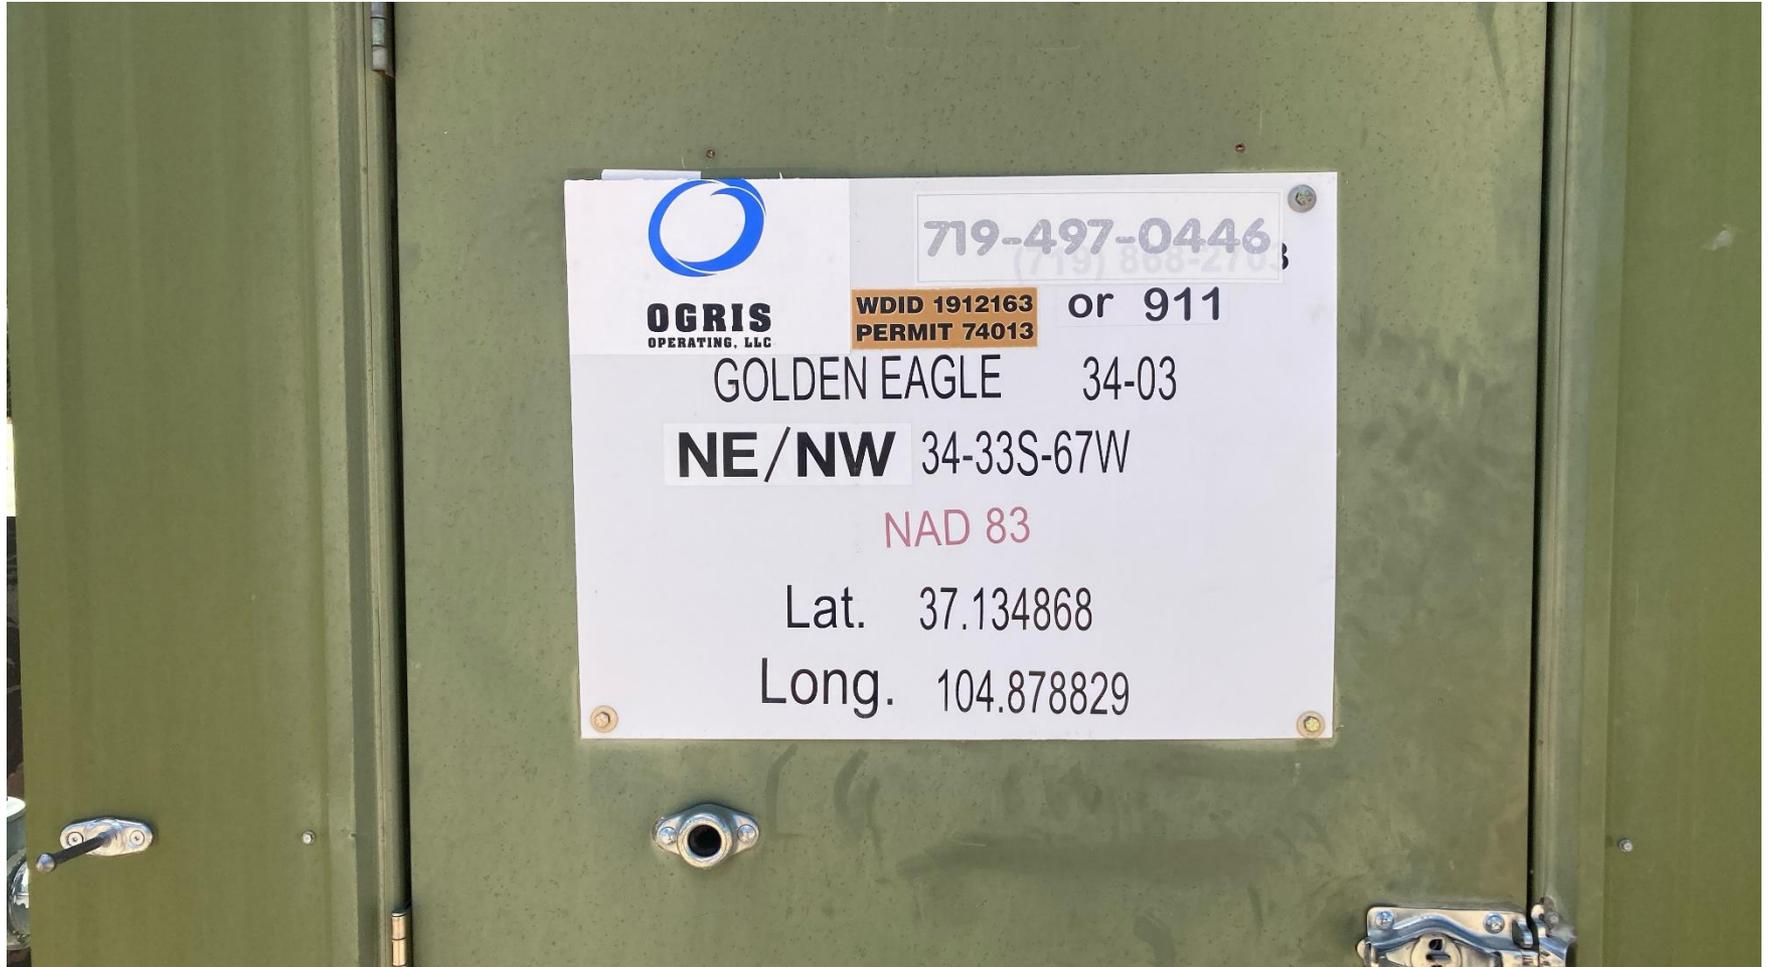
PHOTO 1: WELL SIGN

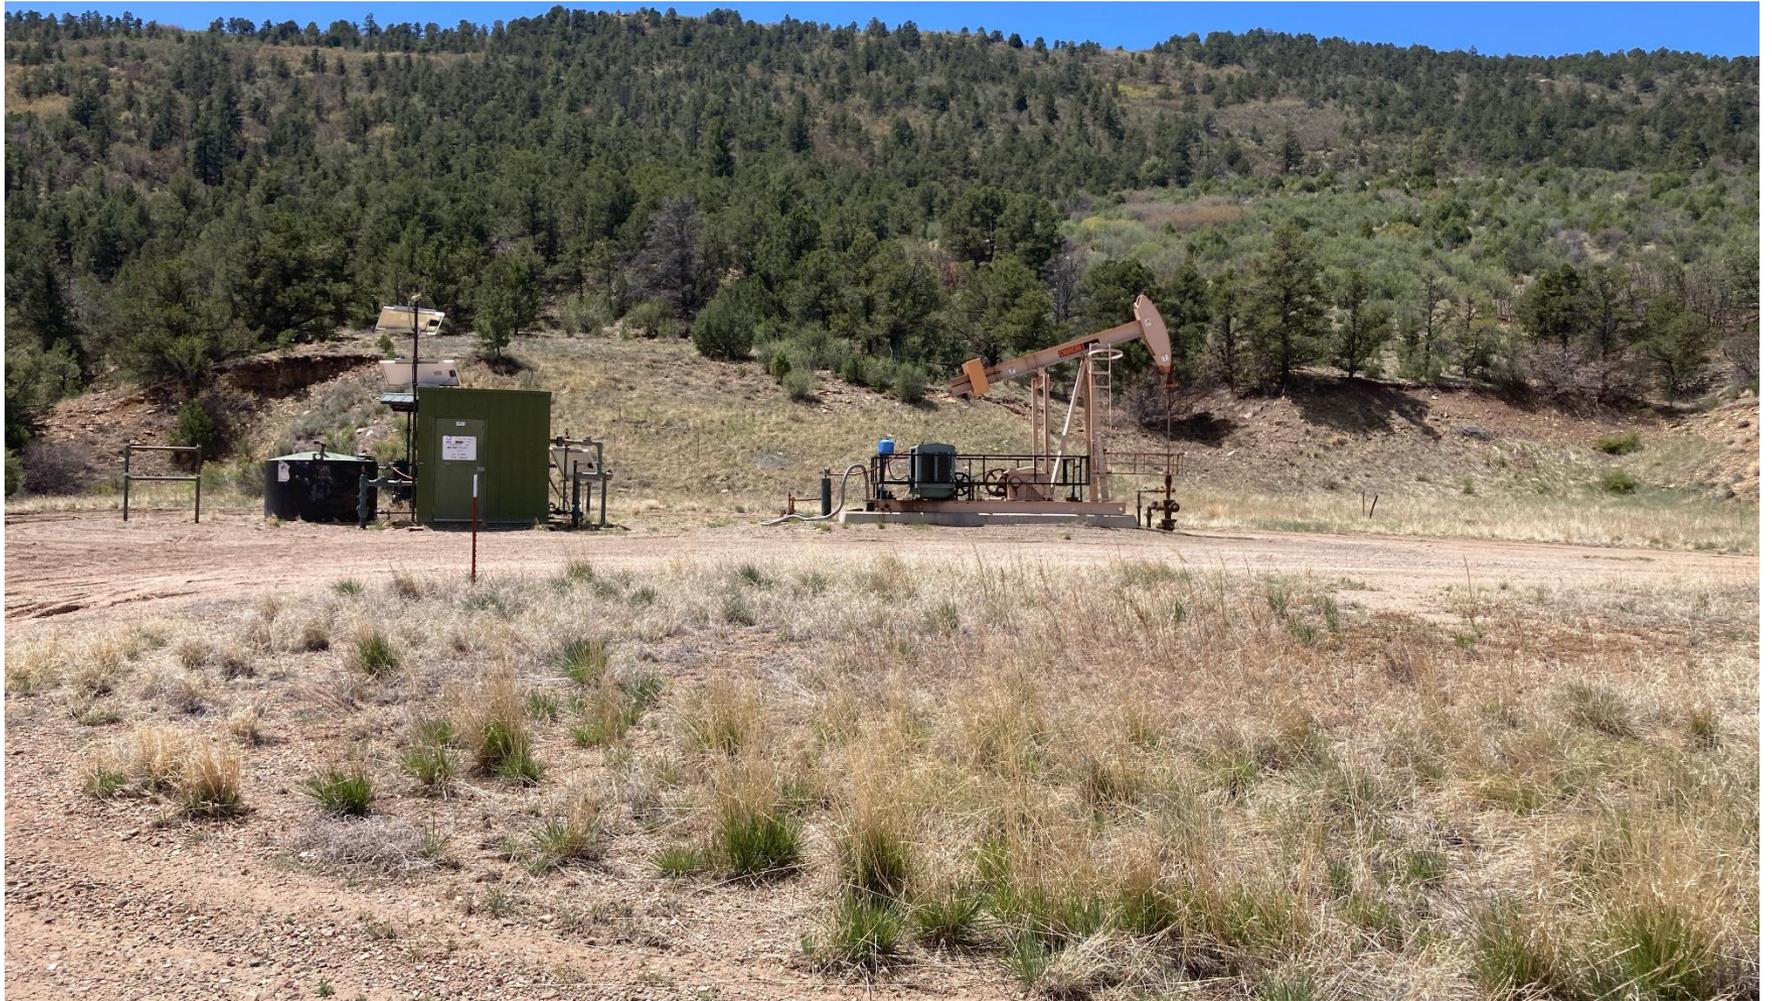
PHOTO 2: LOCATION

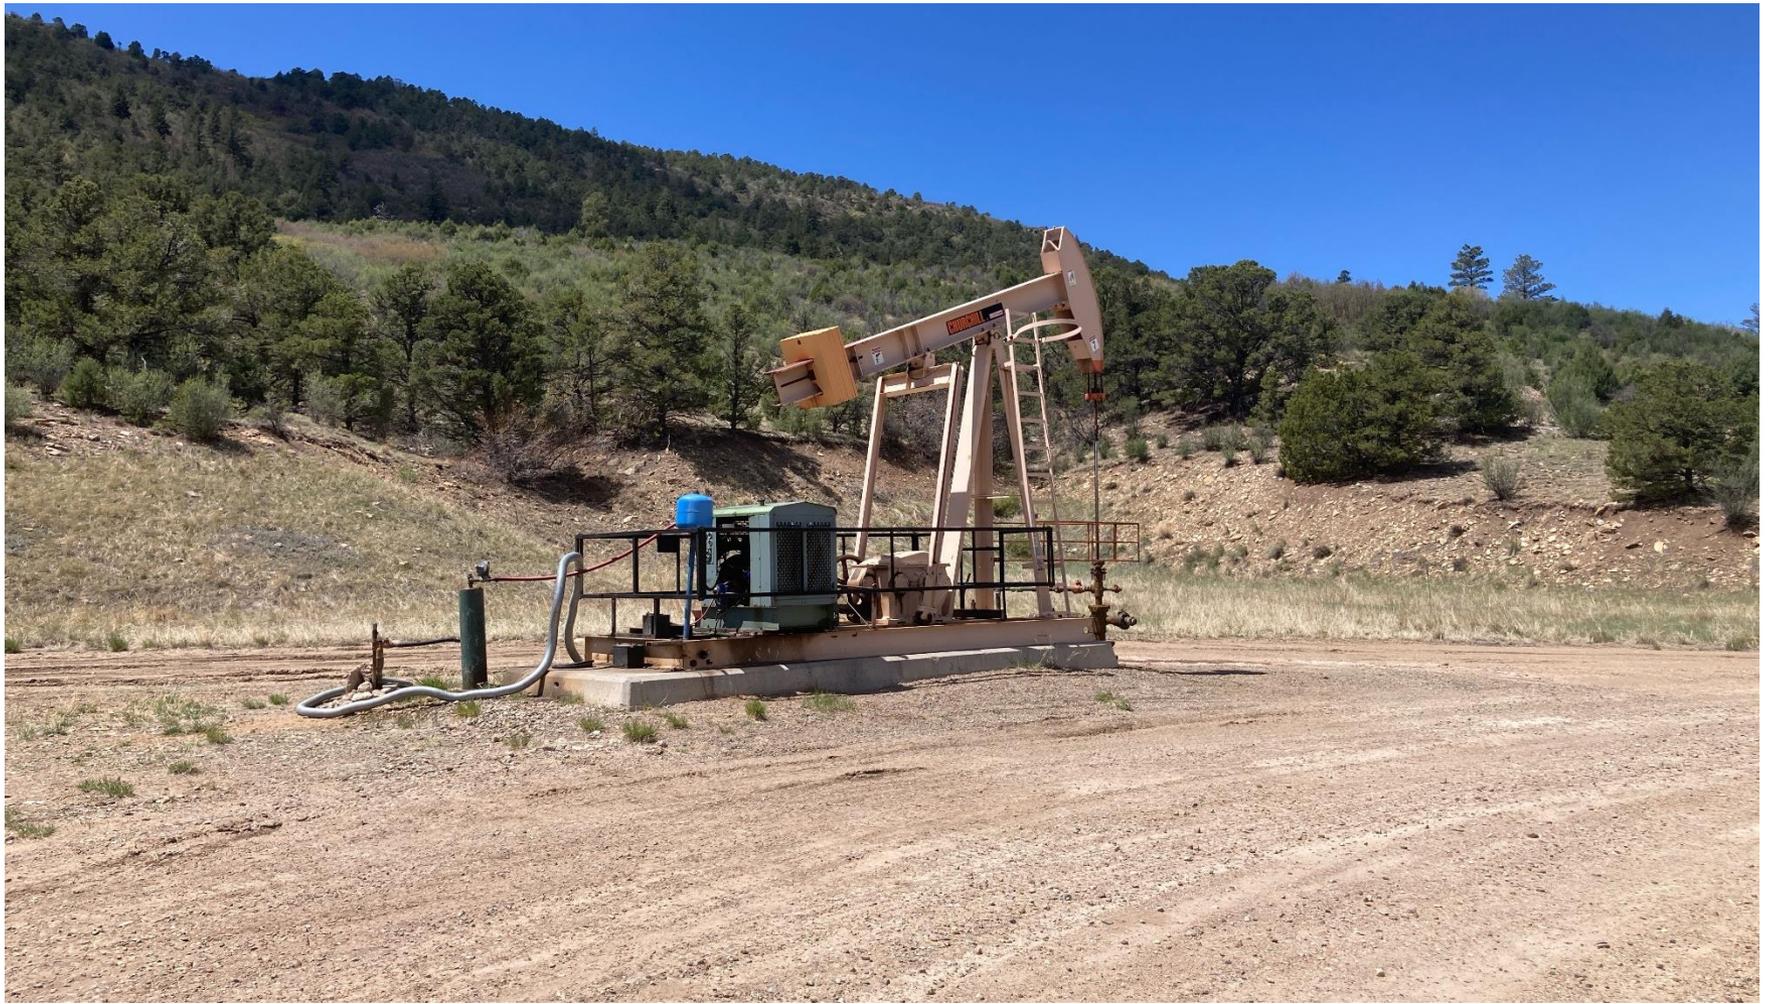
PHOTO 3: WELLHEAD AND EQUIPMENT

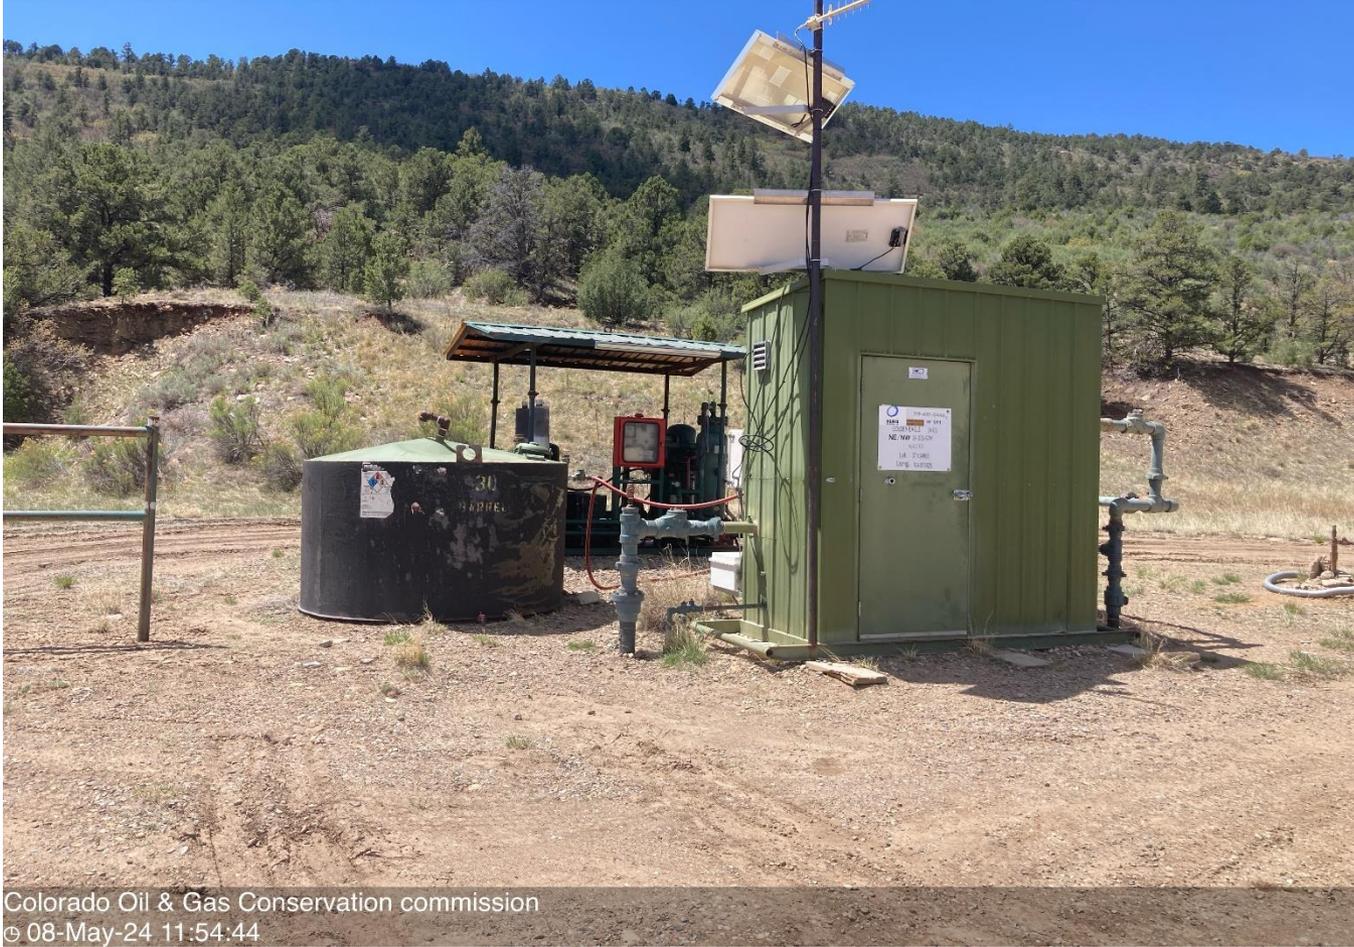
PHOTO 4: WELL EQUIPMENT

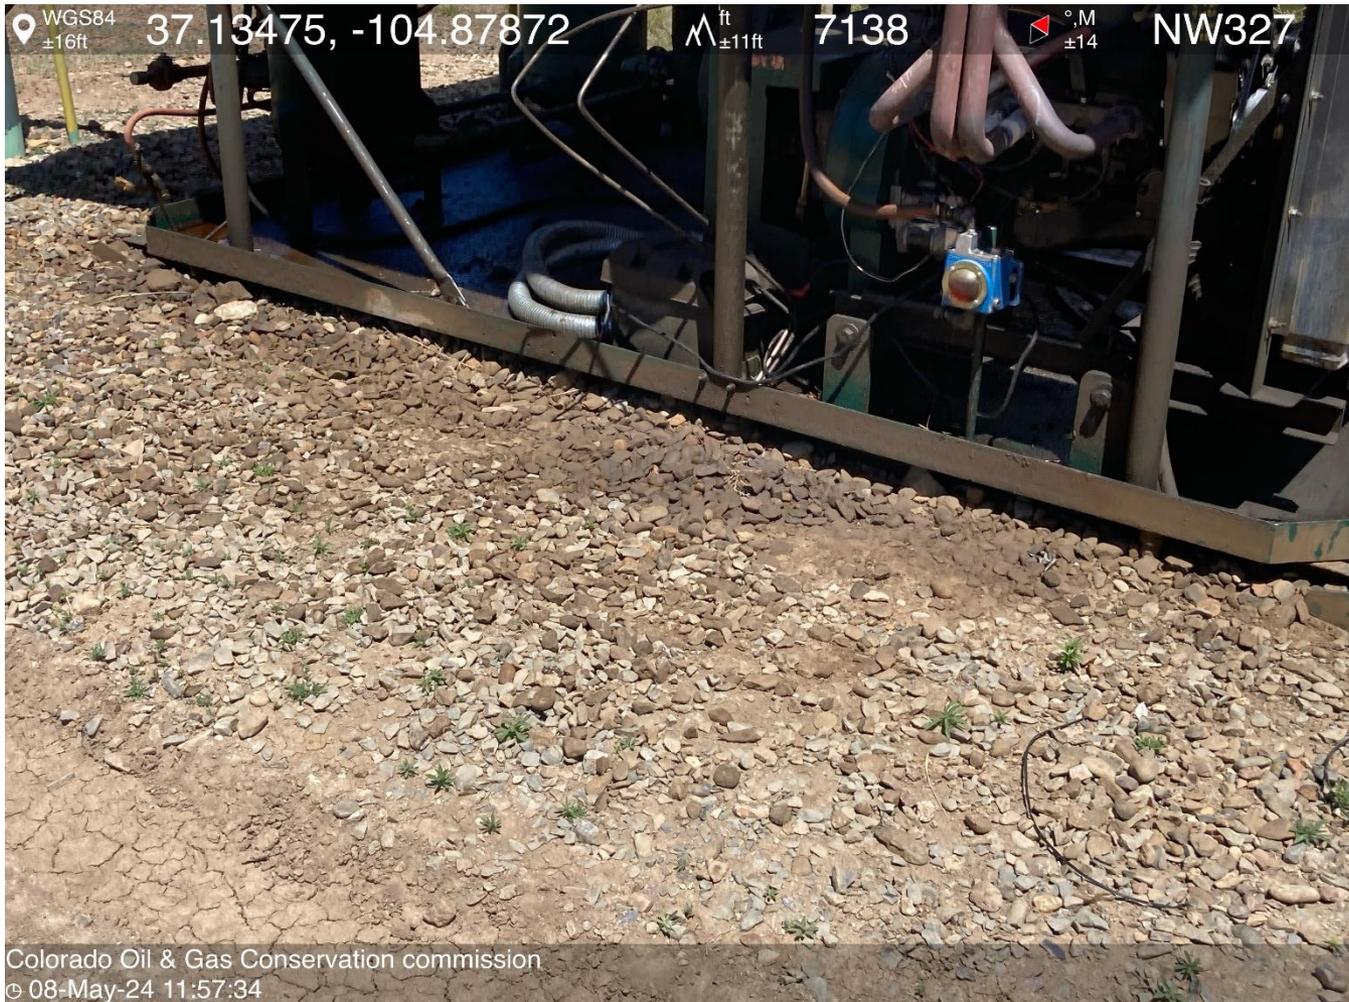
PHOTO 5: AREA OF IMPACTED SOIL NEAR COMPRESSOR SKID. Conduct maintenance on equipment, cleanup stained material and review self inspection processes. COMPLY WITH RULE 1002,.(2).D. CA DATE 6-8-2024.

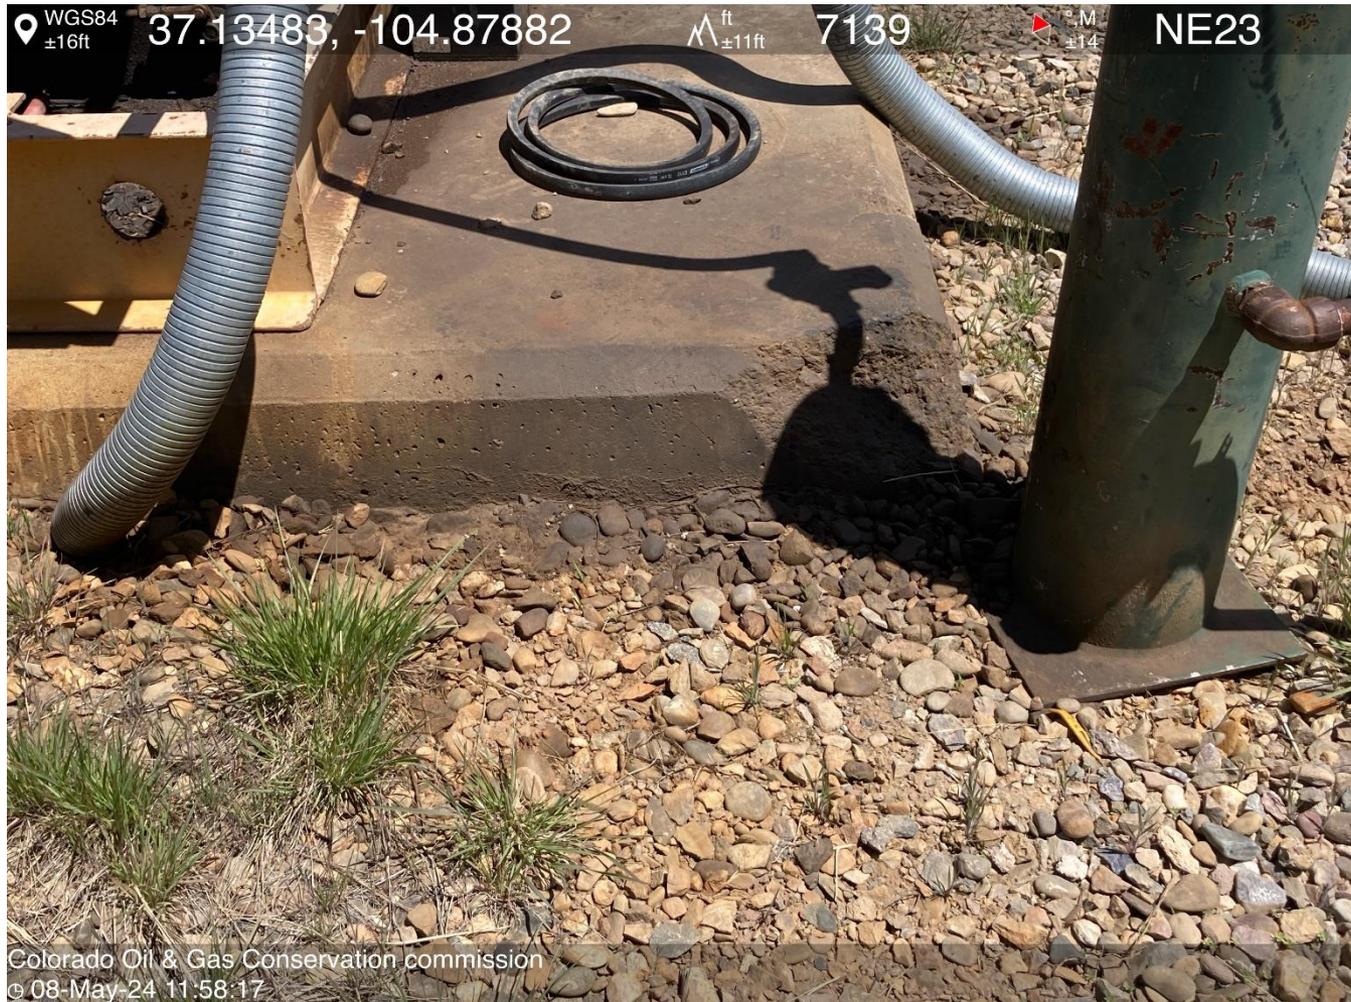
PHOTO 6: AREA OF IMPACTED SOIL NEAR PUMPJACK SKID. Conduct maintenance on equipment, cleanup stained material and review self inspection processes. COMPLY WITH RULE 1002,.(2).D. CA DATE 6-8-2024.

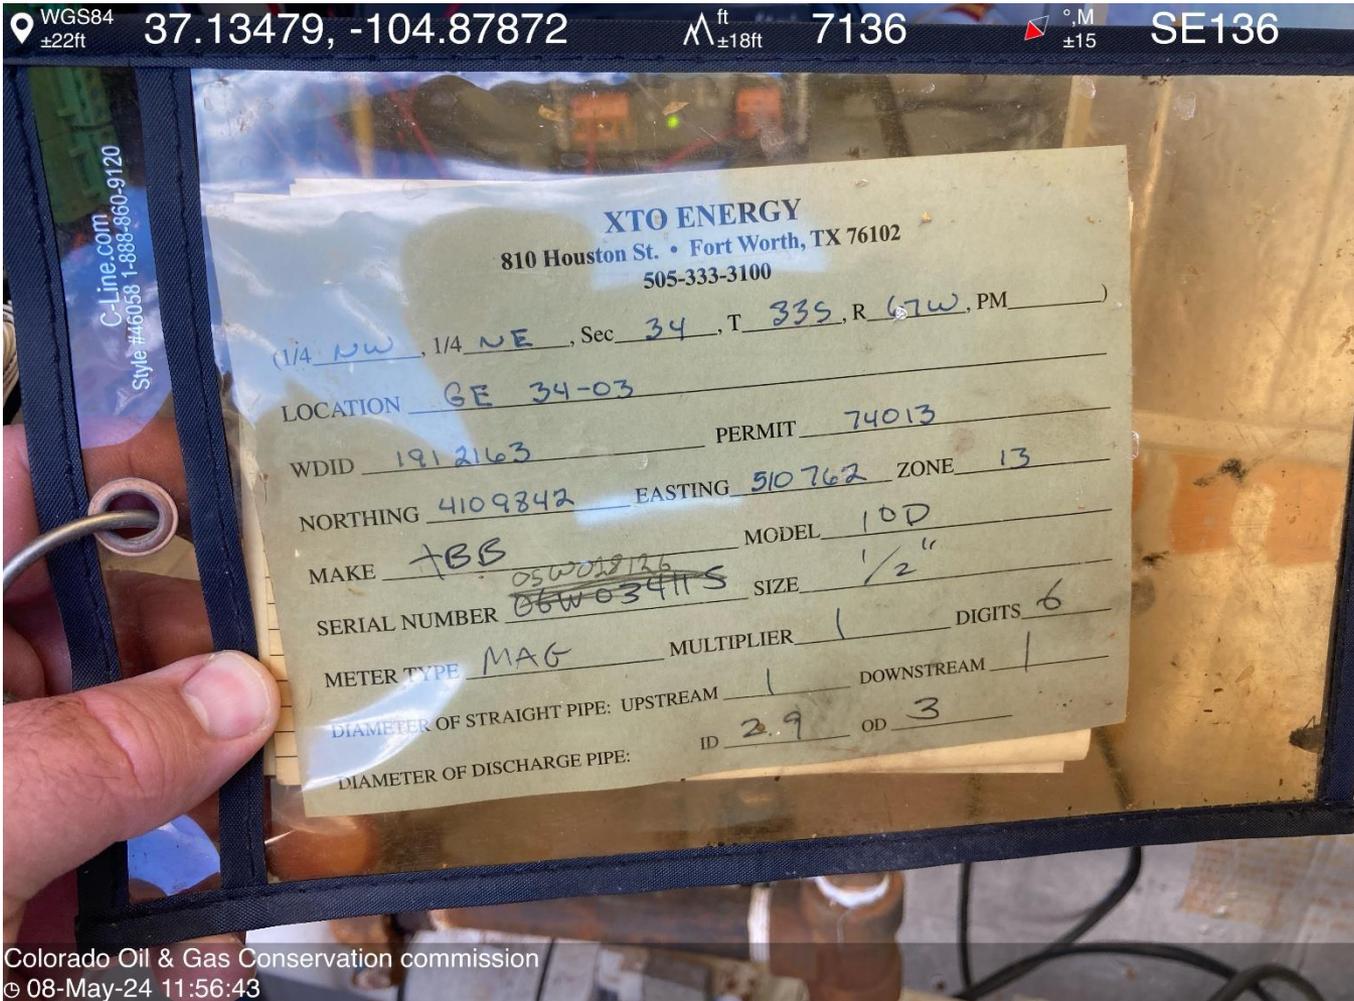
PHOTO 7: NO CURRENT CALIBRATION LOG POSTED AT METER. PROVIDE AREA FIELD INSPECTOR (@ tombeardslee@state.co.us) A COPY OF THE GAS METER CALIBRATION RECORD OR KEEP A COPY OF LAST CALIBRATION RECORD ON LOCATION. CA DATE 6-8-2024.

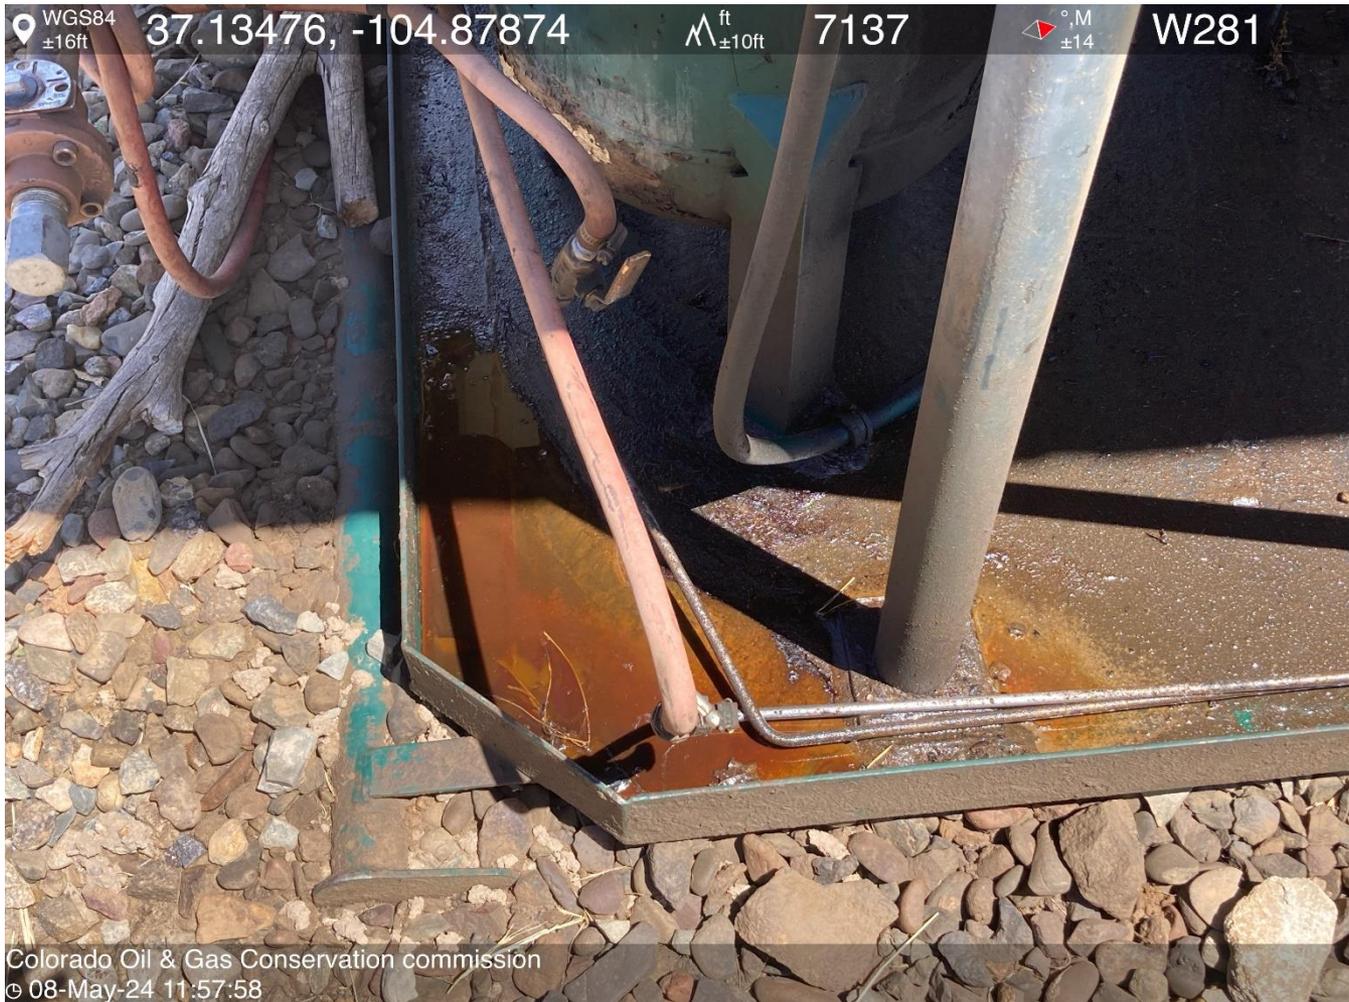
PHOTO 8: OILY WASTE IN ENGINE SKID. COMPLY WITH RULE 1002.f.(2)B, Comply with general provisions of the oil and gas act for wildlife protection AND SB-181. CA DATE 5-9-2024.
