CHEVRON U.S.A. INC.

SKR #698-10-BV PAD  
TRACT 72, SECTIONS 10 & 15, T6S, R98W, 6th P.M.  
GARFIELD COUNTY, COLORADO

**GEOLOGIC HAZARDS MAP**

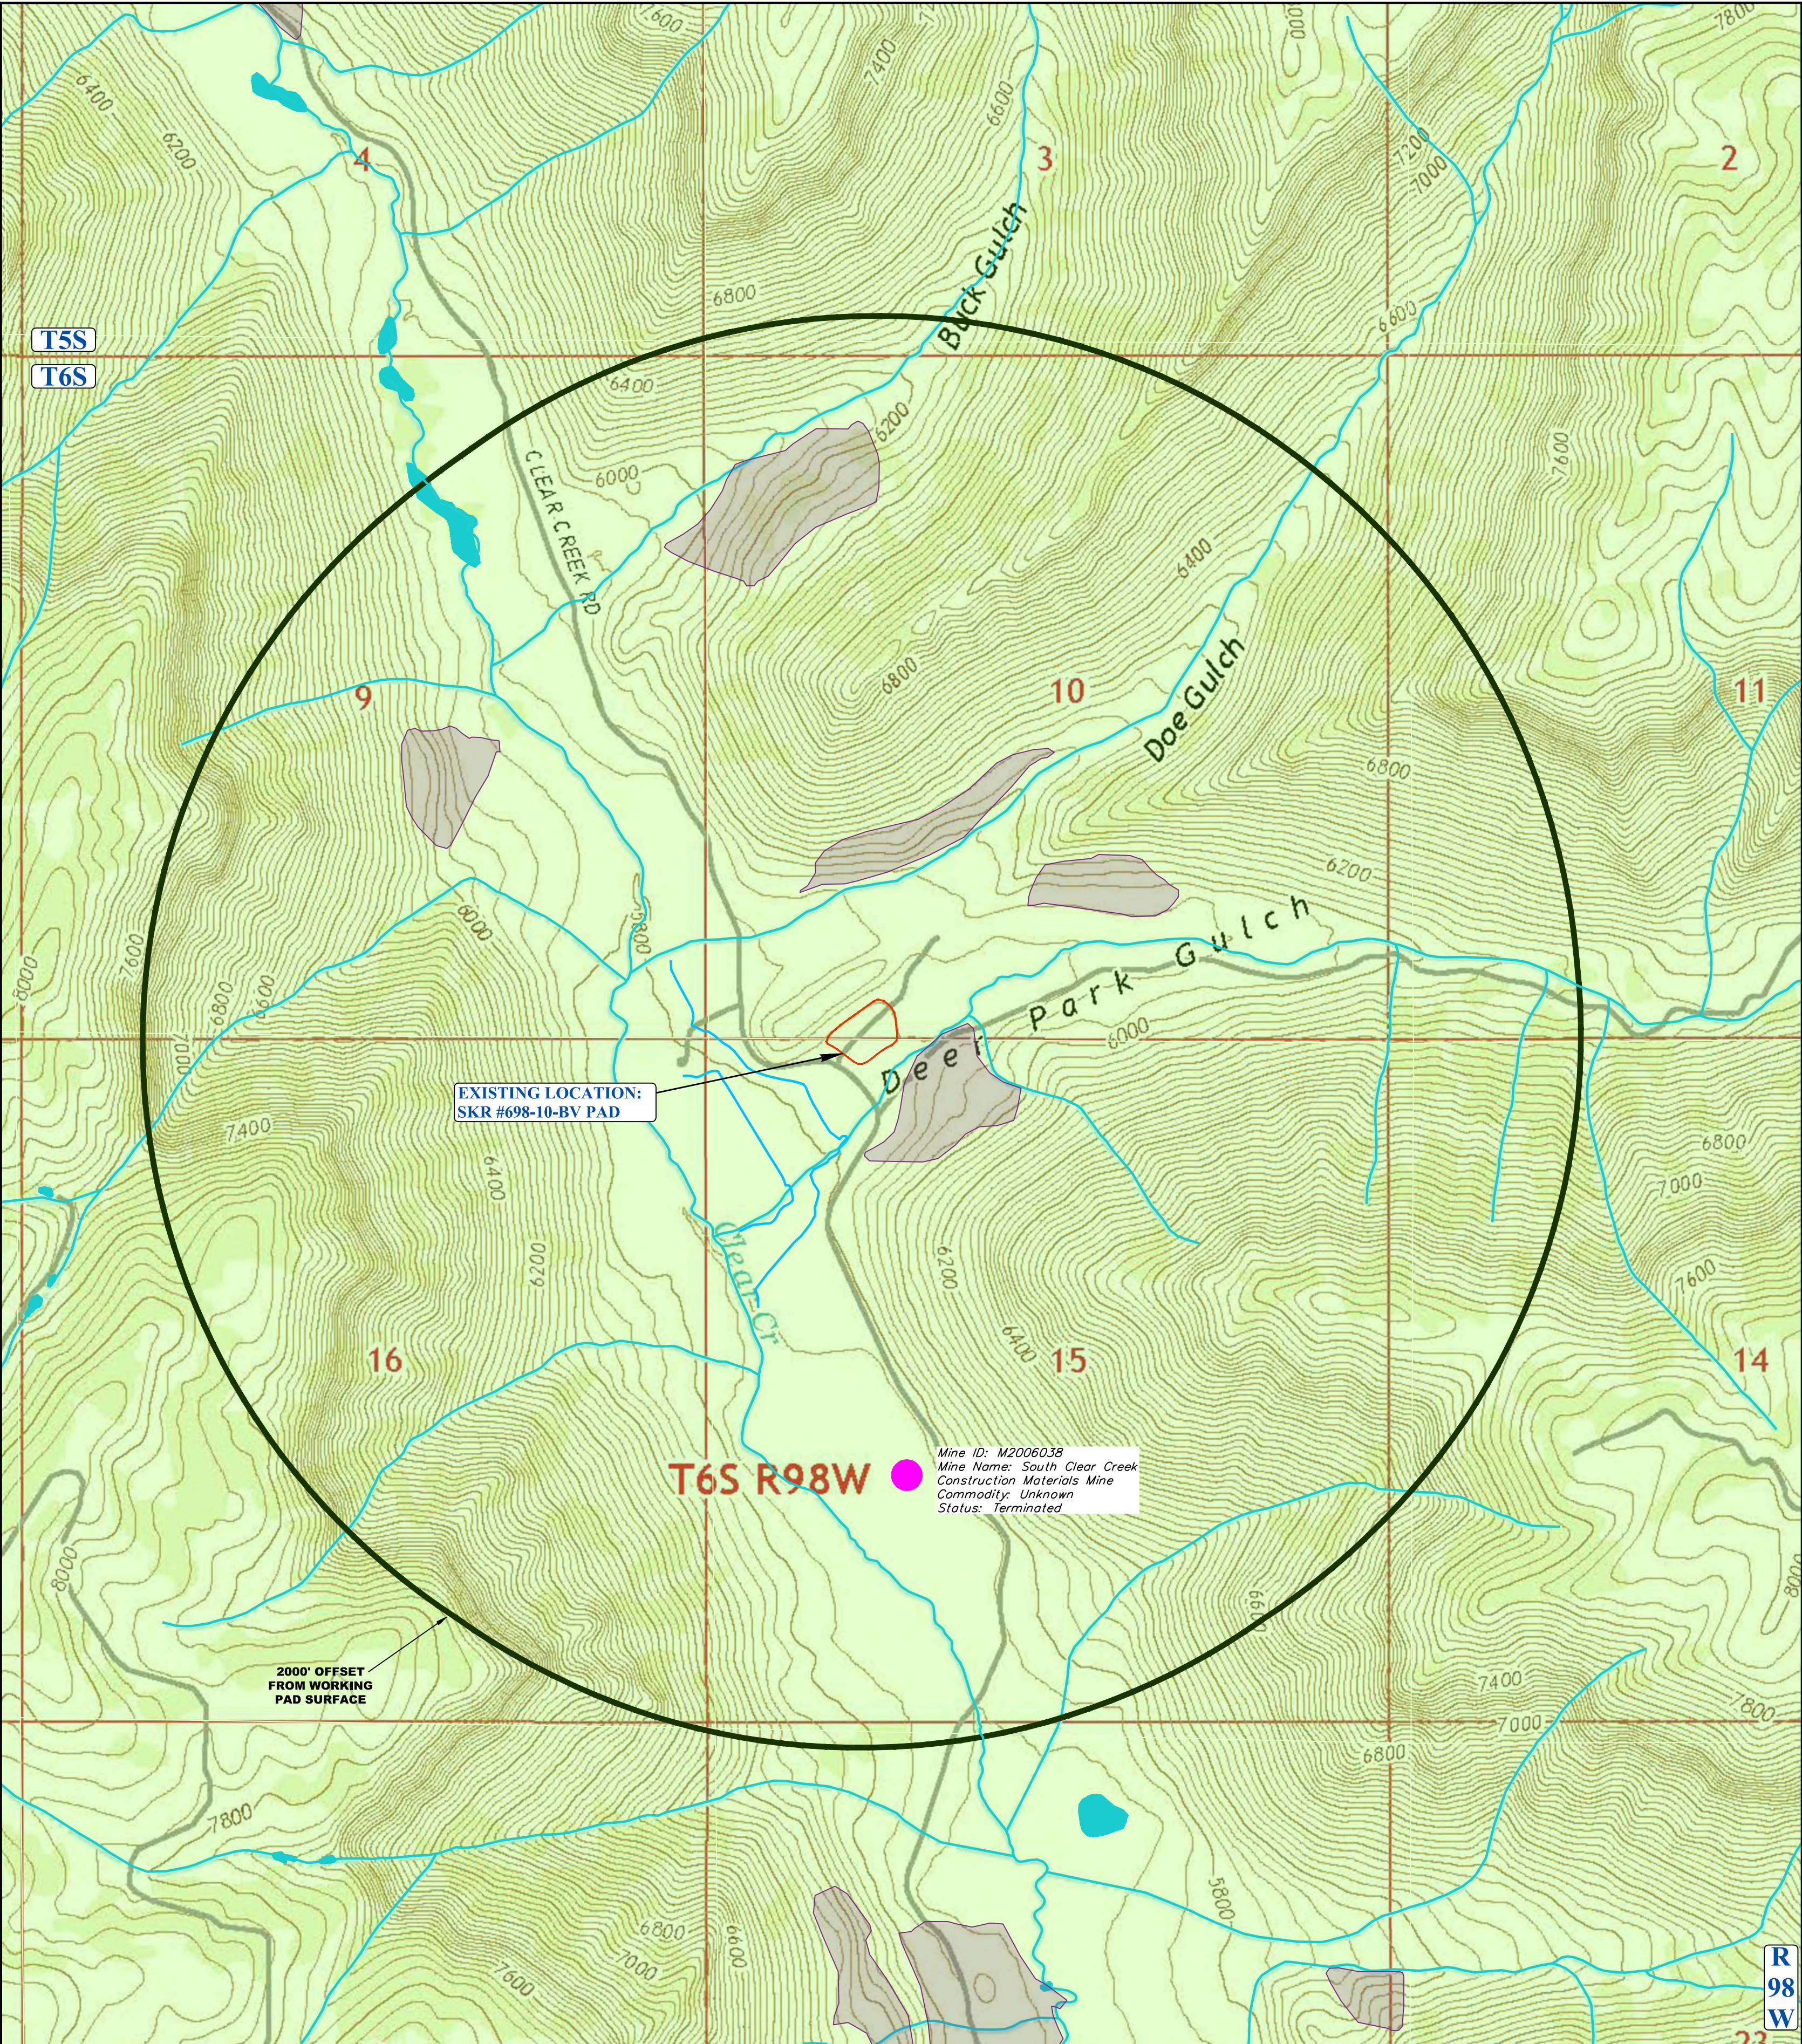
- There are no known/permitted coal areas, landslides or earthquake records within 5280' of the working pad surface. [https://cogccmap.state.co.us/cogcc\\_gis\\_online/](https://cogccmap.state.co.us/cogcc_gis_online/) (07-03-23)

- Fault (ECMC) - None - [https://cogccmap.state.co.us/cogcc\\_gis\\_online/](https://cogccmap.state.co.us/cogcc_gis_online/) (07-03-23)
- Landslide (ECMC) - [https://cogccmap.state.co.us/cogcc\\_gis\\_online/](https://cogccmap.state.co.us/cogcc_gis_online/) (07-03-23)

- Underground Mine (ECMC) - None - [https://cogccmap.state.co.us/cogcc\\_gis\\_online/](https://cogccmap.state.co.us/cogcc_gis_online/) (07-03-23)
- Collapsible Soils (CGS) - <https://cologeosurvey.maps.arcgis.com/apps/webappviewer/index.html?id=a6f816b35fb64d3da096e84af661f070> (07-03-23)

- Radioactive Minerals (ECMC) - None - [https://cogccmap.state.co.us/cogcc\\_gis\\_online/](https://cogccmap.state.co.us/cogcc_gis_online/) (07-03-23)
- Floodplain information was taken from ECMC GIS data. (Floodplain-Colorado 100-year Effective as of (2020) (07-03-23)

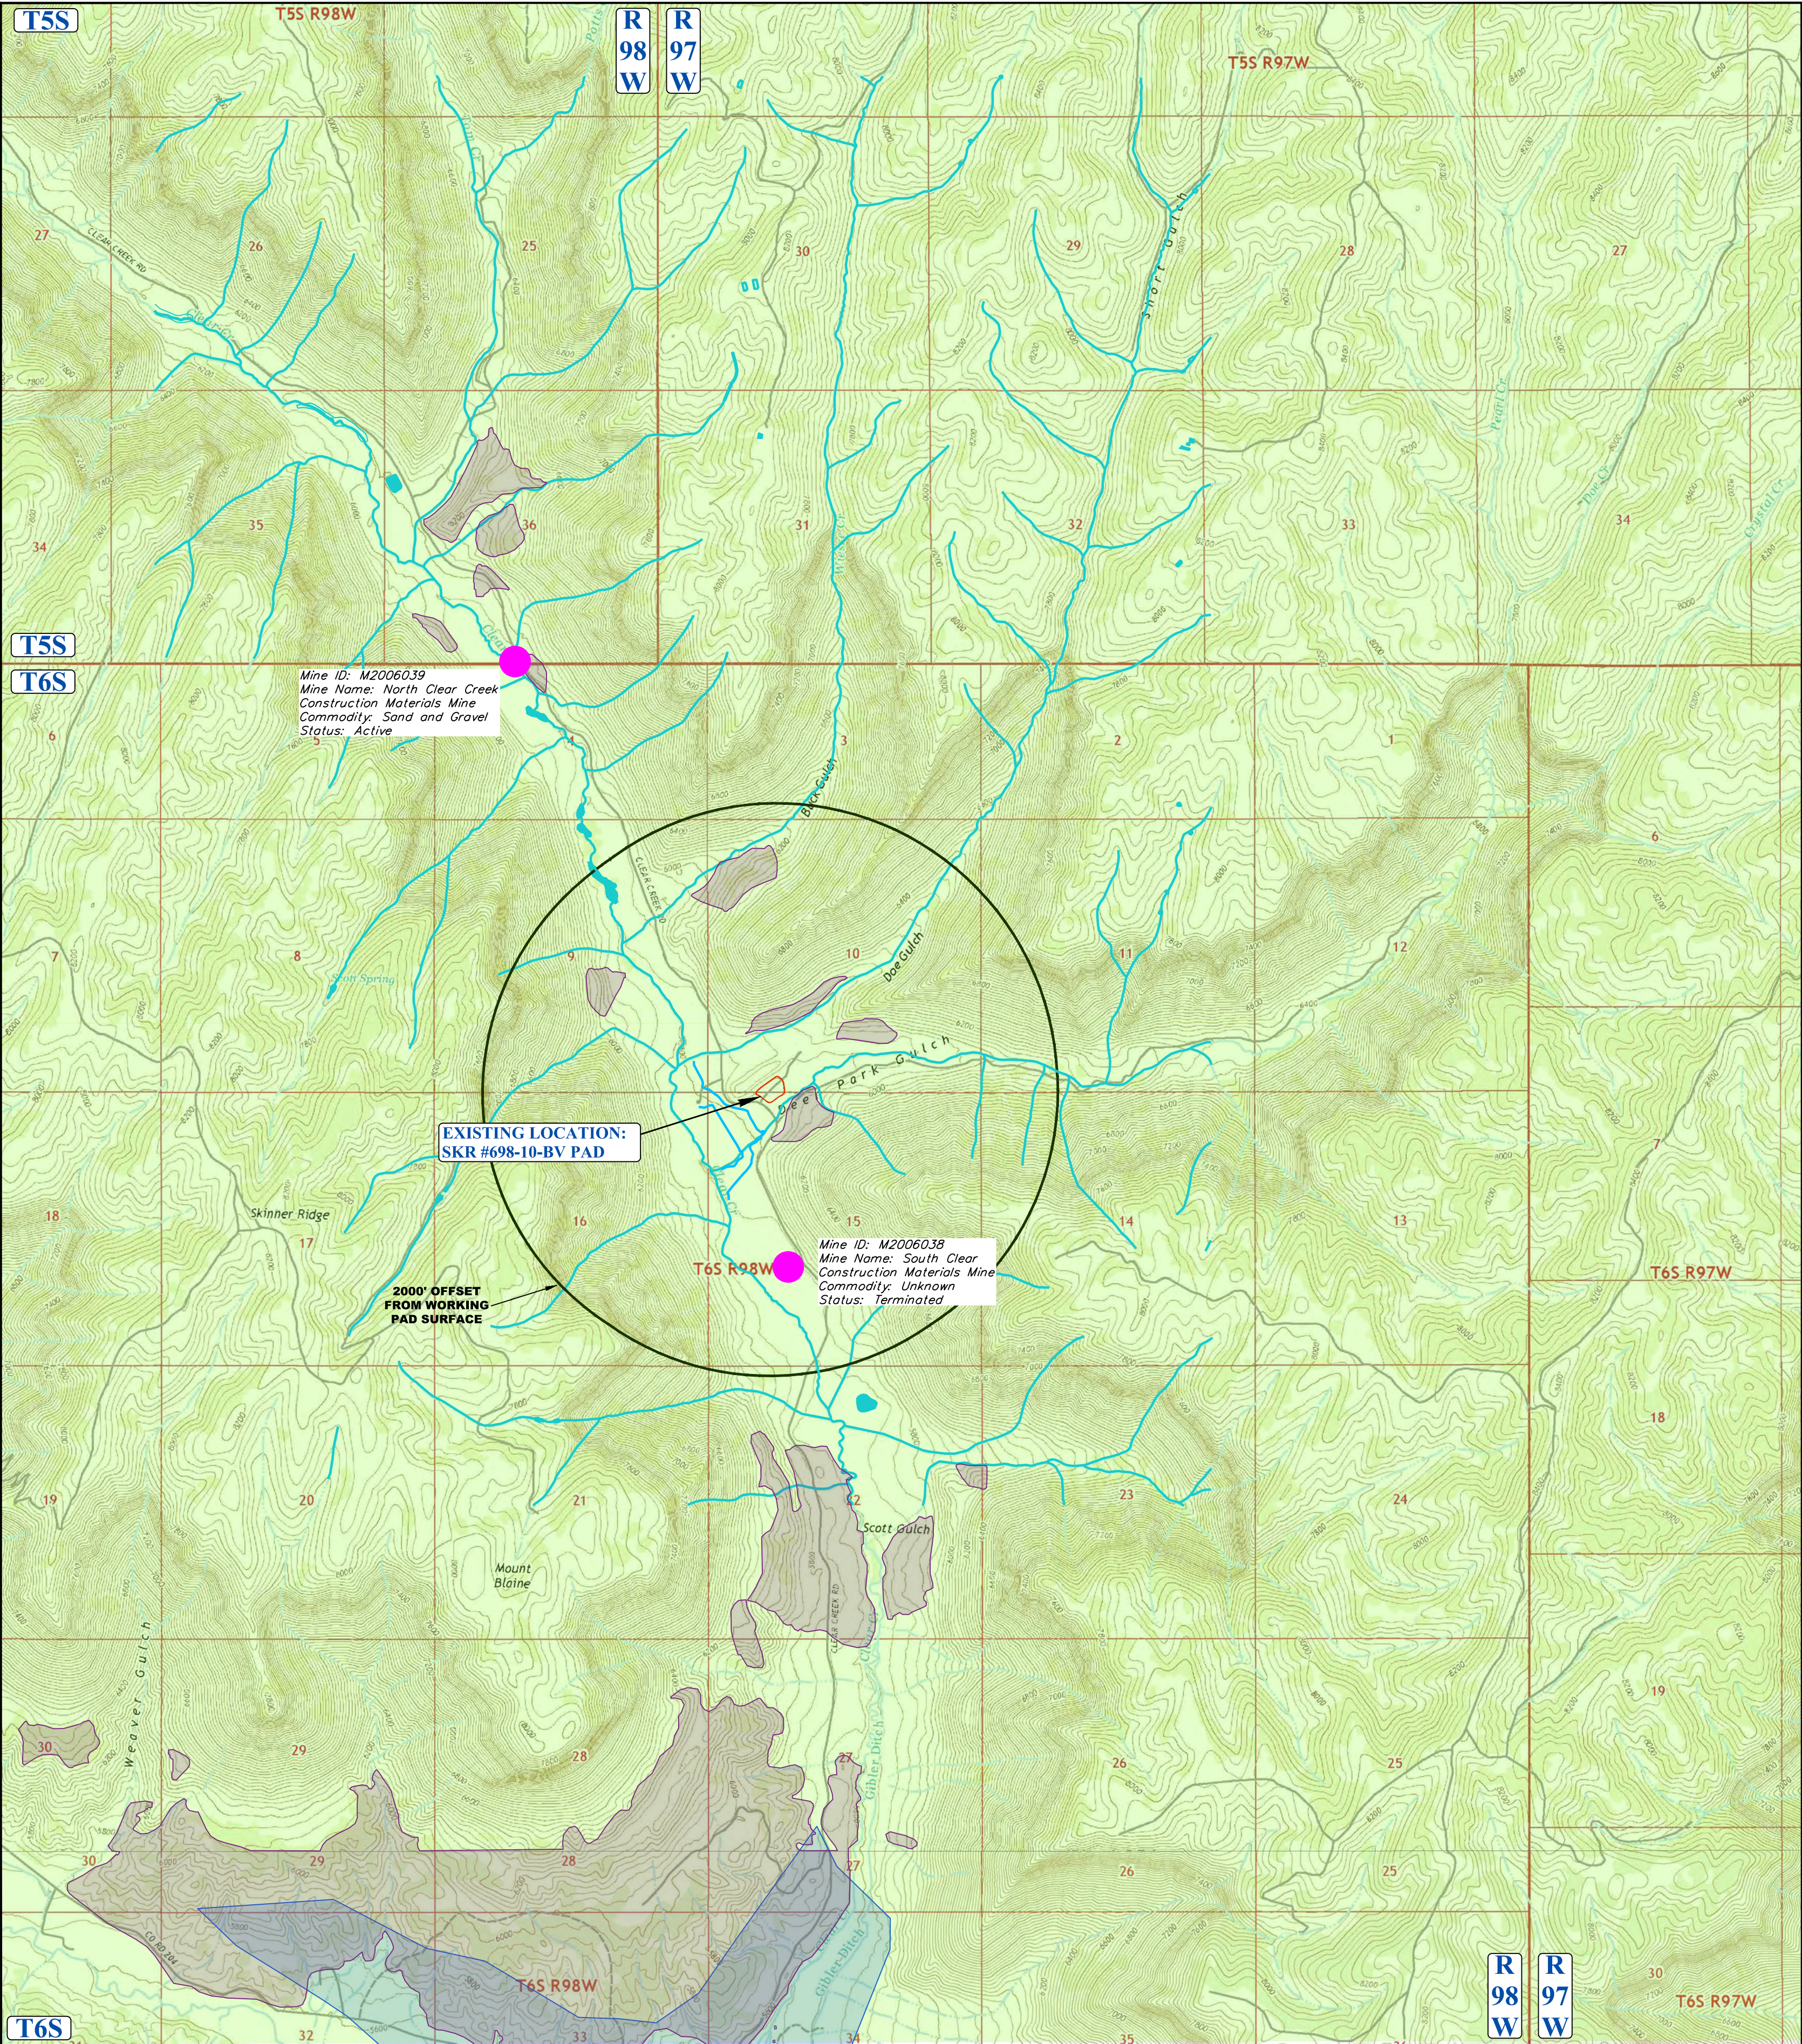
**GEOLOGIC HAZARDS MAP**

- There are no known/permitted coal areas, landslides or earthquake records within 5280' of the working pad surface. [https://cogccmap.state.co.us/cogcc\\_gis\\_online/](https://cogccmap.state.co.us/cogcc_gis_online/) (07-03-23)

- Fault (ECMC) - None - [https://cogccmap.state.co.us/cogcc\\_gis\\_online/](https://cogccmap.state.co.us/cogcc_gis_online/) (07-03-23)
- Landslide (ECMC) - [https://cogccmap.state.co.us/cogcc\\_gis\\_online/](https://cogccmap.state.co.us/cogcc_gis_online/) (07-03-23)

- Underground Mine (ECMC) - None - [https://cogccmap.state.co.us/cogcc\\_gis\\_online/](https://cogccmap.state.co.us/cogcc_gis_online/) (07-03-23)
- Collapsible Soils (CGS) - <https://cologeosurvey.maps.arcgis.com/apps/webappviewer/index.html?id=a6f816b35fb64d3da096e84af661f070> (07-03-23)

- Radioactive Minerals (ECMC) - None - [https://cogccmap.state.co.us/cogcc\\_gis\\_online/](https://cogccmap.state.co.us/cogcc_gis_online/) (07-03-23)
- Floodplain information was taken from ECMC GIS data. (Floodplain-Colorado 100-year Effective as of (2020) (07-03-23)
