Storm Water Management and Erosion control
Location Name: TEP ROCKY MOUNTAIN LLC BAILEY COMPRESSOR STATION
Facility ID: 412030

Section/Township/Range: 22 6S92W

COLORADO
Energy & Carbon Management
Commission
Department of Natural Resources

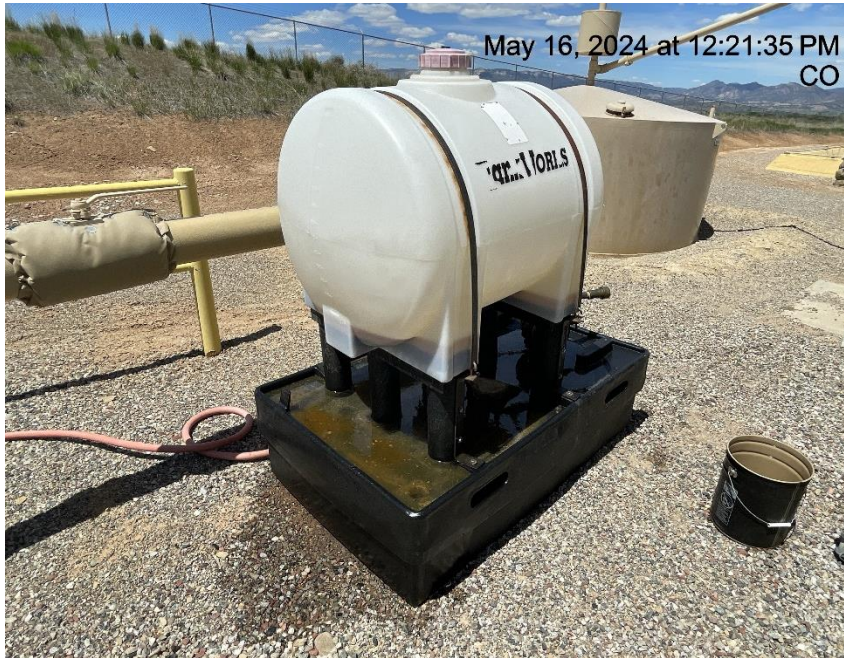
Photo # 7435 Failure to maintain chemical BMP - Chemical tank containment full of fluid/fluid overflowed containment & spilled on the ground

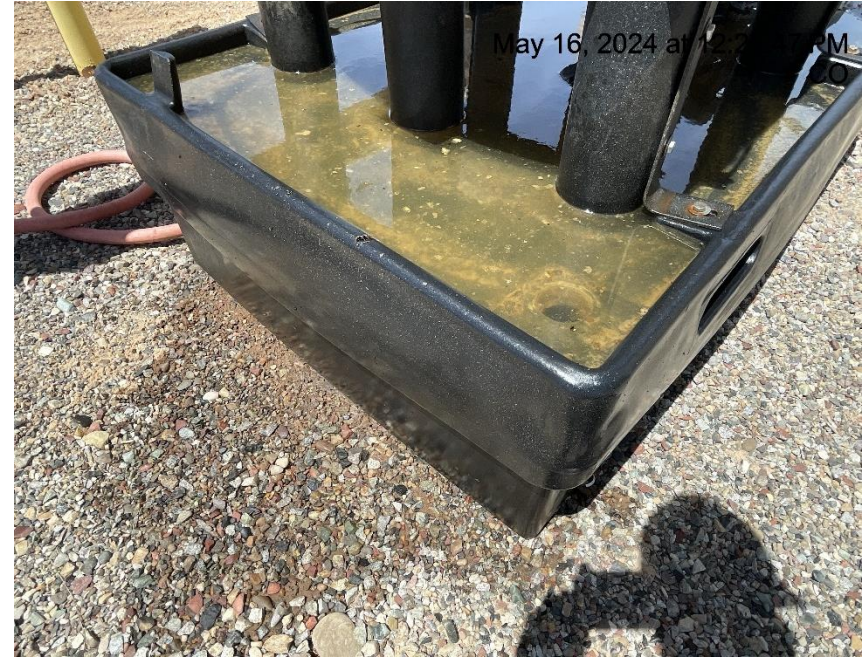
Photo # 7436 Failure to maintain chemical BMP - Chemical tank containment full of fluid/fluid overflowed containment & spilled on the ground

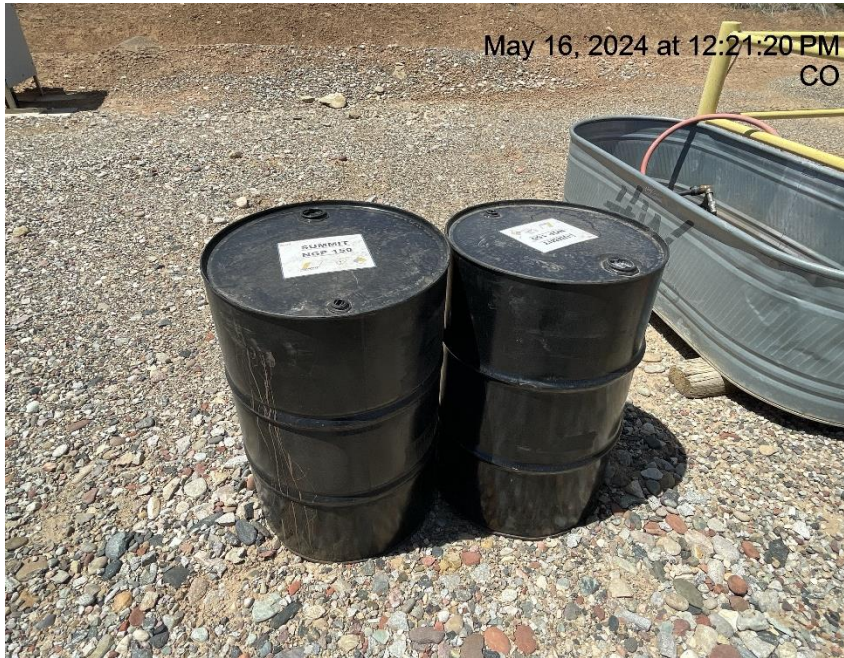
Photo # 7439 Chemical drums with no BMP's/during inspection TEP employee transferred drums to a metal containment
