**Operator: HIGHPOINT OPERATING CORPORATION**  
**Location Name: Anschutz Equus Farms 4-62-20\_21 SWNW**  
**Loc ID: 444717**  
**Inspection: 713900517**

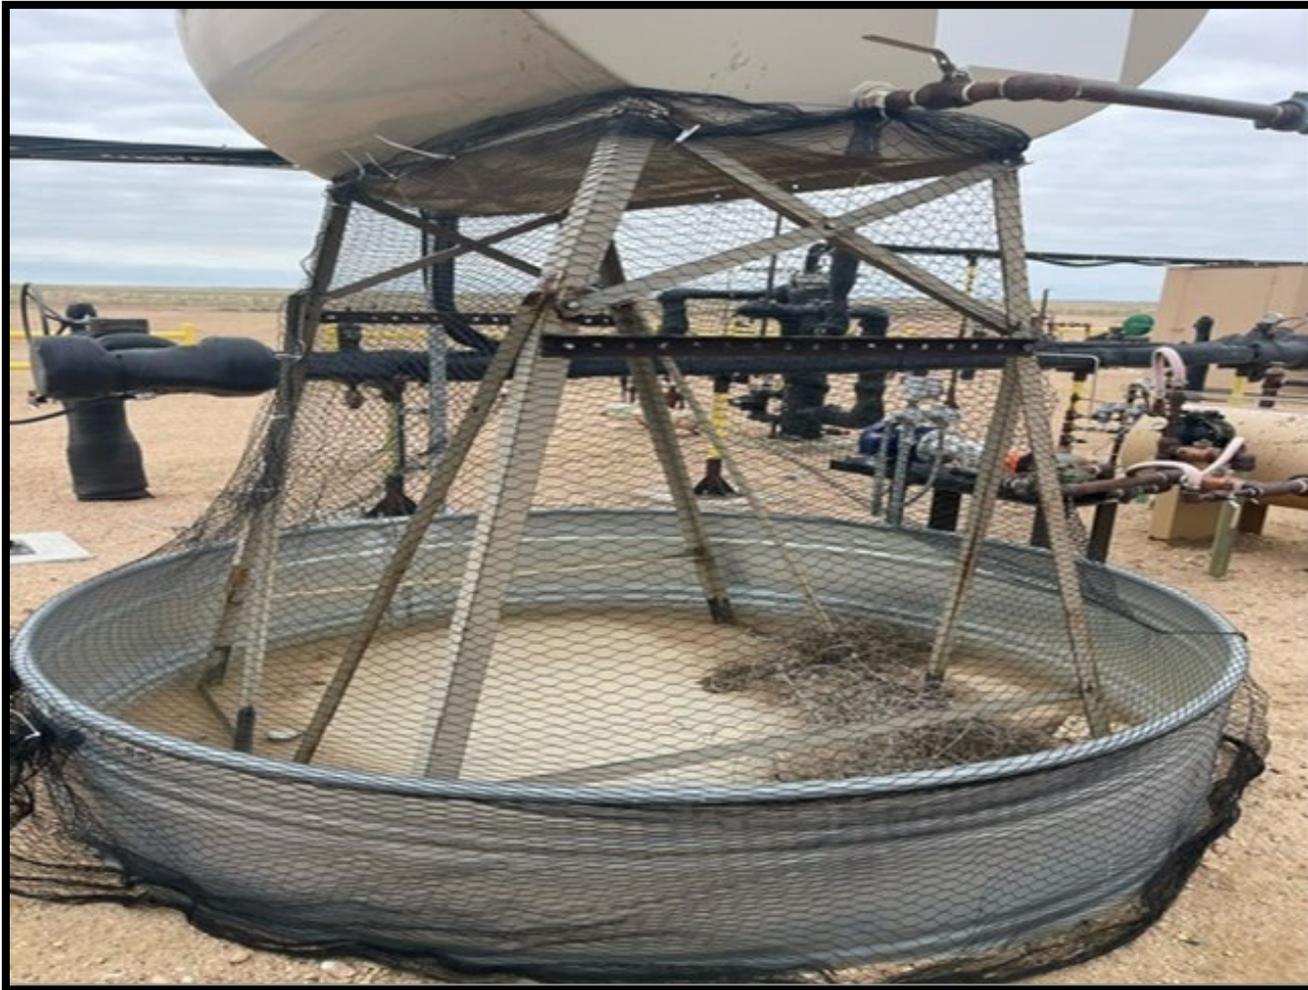
**Exhibit A**

**CA:** Missing wildlife netting on secondary containment. Comply with Rule 608.

**CA Resolution:** Operator has appropriately installed Wildlife Netting to comply with Rule 608.

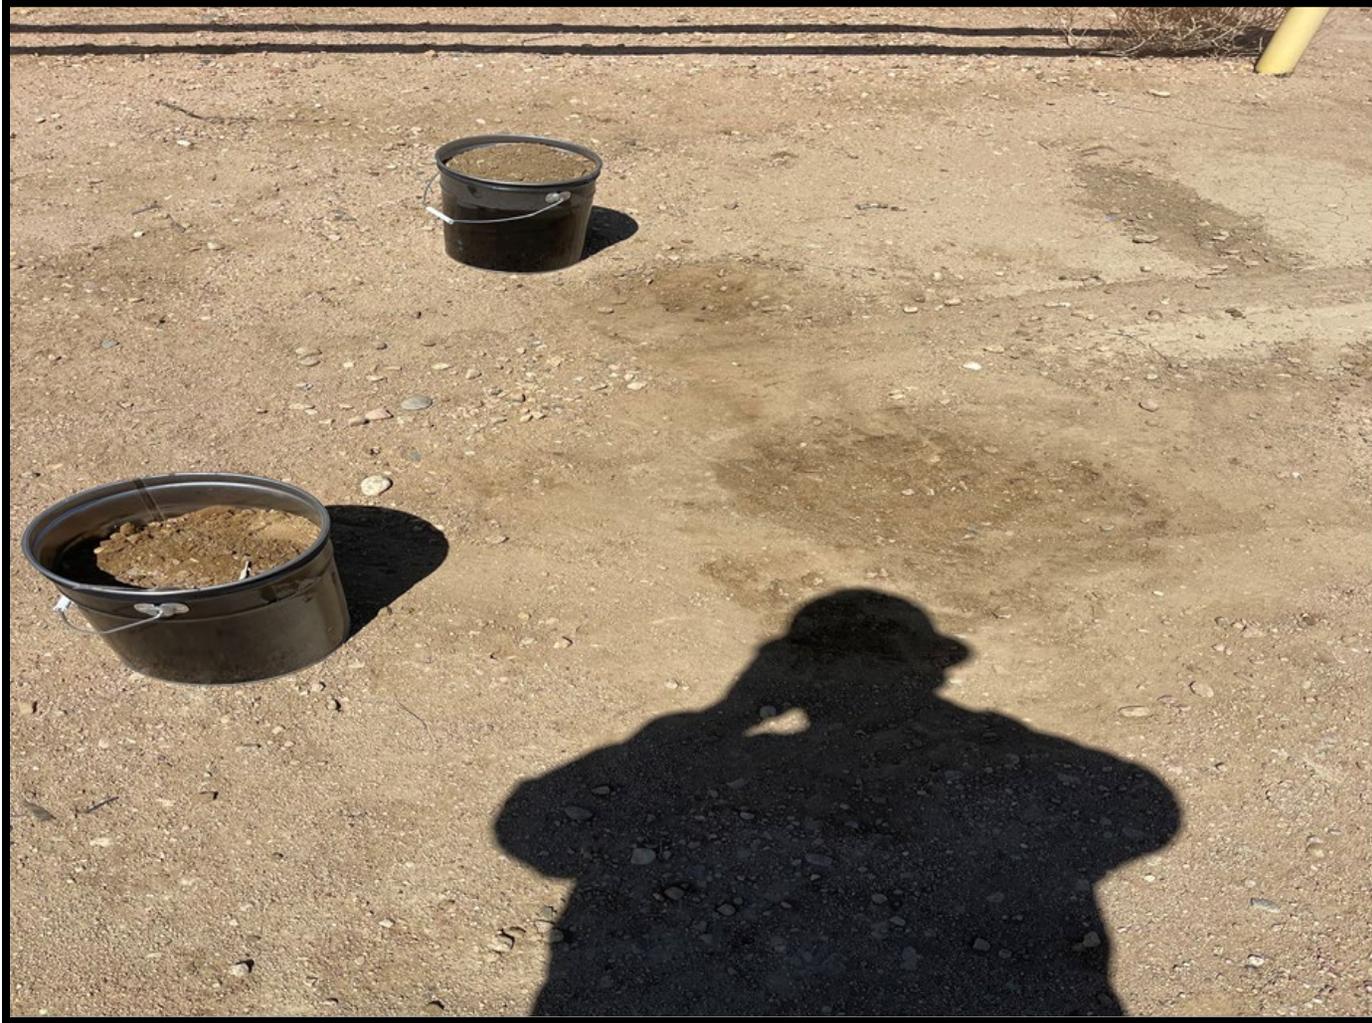
**Exhibit A**

**CA:** Stained soil observed near unplugged hose that appeared to have soil moved over it. Remove stained soil per Rule 912.a.

**CA Resolution:** Operator has reported that the identified stained soil has been appropriately removed/disposed of to comply with Rule 912.a.
